Ex-Post Monitoring of Completed ODA Loan Projects

Project Name: India - Teesta Canal Hydroelectric Project (I), (II) (L/A No. ID-P40, ID-P72)

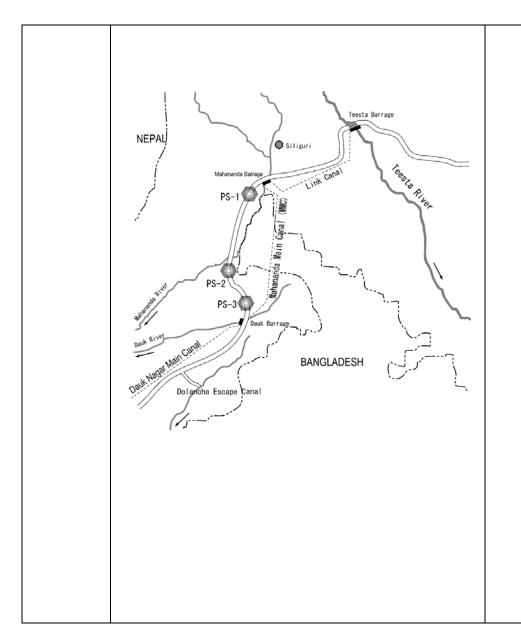
(i) Collapse of MMC revetments
	In the 5.5km from Mahananda Barrage to Power Station No.1
	and for several kilometers further downstream, small concrete
	and for several knowledge further downstream, shall concrete

panels and waterproof sheets are used as canal revetments, but almost all of these revetments have collapsed before reaching even half of the 30-year lives they were designed for. Also, 2km to 3km upstream from Power Station No. 2, levees breached in both 1999 and 2005. There is also deterioration of concrete panels, plant growth in joints, etc. in other canal sections, and if these other sections are left as is, places remain where it is feared that the problems will progress until these revetments also collapse.

If a large volume of water is discharged, damage and decay of levees will progress, with increasing danger of eventual breach. This is why the Irrigation and Waterways Department is careful regarding increases in water discharge volume, with discharge restricted to about one third of the MMC's 345m³/sec. maximum designed discharge volume for almost all the time until today.

On many sections of the MMC until Power Station No. 2, in filling zones where the canal bed is higher than the surrounding elevation, levees are made of piled earth, which furthermore has a sandy composition, so there is a need for sufficiently strong levees and revetments. Based on the experiences described above, the Irrigation and Waterways Department is improving the width of levees and revetment structures in rehabilitation construction work currently being done. After rehabilitation construction work is finished, it is first necessary to confirm performance of the revetments, while slowly increasing water discharge volume over one to two months.
