Ex-Post Evaluation of Japanese ODA Loan Project

“Eastern Gandak Canal Hydroelectric Project”

Third Party Evaluator: IC Net Limited

Field Survey: October 2009

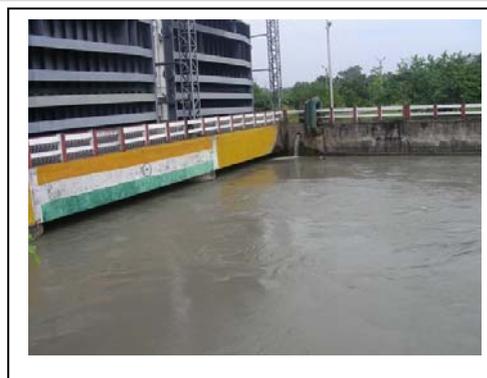
The power plant seen from downstream of the irrigation canal

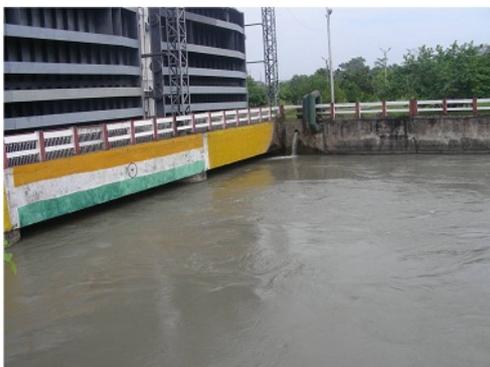
1. The East Gandak hydroelectric plant generates power by using the outlet head. The rated head at time of design was set at 5.3m. However, the head, when two units operate simultaneously, is 4.3m, which is too small to operate the generators under optimum conditions. The cause of this is the water level of the drainage channel reaching the upper limit of design of 104.9m, as pointed out at the time of the ex-post evaluation. Sufficient water quantity could not let two generators operate simultaneously at maximum output because it would cause overflow from the canal.

Fig. 1 Present Condition of the Outlet (One Generator Operating)

2. The operating test carried out in 2003 by the supplier described that elevation of water level is an obstacle to the full operation of the generators. It recommended expansion of width and depth of drainage channel.

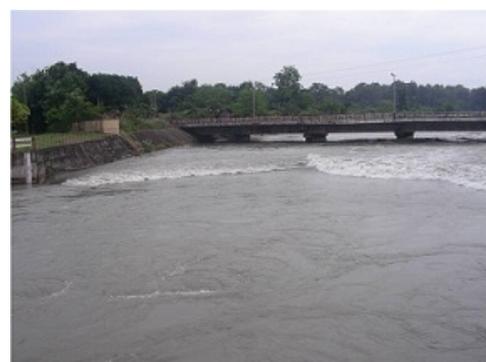
Fig. 2 Present Condition of the Outlet (Opposite Side)

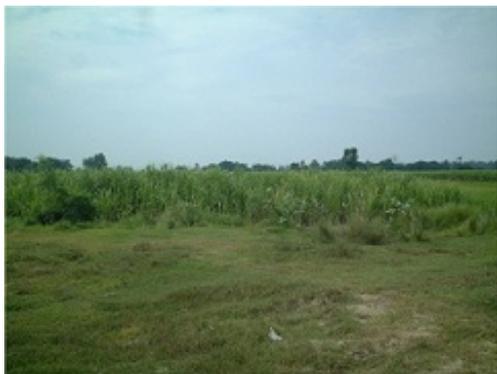
The present conditions of the escape channel, which was proposed by the ex-post evaluation, are as follows. Although a contract of its civil work was signed in 2007, actual construction has not yet begun and the start of construction has not yet been clearly scheduled.

1. The location for the channel has already been confirmed² and a contract of civil work was already signed in October 2007 (project cost: 230 million rupees). Also, the land acquisition has already reached agreement with respective landowners. (The compensation itself has not yet been paid.)
2. At present, the drainage channel has not been constructed and even the foundation work has not yet begun. According to the contractor, commencement of the civil work was planned for November 2009 after the end of the rainy season³.
3. BHPC plans 50% of the budget from their own capital and the rest to borrow from the National Bank for Agriculture and Rural Development (NABARD).
4. BHPC did not clearly answer to enquiries why construction was not commenced at the time of the ex-post monitoring, when two years or more had passed since the contract.

**Fig. 3 Scheduled Location for Construction
of the escape channel**

- 1) As construction of an escape channel, which has been delaying from original schedule, seems one of the effective options for the operation of two generators, urgent implementation is desirable.
- 2) It is necessary to coordinate with the Department of Water Resources concerning the silt in the irrigation channel. Formal communication channel should be used, such as the establishment of regulatory functions between the top of the organisations.

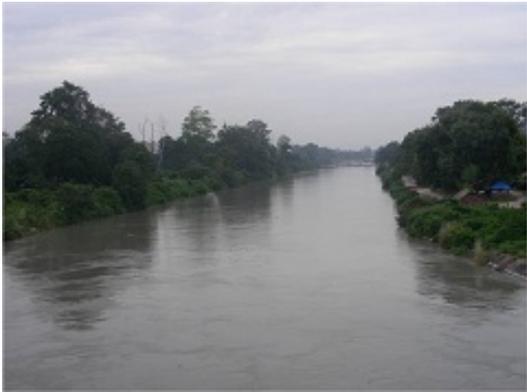
Fig. 9 Irrigation Canal

- 1) As detailed in the chapter of Effectiveness, the deficiency in water quantity due to silt in the irrigation canal, which is the transmission water source for the power generation channel, has become a large problem. The capacity of the irrigation canal, which is under the jurisdiction of the Department of Water Resources, is declining as silt removal operations have not been carried out over the past 15 years.
- 2) No major problems are seen concerning the principal functions of the power facilities. If water quantity and outlet head can be improved, appropriate operation will be possible. However, a fault with the flow meter to monitor the quantity of flow has been reported.
