Malaysia

Ex-post Monitoring of Completed ODA Loan Project
“Rehabilitation of the Tenom Pangi Hydropower Project”

External Evaluator: Nobuyuki Kobayashi
(OPMAC Corporation)
Field Survey: September, 2009

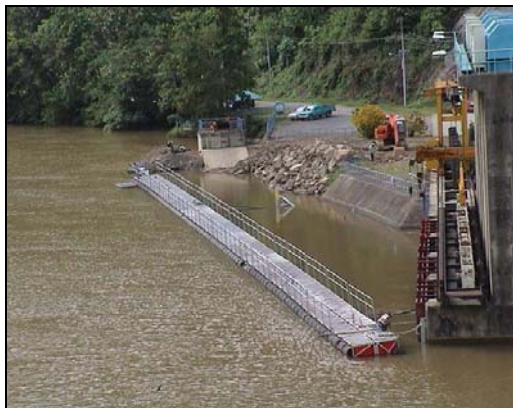
Photo 2: Water intake gate after the ex-post evaluation

At the time of ex-post evaluation, the facility to trap trash was broken as the floats of the trash boom had been washed away. In 2004 (after the ex-post evaluation), a structure for catching trash was constructed in front of the water intake gate (see photo 2).¹³ After half year from the completion of construction, however, damage occurred again. At the time of the ex-post monitoring, no facility to prevent the clogging of trash had been installed at the water intake gate (see photo 3).

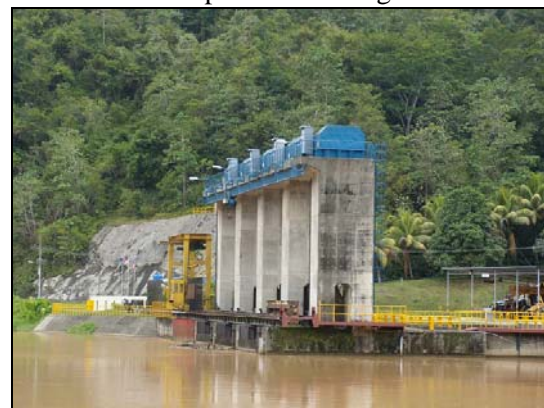
Photo 3: Water intake gate at the time of the ex-post monitoring

The lack of a facility to catch trash causes the danger of clogging and damage to the water intake gate. In the case of 3), furthermore, a switch to a high cost power source such as a diesel

- 1) Expanding meshes in the trash grills installed in the water intake gate so that clogging of trash does not occur
- 2) Raking trash in the settling basin placed between the water intake gate and the water tunnel. Trash screens are placed in the settling basin. Raking machines are currently in use.
- 3) Stopping the power plant, opening the diversion gate, and washing way trash, when a great quantity of trash appears.

generator or natural gas-fired generator is required in order to cope with the insufficient supply of electricity. For this reason, the executing agency plans to redesign and install the trash boom with an improvement in materials and movable parts.

The ex-post monitoring revealed that the trash boom had not been set up and, for this reason, trash had gathered nearby the water intake gate. The executing agency SESB plans to review the design and reconstruct the trash boom. However, the trash boom has broken three times (before project implementation, after project implementation and after the ex-post evaluation) and this trouble is in danger of developing into damage of the water intake gate, a similar accident which occurred in 1988. As trash clogging at the water intake gate is unavoidable due to the design of the power station, it is recommended that the executing agency continues to monitor both trash clogging and its effects on the operation of the power plant and remove trash periodically.

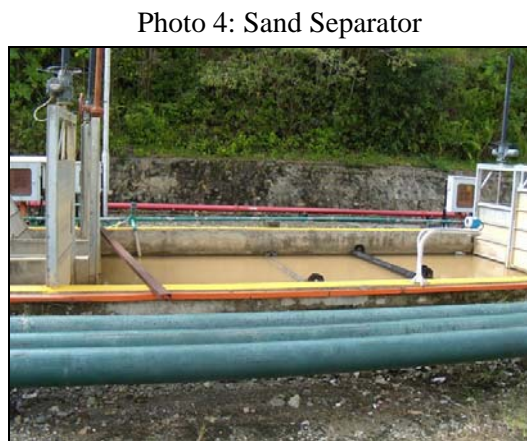
The Tenom Pangi Hydropower Station separates sand from river water and produces cooling water. The water is used for cooling the bearings in the generators. At the time of the ex-post evaluation, the strainer / sand separator was not used because of malfunction. A new system was installed after the ex-post evaluation and the cooling system was updated. As sand clogging is less than at the time of the ex-post evaluation, cleaning of the cooling system does not hinder operation.
