Bulgaria

Port of Bourgas Expansion Project

External Evaluator: Kenichi Inazawa, Office Mikage, LLC

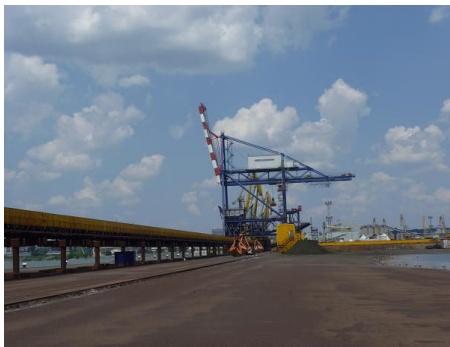
Figure 5: Berth No. 32
(in the far back is the ship unloader procured for the project)

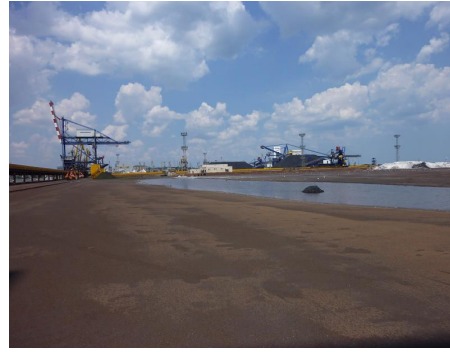
Figure 8: Dent at Berth No.32⁴¹

As shown in Figure 8 below, there is a damaged part (a dent) on the surface of Berth No. 32. According to POB, the dent was made when bulk transport that should have not been conducted was actually conducted, due to the lack of cargo handling equipment.³⁹ As a result, it seems that an excessive load was placed on the area where the dent eventually formed, making the foundation sag.⁴⁰

³⁹ Transport by bulldozers and heavy machineries adds lots of burden (excess load).

⁴⁰ As noted in "Constraints During the Evaluation Study and Point of Concern" on pages 2 and 3, the study (SAPS study) aimed at reconstructing the purpose of port use regarding the whole Port of Bourgas, considering the use method of the project output, Terminal 2A, and at increasing the revenue along with the project purpose, is underway. In the study, the examination of cause and remediation of the damaged part is being investigated.

As a general conclusion of the “Current Status of Operation and Maintenance,” there is no problem regarding the implementation details of maintenance. Nevertheless, as mentioned above, there are concerns that damage has occurred at the berth and that there is no plan to repair this affected area even now. Repair work must be conducted as soon as possible.

2) Regarding the damage in Berth No. 32 at Terminal 2A, Bulgarian side should immediately identify repair methods, a schedule, and costs. The cargo handling volume is currently decreasing, and should berth operating hours become longer because the berths are being used as a transit port, cargo handling will be affected if repairs are delayed. This could become a heavy burden on the financial condition of the Executing Agency, if concerns regarding the lack of maintenance budgets cannot be resolved.
