Ex-Post Evaluation of Japanese Grant Aid Project
“The Project for Improvement of Meteorological Radar System at Cox's Bazar and Khepupara”

Rie Fusamae
Foundation for Advanced Studies on International Development

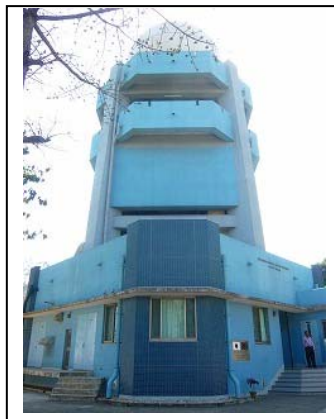
Cox's Bazar Radar Station

The equipment in the two radar stations have managed to be maintained very well: all equipment is currently functioning properly and even looking as good as new. Both stations have kept complete maintenance records using daily, weekly, monthly and semi-annual check sheets. Uses of spare parts and the replacement of parts and components have also been recorded in detail. Mechanical troubles have been dealt with properly; however, it sometimes took a few months to change parts or components because these systems were the first digital radar systems introduced in Bangladesh.

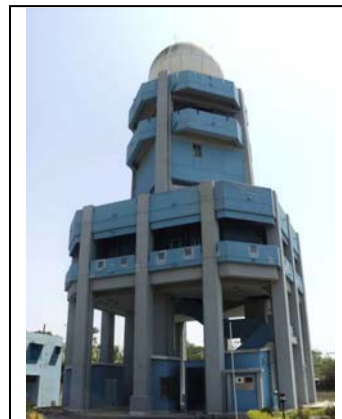
Khepupara Radar Station

The main reasons for the low operation rate of the Khepupara radar were that it was affected by frequent power outages and insufficient fuel supplies for the generator. In response to the situation, the BMD secured a budget for fuel for Fiscal Year (FY) 2010/11⁷. Indeed, the Khepupara radar operated 589 hours in the pre-monsoon season (March – May) in the year, more than triple the previous year's 142 hours. In May alone, the month that precipitation sharply increases, the operation hours increased 78 hours from the previous year to 319 hours. The BMD intends to keep the same operation level in Khepupara until November when the post-monsoon season ends and also plans to operate it for more than 3,000 hours annually in the coming years.
