## 【Ex-Post Monitoring of Completed ODA Loan Project】

### “Samanalawewa Hydroelectric Power Plant (I) (II) (III) and Samanalawewa Hydroelectric Project (Reservoir Remedial Works)”

External Evaluator: Jun Kuwabara,  
(International Development Center of Japan Incorporated)

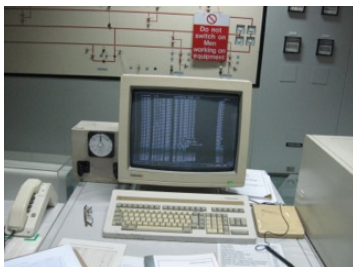
Three out of four monitoring control systems of power generators have broken down, so power plant staff monitor and control the generators using the sole remaining one. If the remaining one should also break down, the generators could be operated manually without taking into account various indicators

such as water temperature. The spare parts of the broken down equipment are no longer available, and repair work is not possible. It has turned out that it would cost 500 million rupees to replace all the relevant equipment of the monitoring control system. As of July 2012, they were examining alternatives with lower cost in the formed technical committee.

Picture 3 Monitoring Control System

It is desirable to examine alternatives that are technically and economically viable and take necessary actions to repair/replace deteriorated equipment and facilities.

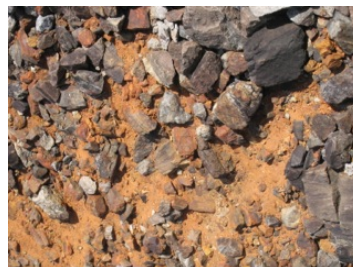
The rock material of the dam, to a wider range, has oxidized and deteriorated as it experienced expansion and contraction due to exposure to sunlight, heat and cold. Most deteriorated rock became sandy, and it could not bear strength to sustain the structure. It is time to replace this, and selection of new rock material will require judicious technical examination, such as rock composition, in order not to repeat similar problems in the near future. As of July 2012, CEB was examining countermeasures with the University of Peradeniya.

Deteriorated bedrock

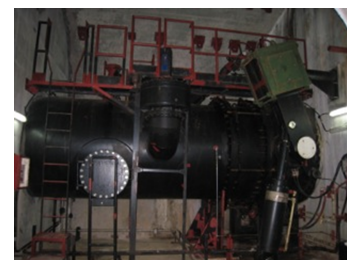
The guard valve is connected to the one which allows water discharge for irrigation. The power station keeps discharging water for irrigation throughout the year. They open and close the valve when they conduct periodic maintenance once or twice a year. As the valve is broken, CEB staff opens and closes it manually. As of July 2012, CEB was negotiating with the equipment suppliers on the replacement of equipment and prices.

Picture 4 Guard Valve

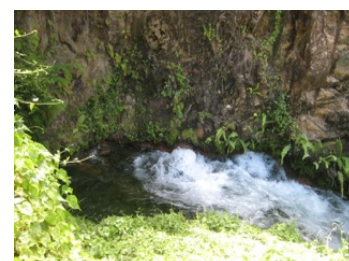
Picture 5 Water Leakage Point

CEB conducted an initial survey in December 2006 with in which they tried to detect the cause of the sudden increase of water leakage. CEB agreed to take an immediate action in October 2007 in response to the recommendations drawn in the ex-post evaluation, with economic viability of the dam operation secured.

The amount of water leakage surged to 4.6m<sup>3</sup>/s in December 2006, which marked the high point. The amount of water leakage lowered in June 2007, and it was around 2.5 m<sup>3</sup>/s after 2008, although it is slightly above the average of 1.8m<sup>3</sup>/s for the ten years from 1996 to 2006.

With regard to the continuing water leakage on the right bank of the dam, no long-term safe solution is secured yet. It is thus recommended to review the survey outcomes up to present, continue necessary measurements, surveys and analyses, and examine concrete countermeasures.
