Ex-post evaluation of Japanese Grant Aid Project

“Water Supply Project in the Southern Region in the Islamic Republic of Mauritania”

External Evaluator: Hisae Takahashi, Ernst & Young Sustainability Co., Ltd.

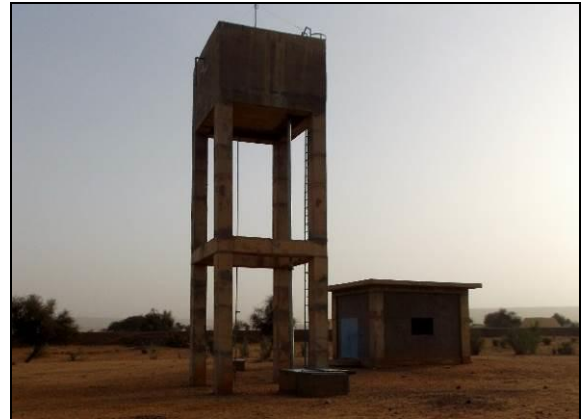
Water Supply Facility Constructed by the Project
