Ex-Post Evaluation of Japanese Grant Aid Project

“Project for the Rehabilitation and Equipment of the Scholastic Centers in the North Region of Nicaragua”

External Evaluator: Hiromi Suzuki S., IC Net Limited

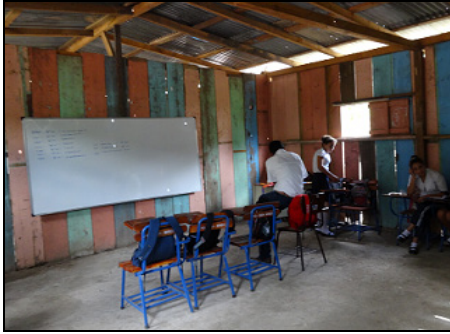
Classroom before improvement:

Walls are made of wood boards, roofs of tin, there is no electricity and there is only one window

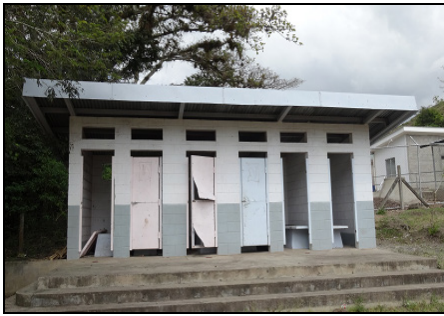
(1) Pit latrines: In this project, 110 pit latrines were developed as part of the educational facilities. During the field study, it was found that the needs of children in lower grades of primary school were not reflected in the design of these latrines when the Detailed Design was prepared. All the pit latrines have a seat height of 52cm, and children lower grades of primary school need teachers’ assistance in order to secure their safety as they cannot use the latrines by themselves¹⁵. In addition, although the Outline Design indicated that wood was the material to be used for the pit latrine booth doors, the doors that were actually installed are of heavy steel which it is even difficult for adults to open and close. One accident in which the door was detached from its frame injuring a child

has been confirmed, thus it is difficult to say that users' safety and privacy are secured. However, because students in higher grades of primary school and students in secondary schools can use the latrines even with this height, out of the 110 booths constructed, 46 booths (42%) are being used, 30 booths (27%) are broken and cannot be used, and in relation to 34 booths (31%), as of June 2015, they were being replaced by flush toilets¹⁶.

External view of pit latrines (six booths. Doors have come off in three of them and cannot be used)

¹⁶ At the time of ex-post evaluation, MINED was making efforts to replace pit latrines with flush toilets in those schools where sewerage has been developed. As of June 2015, 31% of the pit latrines of the project were being replaced by flush toilets.

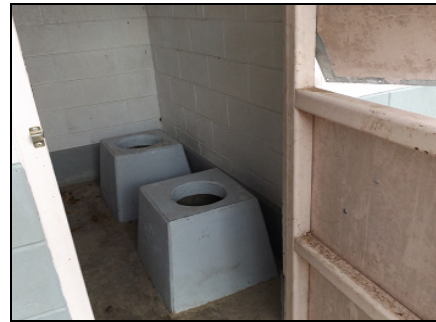
Pit latrines¹⁷

¹⁷ There are two latrines per booth which should be alternated in their use: i.e. while one is being used, the other one has to be covered, and when the one that is being used is full, it has to be covered and the other one is used (Source: "Ex-Post Evaluation Report of the Project for Improvement of Basic Education Facilities in the Department of Rivas, Boaco and Chontales"). At the time of the ex-post evaluation, it was found that MINED as well as all the schools did not know about the correct methods of use and maintenance. According to the interviews, the Procurement Management Agency explained this verbally to each school's principal when the facilities were delivered, but since there were no documents such as manuals, and the information was not transmitted when there were personnel changes, in none of the schools there were teachers who understood the method of use. From now on, it is necessary to conduct repairs and provide guidance on the proper methods of use and maintenance.

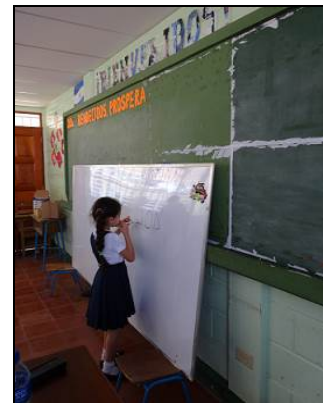
(2) In relation to blackboards, there are two in each classroom, and according to MINED's installation standards introduced in 2008, one has to be installed 60cm above the floor for primary school lower grade students, and the other one has to be installed 90cm above the floor for the rest of the students. However, installation height of all the blackboards of this project was set at 92cm above the floor at the time of the Detailed Design. But, after interviews to MINED, blackboards were being replaced with whiteboards even since before

Blackboards provided by the project and newly introduced whiteboards

project execution in order to prevent teacher’s respiratory problems, and this replacement policy was conducted full-fledged since 2011. However, in this project, after internal reconsiderations within MINED, it was found that the proportion of students for whom it was hard to see the letters written in the whiteboards due to the reflection of light was high, becoming an obstacle to the progress of the class. Thus based on a request from MINED, blackboards were installed instead of whiteboards¹⁸. Due to this, almost all the blackboards installed by the project are not being used as such, but as bulletin boards, or as boards to display student’s works.
