FY2019 Ex-Post Evaluation of Japanese Grant Aid Project

“Project for Improvement of Water Supply System in Metro Cebu Water District”

External Evaluator: Masumi Shimamura, Mitsubishi UFJ Research and Consulting Co., Ltd.

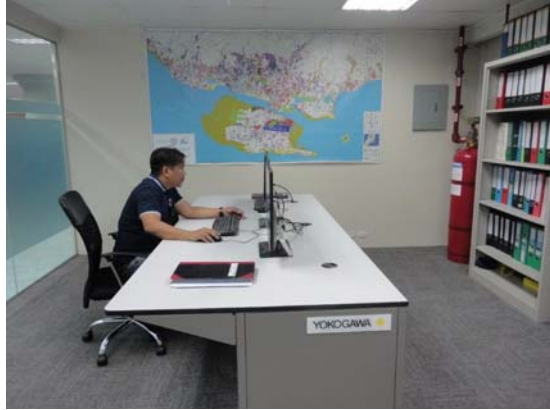
SCADA Room inside the MCWD Main Office

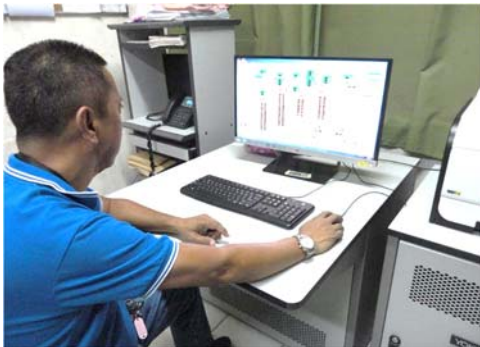
SCADA Client in Talamban Satellite Office

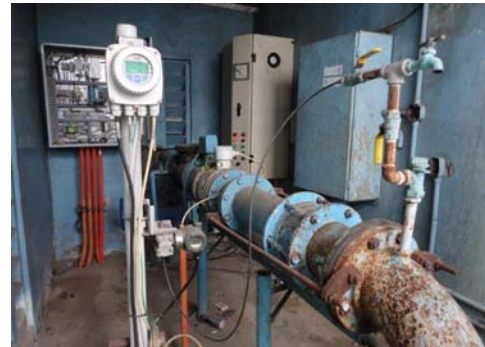
Well Pump Station Electro-Magnetic Flow Meter,  
PLC Board

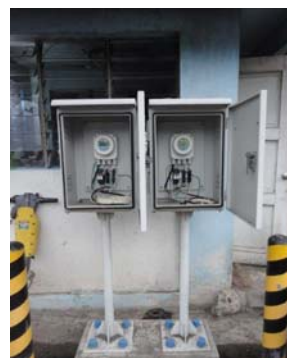
Flow Meter

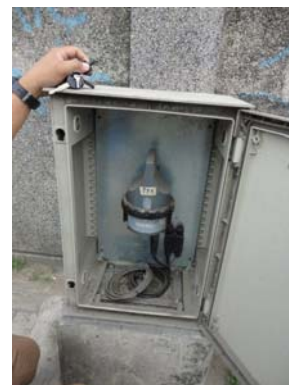
Pressure Sensor at Water Pressure Monitoring Point
