FY2020 Simplified Ex-Post Evaluation Report of Japanese Grant Aid Project

External Evaluator: Takako Haraguchi, i2i Communication, Ltd. (January 2022)

Country Name	The Project for Rural Water Supply (Phase III)
Republic of Rwanda

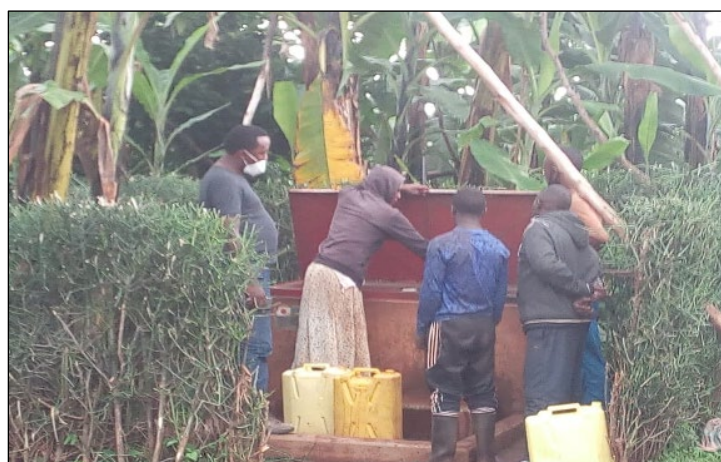
Public water tap (Murama Sector, Kayonza District)

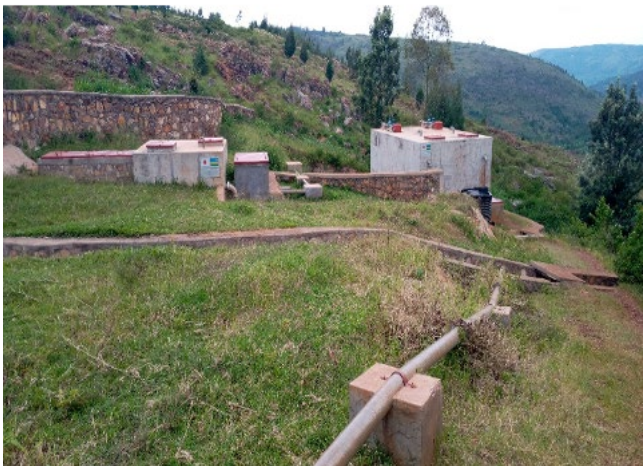
Spring intake facility (left), receiving tank (right), transmission pipeline (foreground)
(Rukira Sector, Ngoma District (Rukira East))

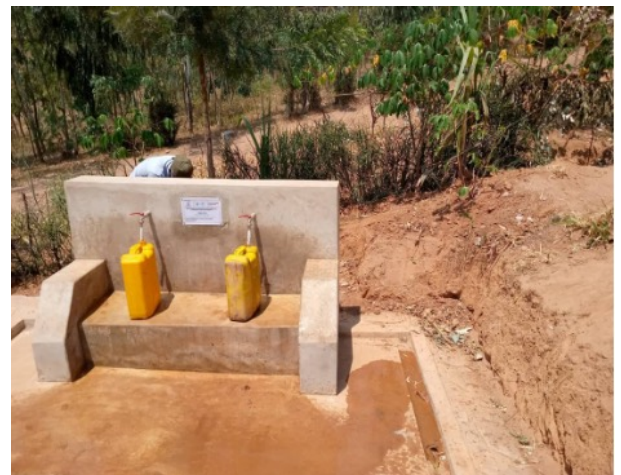
Public water tap installed by the district by extending the distribution pipeline from the project facility
(Remera Sector, Gatsibo District)
