FY2021 Simplified Ex-Post Evaluation Report of Japanese Grant Aid Project

Country Name	The Project for Improvement of Water Supply System
Republic of Palau

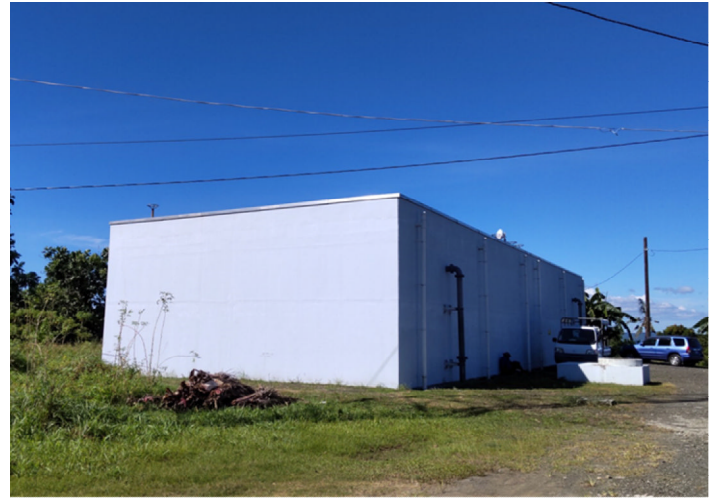
Malakal service tank, newly constructed under this project (source: taken by the evaluator)

¹ There had been a Malakal service tank on Malakal Island. However, it had never been used, and its durability could not be guaranteed due to possible leakages. Therefore, it was newly constructed under this project.

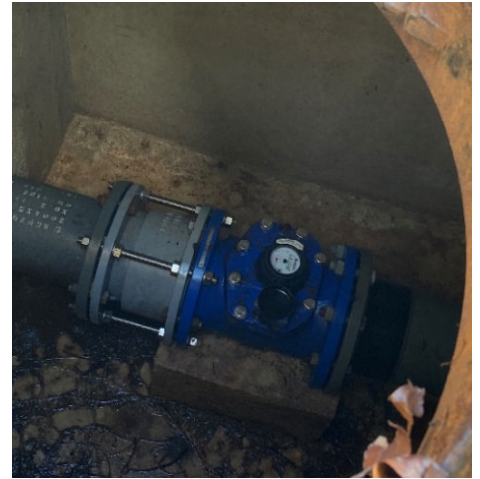
Flow Meter at Ngerkesoaol Service Tank Installed under This Project (source: taken by the evaluator)
