Republic of Nicaragua

FY2022 Ex-Post Evaluation Report of
Japanese Grant Aid Project

“Project for Improvement of Educational Facilities in the Madriz and Nueva Segovia
Departments”

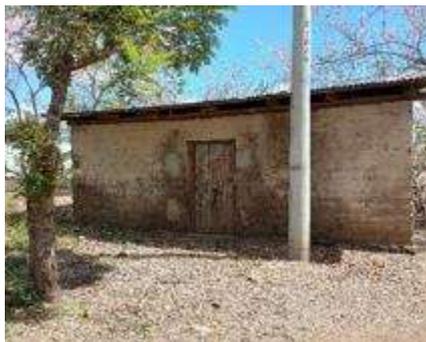
Photo 1. A Classroom Used before the Project (Madriz)

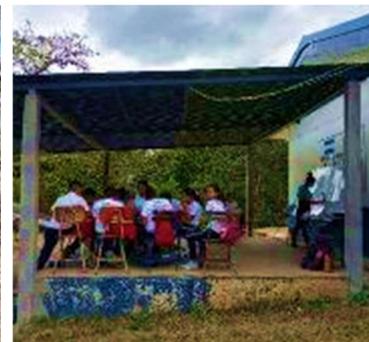
Photo 2. Open-Air Class at the Time of Ex-Post Evaluation (Nueva Segovia)

rugged. Many schools are located on sites where erosion cliffs are immediately approaching or on sloping sites, and many schools in the target area were at risk of damage from the inflow of sediment and muddy water from slopes and streams into the school sites; collapses; and falling rocks. Furthermore, at the time of project planning, many classrooms were buildings made of bricks or concrete blocks reinforced with concrete frames, buildings of blocks made of soil and mortar around them (Photo 1), or temporary wooden buildings. Because of the lack of classrooms, classes were sometimes held in the vacant spaces of neighboring houses or on vacant lots. Even at the time of ex-post evaluation, about 30% of the 9,105 schools nationwide needed immediate maintenance (Photo 2).⁵

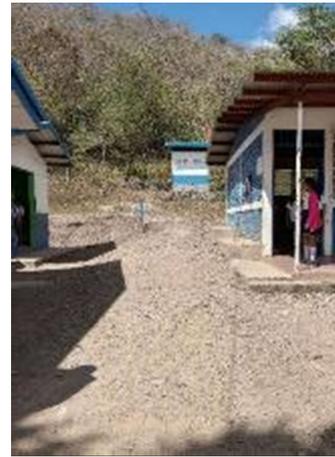
The Interviews conducted with teachers and students during the field survey to confirm the actual use of the restrooms revealed that some toilets were not being utilized much. In the preparatory survey, it was assumed that excreta would be pumped once a year to maintain them, but none of the toilets had accumulated enough dirt to be visually confirmed. Male students often urinate outside without using the toilets. A few students seemed to be more accustomed to using the old toilets (which had a simple hole and no seats). In addition, students, especially in the lower grades, gave examples of reasons for not using the toilets more often: “I am afraid of falling into the hole,” “I am afraid of the private room that can be locked,” and “I am afraid because the toilet booth is far away from the classroom (where teachers are out of sight)” (Photo 6).

Photo 6. Toilet Booths Seen Backward, far from the Classroom Building (Madriz)

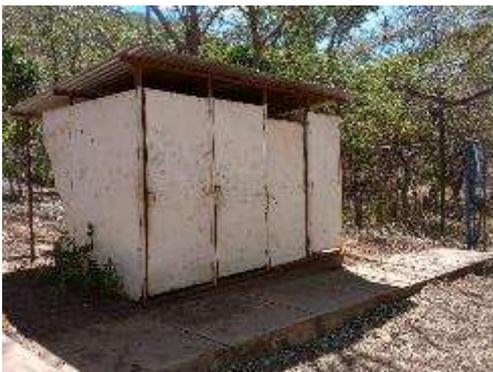
Photo 7. Toilet Booths which Used to be Utilized Before (Madriz)

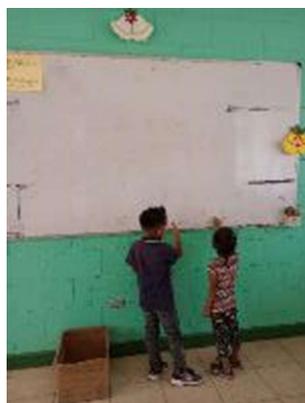
In addition, a past ex-post evaluation of the school facility development project pointed out that some whiteboards and toilets were too high for younger students, but in this ex-post evaluation, the majority of schools responded that these heights were appropriate.¹⁸ The height of whiteboards differs between preschool and primary classrooms, and if classrooms are appropriately assigned according to grade level, presumably the height should not be a problem (Photos 11 and 12).

Photo 11. Whiteboard Placed Relatively High (Madriz)

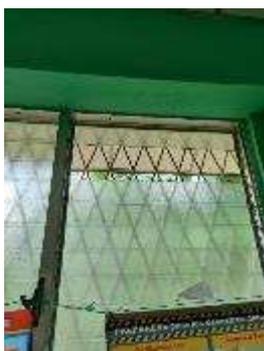
Photo 14. Missing Window Plates (Nueva Segovia)

- Missing glass plates in windows: In 13 of the 28 schools, a part of the glass plates was missing. The reasons for this were breakage due to students' carelessness or natural fall. Parents paid for the damage their children's carelessness caused. None of the schools have left the windows in a damaged condition. In four schools, some of the window fittings were stuck and the glass plates could not be opened or closed.
- Cracks in floor tiles: Cracks were found on classroom floors at six schools. This was because the floor tiles were floating and cracked due to voids in the substrate and desk legs

It is recommended to DGIE that the defects in the facilities observed in this ex-post evaluation be prioritized in terms of their impact on the learning environment and that they should be repaired sequentially.

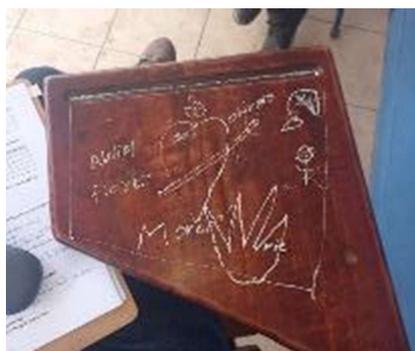
Photo 15. Graffiti on the Desk (Madriz)

- Graffiti on the student's desk: There was graffiti on the desks in all schools, although to varying degrees.
- Drainage ditch: Cracks were found in three schools, and rainwater and mud were likely to accumulate in nine schools.

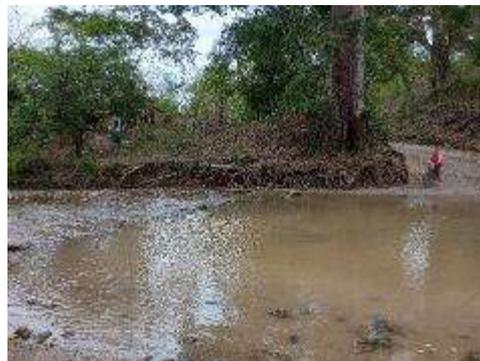
- Water level gauges: There were no gauge at all three schools; floodwaters had washed away one, a construction vehicle had destroyed one (Photo 17), and one was damaged or stolen due to mischief. However, neighbors and school principals have communicated via phone and no river passing has been allowed while the water level was rising. There are plans for DGIE to install them again in the three schools.

Photo 17. River where the Water Level Gauge Had been Installed in the Front Side (Nueva Segovia)
