# FY 2022 Ex-Post Evaluation Report of

Japanese Grant Aid Project

"The Project for Rural Water Supply in Lake Kyoga Basin, Eastern Uganda"

External Evaluator: Tomoko Tamura, Kaihatsu Management Consulting, Inc.

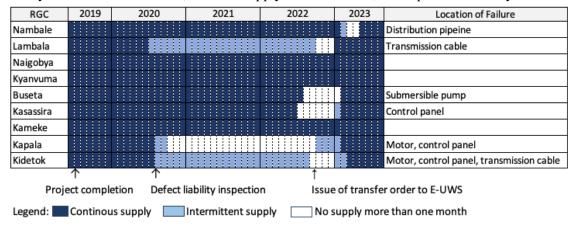
#### **Figure 1: Status of Operation of the Water Supply Facilities**

Figure 1 shows that water supply was intermittent or stopped for several months up to more than 2 years in 6 of the 9 RGCs, as water supply facilities failed, and repairs were delayed.

In Lambala, Kapala, and Kidetok, water supply was intermittent or stopped for more than two years due to facility failures and delays in repair because of the following circumstances.

- In Lambala, the transmission cable connecting the solar power generation facility and a water pump was damaged and disconnected during road construction. The WSSB repaired it, but inappropriate materials used for the repair caused a leakage at the connection of the cable. In addition, leakages occurred at another location where the transmission cable is buried in a swamp and submerged in water for a long time. The WSSB operated the facility intermittently while repairing these leakages, but repeated leaks in October 2022 damaged the inverter, which completely shut off the water supply.

- The control panel failed due to fluctuations in commercial power voltage in Kapala and Kidetok. This problem could not be resolved adequately, even though the contractor of the project installed an AVS (Automatic Voltage Stabilizer) in the panel after the project was completed. In Kidetok, sunlight raising the temperature inside the control panel, and vandalism, also caused the control panel to fail.

The repairs were delayed due to a delay in the Ministry of Water and Environment reestablishing the operation and maintenance system of the water supply facilities of the project, due to Covid-19. The WSSBs, which were responsible for the operation and maintenance of the facilities after completion of the project, were able to operate and maintain the facilities on a daily basis but were not able to adequately repair the facilities and promote the house connections. The Ministry was scheduled to support and intervene when major repairs were needed. Sometime after completion of the project, the Ministry recognized that some WSSBs had failed to repair their facilities and had stopped supplying water. Therefore, they began to study the possibility of transferring this responsibility from the WSSBs to the E-UWS, in order to rebuild the operation and maintenance system. However, the study and decision to transfer the responsibility took time. It required research and analysis of the current status of the operation and maintenance of the WSSBs, consultation with the sub-counties that own the facilities, and confirmation that the E-UWS had the capacity to take over the operation and maintenance of the facilities. However, the Ministry was unable to proceed with these tasks expeditiously due to Covid-19. Specifically, restrictions on the movement of Ministry staff<sup>21</sup> and Ministry budget cuts (discussed in the Sustainability section) affected the delays.

In September 2022, the Ministry sent out a gazette notification of transfer, and E-UWS immediately assigned the necessary personnel to each RGC for operation and maintenance, conducted a survey of the current condition of the water supply facilities, and made the necessary repairs. For example, in the three RGCs mentioned above, where water supply had been suspended for a long period of time, all damaged, malfunctioning, or destroyed components, including motors, liquid relays, timers, and circuit breakers, were replaced with new ones. In addition, new phase monitors were installed at various locations to prevent electrical components in pumps and motors from being damaged by extreme voltage fluctuations. Commercial power was used to operate the pumps in Lambala, as it was difficult to resolve the leakage in the transmission cable quickly.
