Ethiopia

Ex-Post Evaluation of Japanese Grant Aid Project "The Project for Rehabilitation of Trunk Road (Phase III)"

External Evaluator: Sachiko Matsumoto, FASID

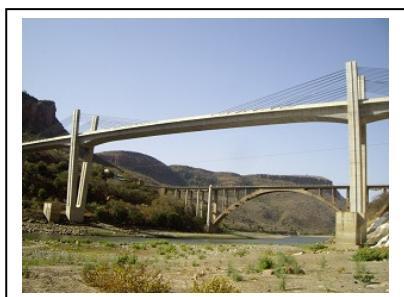
(Abay Bridge (New/front, Old/back))

There is no sedimentation such as garbage and the state of the river wall and the base of the bridge have not changed since the completion, so the maintenance situation of the bridge is good.

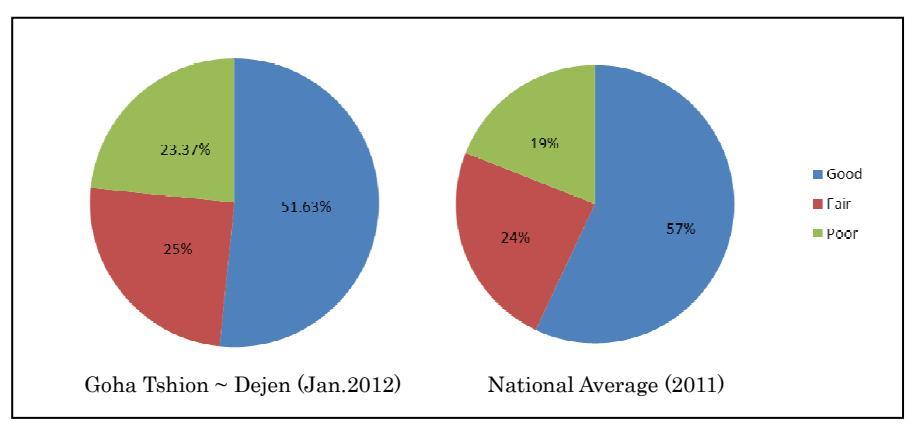
The road condition for January 2012 is as shown in table 7 (the left figure): good section was 51.63%, fair section was 25%, and poor section was 23.37%. The ratio of good road conditions kept for this road is slightly less than the average condition of the whole country in 2011 (figure 7, the right figure), but considering the special topography of the gorge and the technical difficulty for maintaining this section due to landslide damage, it is fair to claim that the maintenance level of this road falls within the range that can be considered average road condition for Ethiopia. Rutting and corrugations account for between 70-80% of the poor section of the road.

Although the ERA recognizes the necessity of corrugation repair⁴⁵, priority for repair work has been given to the landslide section and repairing corrugation has not yet started due to its relatively low level of emergency. It should be said that although rutting and corrugations reduce driving comfort, they do not cause trouble in regards to the flow of traffic. Therefore, although poor sections exist, they

Within this project section, it is recommended to repair the pavement where it subsides. It is also desirable to increase the frequency of undertaking road condition surveys and repair works, since the ground where landslide influences is unstable and road surface subsidence needs frequent repair. When it is not possible to make immediate repairs for reasons such as a large scale landslide or a technical issue it is suggested to reduce the risk of accidents by painting road marking so that drivers are warned of irregularities in advance. In addition, it is desirable that the ERA refer to the technical proposal which was submitted by the project consultant and thoroughly discuss the methodology of corrugation repair works at the time of ordering construction work.
