#### Republic of Peru

## FY 2016 Ex-Post Evaluation of Japanese ODA Loan Project "Provincial Cities Water Supply and Sewerage System Improvement and Expansion Project"

External Evaluator: Hajime Sonoda, Global Group 21 Japan, Inc.

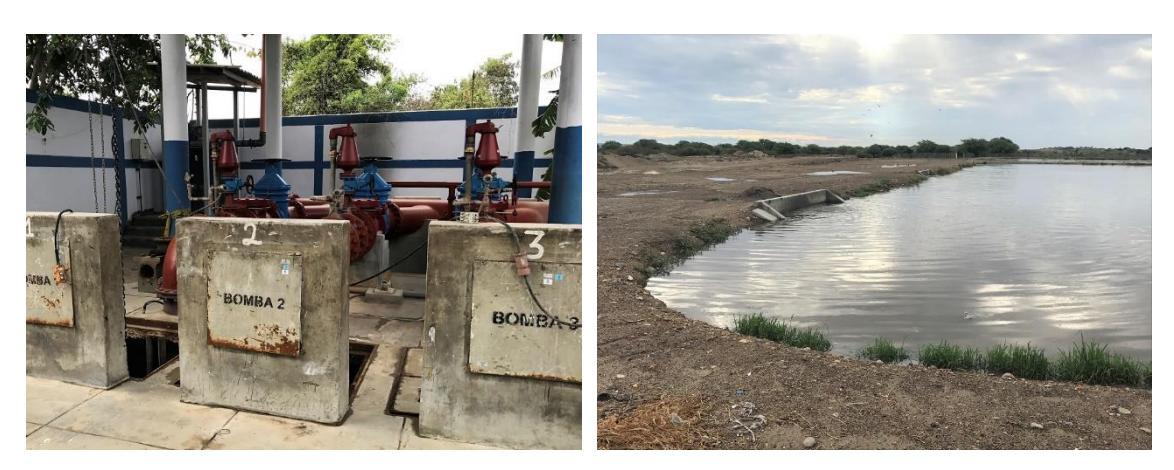
Sewerage pumping station (Piura)

El Indio STP (Piura)

According to the Piura Zone Office of the SSC, most of the city's 28 pumping stations for sewerage have electrical and mechanical problems. The pumps are damaged fairly quickly because of their full operational status, including reserve pumps, to deal with a large volume of sewage and also because of the much inclusion of sand and rubbish in the sewage.<sup>49</sup> An automatic operating system (system to control pumping operation in correspondence with the water level of collected sewage) and control panel frequently break down due to the adverse impact of voltage fluctuations. Because there are too many problems, repair work falls behind and there is no leeway to implement preventive maintenance. The fact that pumping operation can hardly afford to stop because of the large volume of sewage makes the implementation of preventive maintenance and repair work difficult.

At the El Indio STP, sludge and weeds floating on the surface are cleaned but deposited sludge in the treatment basins is not removed due to financial constraints. One of the ponds constructed under the Project at this STP has been divided by a dike constructed under a regional government project and is not in operation. This dike was introduced by the regional government for the purpose of installing an aeration system to increase treatment efficiency of the STP which had failed the wastewater quality standard due to over-loading. However, this project was suspended following a change of the regional government.<sup>50</sup> The water channel connected to the outlet channel of this STP was constructed by the regional government under the same project, but its temporary nature makes it prone to collapse. According to MVCS, the Piura SSC is conducting such regular maintenance works on the channel based on an annual plan as sludge extraction, weeding and slope strengthening.

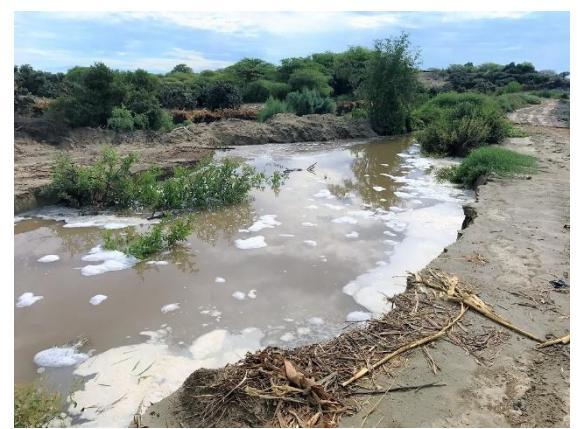
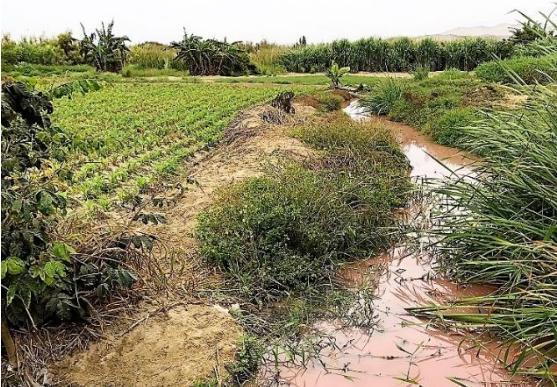
Extension of outlet channel for El Indio STP (Piura)

Irrigation channel connected to Centro Sur STP (Chimbote)

There is a private airfield near the Centro Sur STP in Chimbote. After the implementation of the Project, marshes were formed at the side of this airfield and water birds visiting these marshes began to disrupt airfield operation. According to the Chimbote SSC, the marshes are believed to have emerged due to a rise of the groundwater level. However, it cannot be denied that the discharged treated sewage from the Centro Sur STP may have also been a remote cause. Although this STP is over-loaded, further expansion is difficult because of its limited land. In view of these, the Chimbote SSC plans to close this STP and expand the Las Gaviotas STP so that the sewage currently sent to the Centro Sur STP will be diverted to the Las Gaviotas STP via a new pumping facility for treatment. At the Las Gaviotas STP in Chimbote, an outlet channel to the sea has been constructed with the government's own funding and the recycling of treated sewage is restricted to reeds, etc. Because of this, the partial excess of the quality standard for treated sewage at this STP does not pose any major environmental problems. In contrast, the continued practice of discharging untreated sewage from northern Chimbote SSC plans to expand the Las Gaviotas STP in the future so that it can treat the entire sewage from both southern and northern Chimbote.

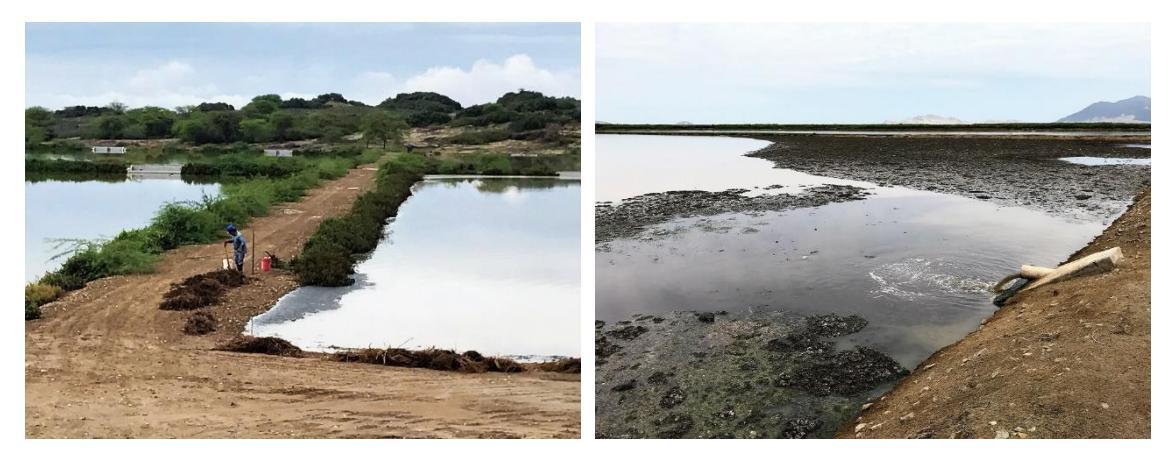
Left: Cleaning works around the treatment pots (El Indio STP, Piura) Right: Las Gaviotas STP (Chimbote)
