FY2019 Ex-Post Evaluation of Japanese Grant Aid Project

“The Project for Urgent Improvement of Water Supply System for Yangon City”

External Evaluator: Tomoko Tamura, Kaihatsu Management Consulting, Inc.

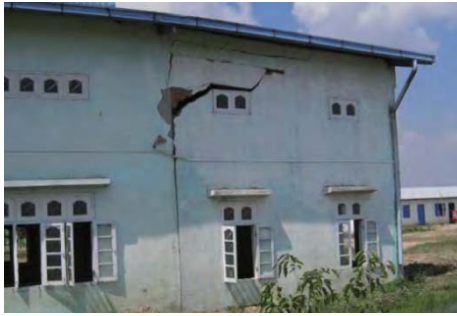
(a) The transmission and distribution pumps at the Nyaungnnapin First Phase Water Treatment Plant provided 40% of the total water supply of the city, however, two of the four pumps were out of order and were suspended. The two pumps that were in operation also broke down frequently, because they had large cracks and water leakage, and because the water hammer prevention unit⁴ was defective. The pump house also had large cracks in the wall due to uneven settlement and was not suitable for use.

Pump House (at the time of planning)

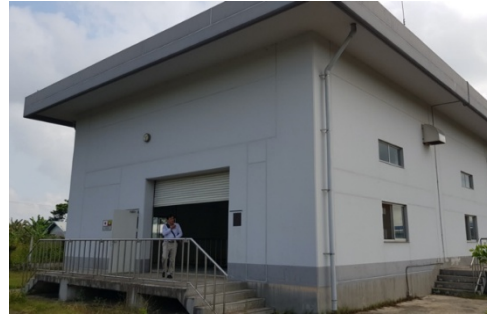
Pump House
(at the time of ex-post evaluation)

The pumps in the water treatment plant are operating smoothly, and maintenance work, including operation, lubrication and inspection, is carried out properly by maintenance staff of the water treatment plant management office. There are no defects in the components of the pump house. Daily inspection of moderate leakage from the pump shaft seals during operation, monthly checks of water level and drainage of air valves, monitoring of water meter values of the transmission pipeline, and periodic cleaning of the flow meter, which were suggested in the defect inspection, are also implemented.

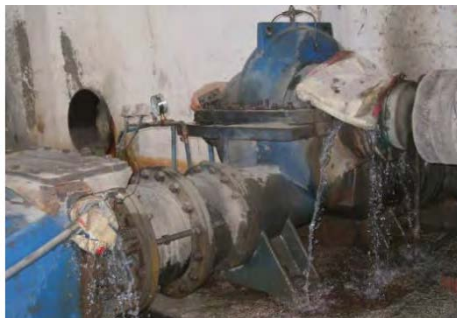
Transmission and Distribution Pump
(at the time of planning)

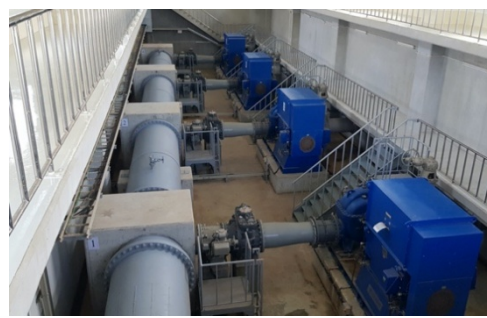
Transmission and Distribution Pump
(at the time of ex-post evaluation)

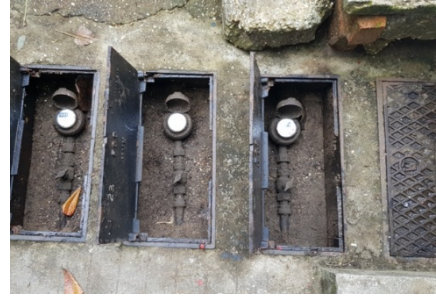
Individual water meters installed in Yankin Township

The renewed distribution network is in good condition with no leak or defect. The water meters installed in each household are functioning without any problems. The staff scraped off and cleaned soil accumulates in the water meter box, if any, at the time of meter reading. It was pointed out that the filter in the meter had to be cleaned at the time of the defect inspection. This is to prevent the filter from being clogged by impurities in the water and causing measurement failure. The Yankin Township Office only carries out this cleaning when there is a complaint from a consumer and does not conduct the proposed annual cleaning.

As pointed out in the defect inspection of the project, the Yankin Township Office is advised to clean the filters of the consumer water meters regularly approximately once a year, in order to prevent clogging of the water meter causing measurement errors.

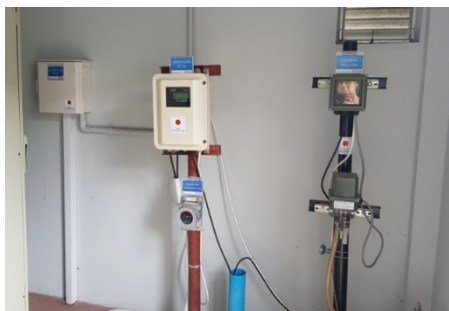
Data recording equipment for DMA monitoring system installed in Yankin Township

The data recording unit of the DMA monitoring system is functioning normally, and data is recorded daily and monthly. Staff in the monitoring room of the system received and analyzed the data and produced reports. A software defect was found in the system in late 2017. Although the warranty period had expired, the supplier of the system dispatched a technician from India, taking into account the importance of the problem. He inspected and repaired the defect free of charge. Thereafter, the environment of the internet service which is needed for receiving the data, was changed, and the Authority changed the internet service provider. As a result, the system was functioning without problems in December 2018.

However, the speed of the internet became extremely slow; it has become impossible to receive the data for flow rate continuously, and it is taking a long time to boot the system after a power failure since January 2019. The data received is recorded daily and monthly, and reports are being prepared and submitted. However, the NRW ratio cannot be calculated because there is missing data. With regard to this issue, the Water Resources and Water Supply Authority mentioned that

The DMA and DMA monitoring system introduced to Yankin Township in the project were expected to be a model for DMA formation and water distribution monitoring in the country in future. However, at the time of the ex-post evaluation, the equipment did not receive data continuously, and the measured flow rate was around three times more than the consumption volume; therefore, it was not utilized for water distribution monitoring. The Water Resources and Water Supply Authority would like to repair and operate the device by integrating it with the water transmission monitoring system introduced in the technical cooperation project, as well as with the DMA monitoring system to be introduced to multiple townships in two ODA loans. However, to realize this, time and cost for technology development, such as software integration, will be needed. Therefore, until this happens, the Authority is recommended to improve the communication environment of the location of the equipment by introducing fiber-optic network, investigate if there is any distribution out of the DMA, and if there is, install a flow meter to the relevant distribution branch point, in order to keep the DMA measurable, and to make the system functioning and utilize it for the distribution management.

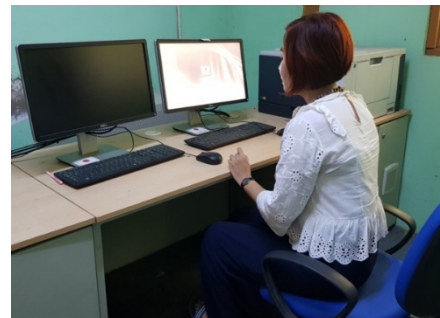
Monitoring equipment for the DMA monitoring system installed in Yegu pumping station
