Ex-Post Evaluation of Japanese Grant Aid Project
“Extension and Reinforcement of Power Transmission and Distribution System
in Kathmandu Valley (Phase 3)”

1. Project Description

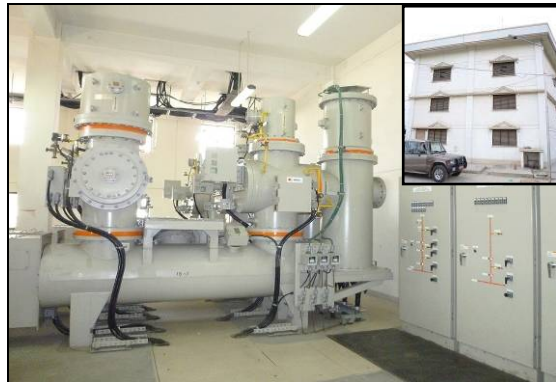
Gas Insulation Switch (GIS) and
K3 Substation building

Regarding the current status of the equipment, the GIS is currently operated with the DS/ES interlock system is locked, since the GIS’s interlock system could not be properly set because of a malfunction in a rotary switch. This requires inspection and repair by a technical expert from the manufacturer. NEA has no plan to solve this problem until the next periodic inspection of the GIS by the manufacturer once every ten years.

While the inter-lock system of the GIS in K3 substation is locked, it is necessary to prevent operation errors by instructing operators to pay close attention to it.

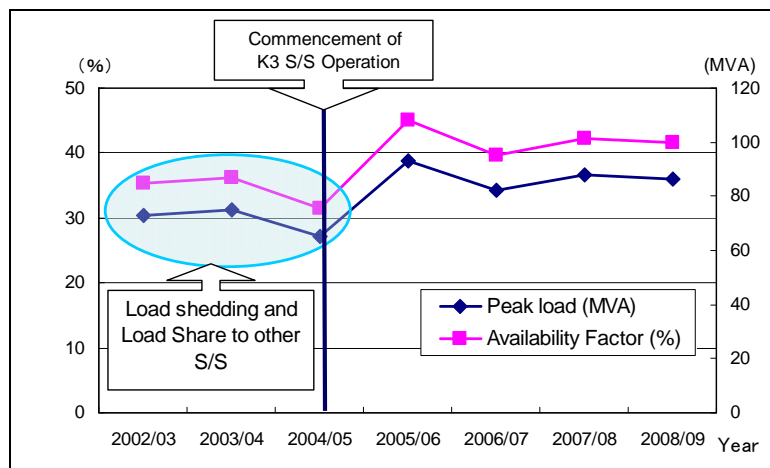
Figure 2: Availability and Peak Load at Patan Substation

This project is consistent with the N-1 standard system plan. At present, the K3 substation and K2 switchyard are each supplying 50% of the load in almost the same area. Without the K3 substation, load shedding due to overload would presumably have continued in power source substations for the K2 switchyard such as the Patan substation. As shown in Figure 2, examining the trends in availability factor and peak load at the Patan substation, stable power supply (without load shedding or replacing the load to other substations) has been realized since the K3 substation commenced operation. If there were no K3 substation, the power supply may have deteriorated further as additional load shedding would have been necessary to meet the increasing demand.

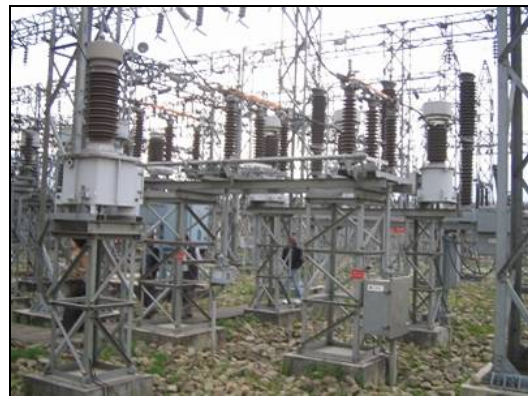
Photo 1: Overview of Equipment in Siuchatar Substation

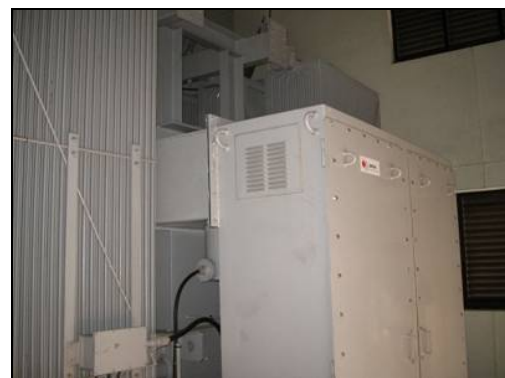
Photo 2: Transformer in K3 Substation

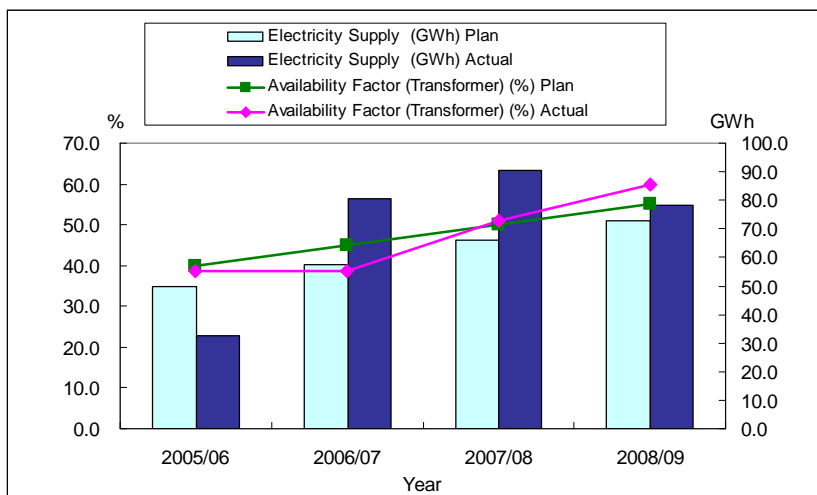
Figure 3: Availability factor and electricity supply of K3 Substation

The availability factor (total of two transformers) is nearly the same as planned for each year after the third year of operation commencement. The target operation indicator is approximately 50%, so that one transformer can cover the total electricity supply in case of a problem with the other transformer. Actual availability factors have been slightly above or below 50%. The volume of electricity supply has been nearly as per the yearly plan.

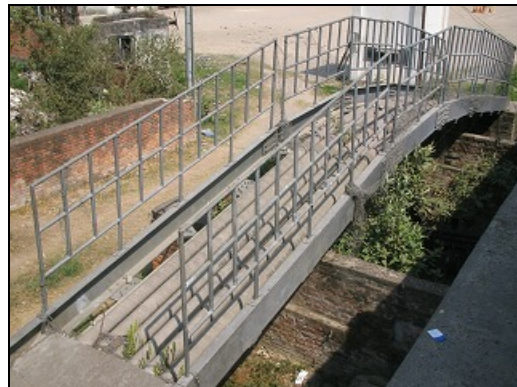
Photo 4: Underground Transmission Line Cable (at river-crossing point)
