Cambodia

Ex-Post Evaluation of Japanese Grant Aid Project
“The Project for Improvement of Water Supply System in Siem Reap Town”

Yukiko Sueyoshi, Global Link Management Inc.

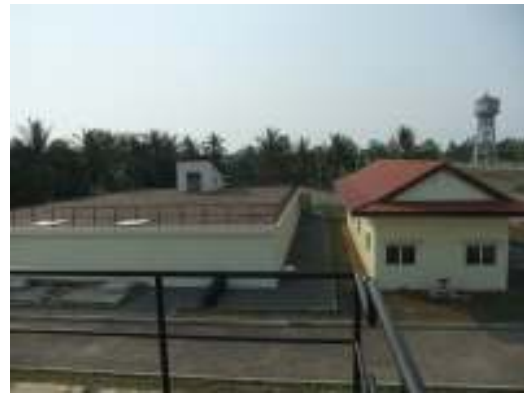
Reservoir(left),Pomp Station (right),
Elevated Water Tank(back right)

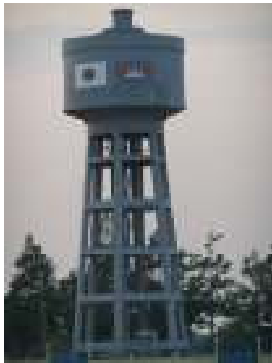
Elevated Water Tank

2) According to SRWSA, for the water stains on the elevated water tank, it has been repaired from outside of the tank by the local constructor.

Some of the equipment and facility (the monitoring panel and the elevated water tank) provided under this Project have malfunctioned, therefore, it is recommended that SRWSA to define the causes and adopt proper countermeasures for repair and prevent recurrences.

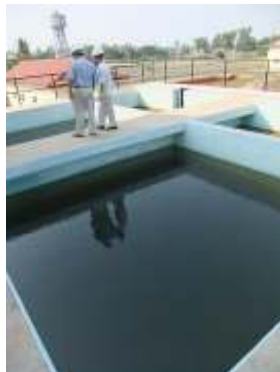
Receiving Well
