**“Nhat Tan Bridge (Vietnam-Japan Friendship Bridge) Construction Project”**

External Evaluator: MITANI Katsuaki, TOYOTOME Ichiro

Katahira & Engineers International

Field Survey: AUGUST 2010

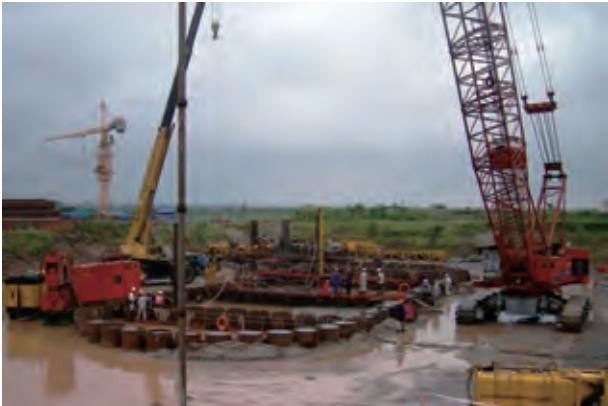
General view of construction of the pier P14

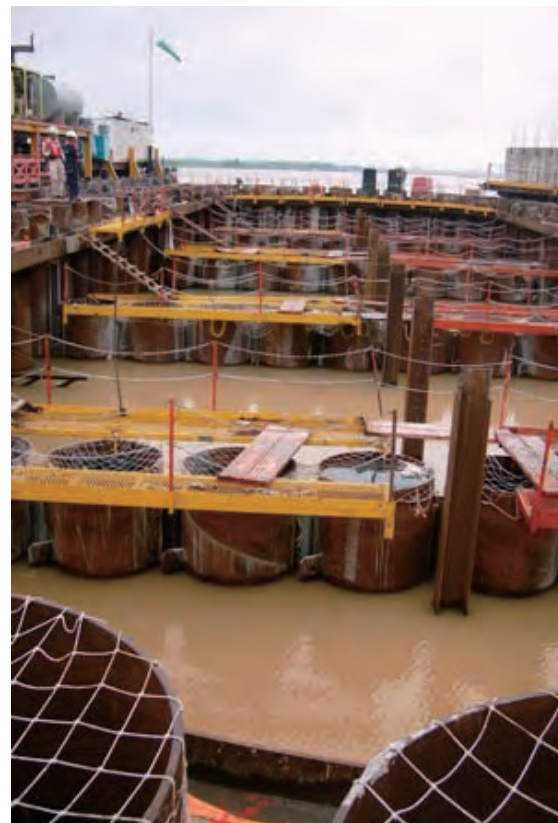
Net for falling prevention and unit scaffold

It is noted that P1 JV member assigned Safety Officers and applied safety standard in Japan to the safety facilities, such as net for preventing workers falling down inside of steel pipe pile, a diameter of which is 1.2m, and unit type temporary scaffold.
