Ex-Post Evaluation of Japanese Grant Aid Project
“The Project for Reconstruction of Athi Bridge and Ikutha Bridge”

External Evaluator: Nobuyuki Kobayashi, OPMAC Corporation

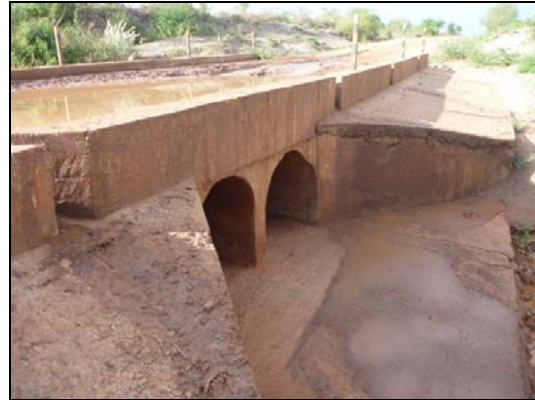
Photo 2: Drift

prevented the flow of traffic, especially in the rainy season. Since there were several drifts⁸ around the bridges, heavy rain often halted traffic. In interviews with drivers in the Kibweze - Athi - Ikutha section, some said that traffic on the bridges was smooth all year round but the improvement of roads near the bridges was not satisfactory and, for this reason, some drivers used other trunk roads. It is presumed that even at the time of the ex-post evaluation a part of the traffic to Embu and Kitui, major cities on the B7 road, was via the Mombasa Road (A109). If the section between Kibwezi and Kitui (in particular pavements and new bridges) is improved in the future, traffic volume is expected to further increase.

⁸ Bridge can be used when the water level in rivers is low but is submerged when the water level is high.
