Ex-Post Evaluation of Japanese Grant Aid Project
“Rehabilitation of Trunk Road”

External Evaluator: Keishi Miyazaki and Mitsue Mishima, OPMAC Corporation

The project objective was to improve transport capacity and passenger and cargo movement in the country by the rehabilitation of National Route N1 road between Kasoa and Yamoransa (98.2km).

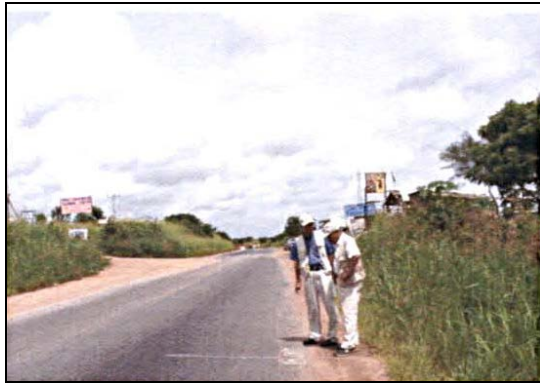
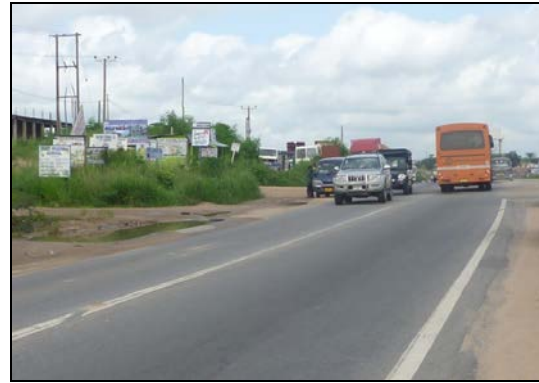
Photo 1: Beginning of the Project Road (Near Kasoa): Before and After the Project

Before Project

After Project (As of May, 2011)

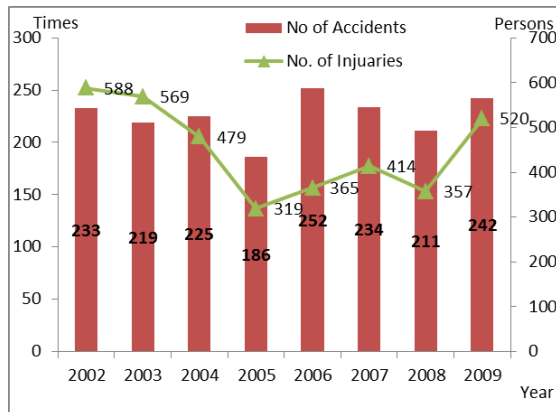
Figure 3: Number of Traffic Accidents and Injuries (Kasoa-Yamoransa Section)

However, data showed no significant change in the numbers of traffic accidents and injuries pre and post-project, as seen in Figure 3 and 4, and thus no improved safety effect can be seen in the project. The annual average of fatal accidents between 2002-2005 (pre-project) was 52 deaths/year, whereas this number increased to 79 deaths/year between 2006-2009 (post-project). The number of deaths increased around 2006 when the project was completed. According to the local police in the target area, there is an awareness of the increase in pedestrian accidents and of more severe accidents since the implementation of the project. In some cases, the road humps themselves have caused accidents as drivers do not always reduce their speed when they enter road hump areas. GHA and local residents have also mentioned the issue of the increase in pedestrian accidents.

After an analysis of the overall accident trends and the opinions of relevant people, the reasons why traffic accidents increased immediately after the project are considered to be enhanced velocity through improvement of the road, together with drivers' actions such as speeding as well as a low level of awareness about the issue of traffic safety on the part of pedestrians and drivers. The Basic Design Report of the project proposed to the Ghana side that "improvement of the road condition by the project will increase vehicle velocity. Ghana is thus required to conduct a traffic safety awareness campaign for local residents and drivers in order to avoid severe accidents". However, this proposal was not implemented until project completion.
