Project for Improvement of the Hygienic Environment of the Reconquista River Basin

External Evaluator: Pegasus Engineering Corporation

1. Project Description

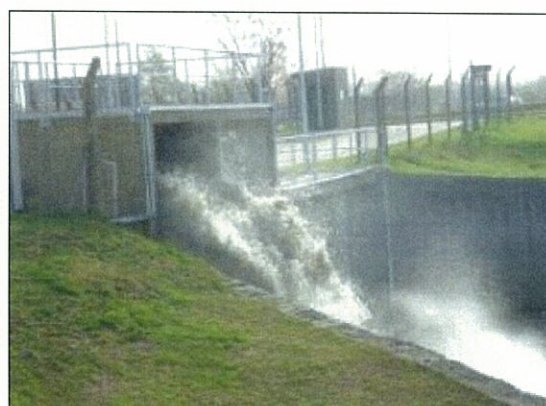
Pump Station No. 9

The integrated controls of the ninth pump station are usually operated by a staff of six members. The operations and maintenance of the other pump stations are monitored and supervised from this station. An additional eight people are assigned during the flood season. Government retirees assist the private corporation (Ilubaires S.A.) in the operation and maintenance of the stations. The local government cooperates with Ilubaires by posting monitoring data on their website.

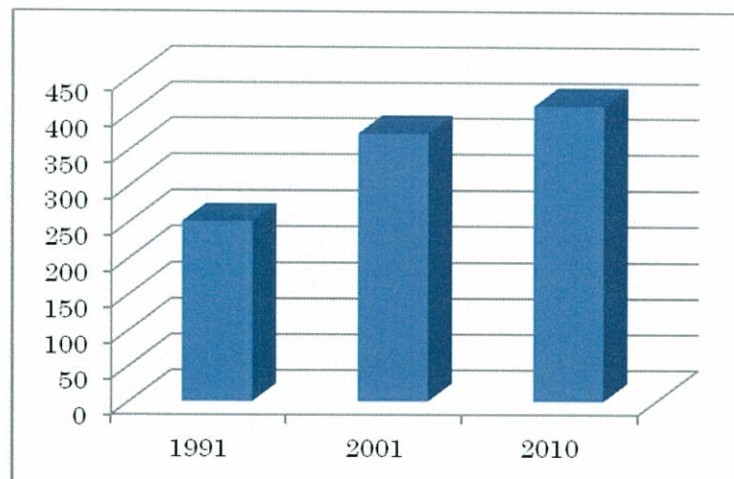
Fig. 1 Increase in the Local Population within the Project Region (unit: 1000 people)

was land previously classified as a flood risk area. According to COMIREC, the improved price of this land has made it competitive with the surrounding land. Land prices were estimated to be about 6,000 pesos maximum (approximately 11,028 yen) /m². Another effect of the project was an increase in the local population. The total local population recorded in 1991 was 2,510,000, 3,730,000 in 2001 and 4,120,000 in 2010.

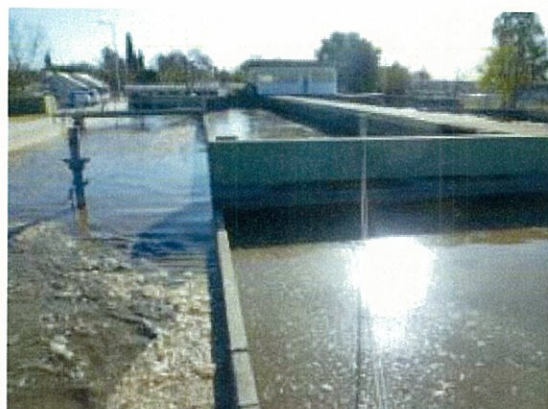
Photo 3 Hurlingham Disposal Plant

The operational conditions of the two sewage disposal plants out of the four that are in operation and the maintenance of the pumping stations were confirmed through visual observations (at pumping stations 6 to 10), and the monitoring activity, periodic inspections, garbage removal, etc. were adequately implemented.

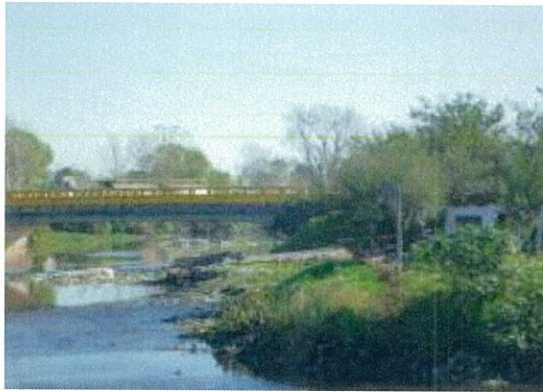
Photo 5 The Taurita Bridge

According to the COMIREC responses to the questionnaires, the Taurita Bridge, which spans over a narrow area of the Reconquista River, was listed as one of the reconstruction works planned by the IBD. Expansion and reconstruction of Taurita Bridge are scheduled to take place in 2012 to 2013.
