0. Summary

1. Project Description

The Rupsha Bridge

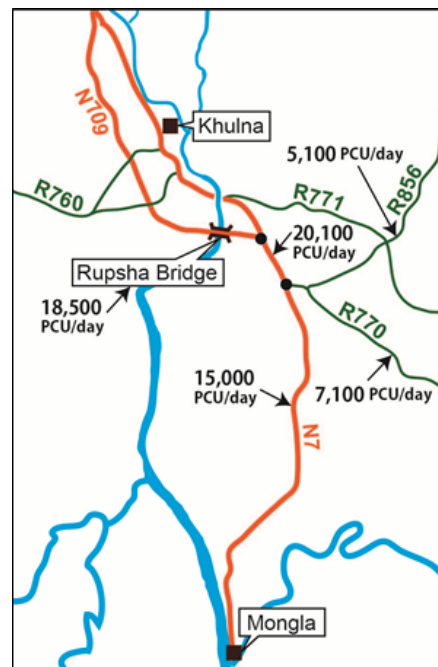
Figure 2: Traffic Distribution (2015 Forecast)

One factor which explains why traffic volume did not meet the forecast at the time of the appraisal is that cargo handling at Mongla port, in particular cargo handling at the jetties, was below forecast¹⁴. The forecasted traffic distribution for 2015 shows that traffic in the section starting from or ending at Mongla port significantly affects the traffic volume on the Rupsha Bridge (see Figure 2)¹⁵. While cargo handling at Mongla port was 2.87 million tons in FY1997/98, the forecast at the time of the appraisal suggested that it would reach 5.81 million tons in 2015. The actual figure for cargo handling at Mongla port in FY 2009/10, however, recorded only 1.65 million tons. Assuming the containerization of cargo, the forecast for cargo handling at jetties should increase from 0.16 million tons (6% of total cargo handling) in FY 1997/98 to 2.13 million tons (37% of total cargo handling) in 2015. The actual cargo handling at jetties was 0.22 million tons (13% of total cargo handling). At the time of the ex-post evaluation, the construction of a long bridge over the Padma River was planned. After
