Ex-Post Monitoring of Completed ODA Loan Project  
 Republic of Ghana

Water Sector Rehabilitation Project

External Evaluator: Tomoko Matsushita  
 INGEROSEC Corporation

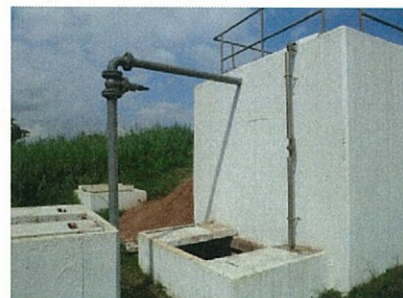
Large-scale facility (Ho)

At the large-scale facilities (i.e. facilities where large-scale water intake equipment and treatment equipment are installed: in the Volta Region, this corresponds to Ho, Hohoe, and Keta-Anloga), GWCL headquarters have prepared annual maintenance plans, and maintenance is carried out in accordance with the plans. Thus the quantity of water supplied and the facility utilization ratio exceeded the planned values.

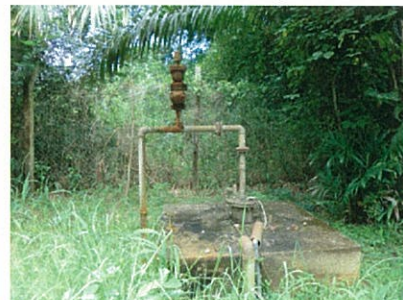
Small-scale facility (Sovie-Digbe)

However, at the small-scale facilities (i.e. facilities with small-scale water intake equipment installed, that treat the water with simple filters: this corresponds to

Nkonya-Ahenkro, Sovie-Digbe, etc.), maintenance is not sufficiently implemented, which affected the status of operation of the facilities. Also, according to the explanation of GWCL, the reason that the quantity of water supplied at Denu-Aflao reduced was because an elevated tank had a breakdown, and another tank in a nearby location was used instead. Although the latest data for Tamale in the North and Wa in the Northwest was not provided, judging from the 2008 data, it is considered that the planned values are being achieved.

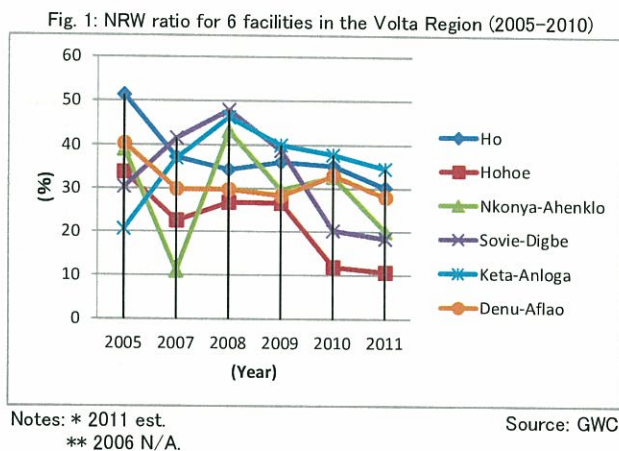
Figure 1 shows the transition in the NRW ratio for 6 facilities in the Volta Region. The average NRW ratio for the 6 facilities is 23.6% (2011 est.), and although there are fluctuations, it has improved from 30% at the time of the ex-post evaluation.

According to hearing surveys with GWCL, the reasons for the improvement in the NRW ratio were (1) implementation of the World Bank's "Urban Water Project"<sup>2</sup>, and (2) establishment of the system of water tariffs by GWCL<sup>3</sup>.

However, the values of the NRW ratio for all the facilities fluctuate greatly. Time was not allocated to investigate the reasons for this during the period of the field survey, but based on the interviews with GWCL and reports, it was confirmed that there were issues such as (1) the rate for normally-functioning customers' meters is low at about 40%, so the accurate quantity of water used is not known<sup>4</sup>, and (2) at some facilities, the water flow meters that measure the quantity of water supplied are faulty<sup>5</sup>. It was inferred that because the measurement by meters is insufficient, it is not possible to calculate the NRW ratio based on the accurate quantities of water supplied, quantities of water distributed, and quantities of water consumed, etc., which is the reason that the numbers fluctuate significantly. It is necessary that GWCL continues its efforts to grasp the status of water supply and water distribution based on accurate data, and to investigate appropriate

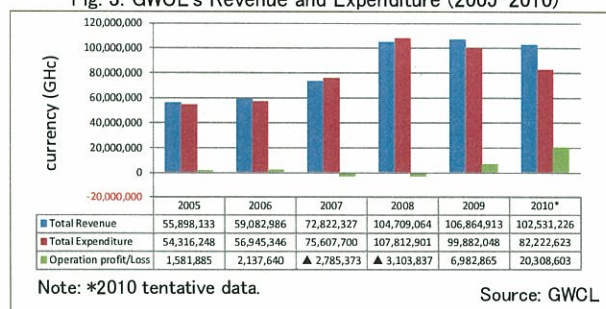
Fig. 3: GWCL's Revenue and Expenditure (2005-2010)

Although GWCL's gross assets are on the increase, there was a reduction in capital between 2009 and 2010. Thus the capital-to-asset ratio was around 90% between 2005 to 2009, but it dropped in 2010. Until 2008, both the revenue and expenditure of GWCL were on the increase, but from 2008 revenue maintained a certain level whereas expenditure tended to reduce, and from 2009 onwards an operating profit was produced. It is considered that the reasons for the increase in operating profit are an increase in the number of customers, the improvement in the tariff collection ratio, and an increase in the water tariffs. Also, as shown in Figure 6, GWCL has made efforts to reduce its expenditures, so the management status of GWCL can be said to be healthy. However, as this refers to the

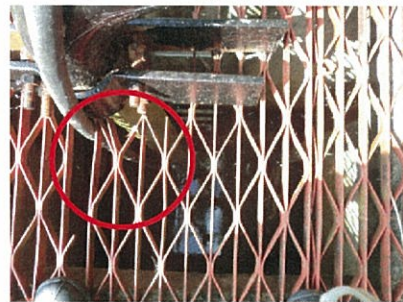
Based on the interviews at the Volta Regional Office, at large-scale water facilities, periodic maintenance (e.g. changing sand in the filters, inspection and repair of equipment) was conducted in accordance with annual maintenance and clean-up plans, prepared by GWCL headquarters. Also, at the facility in Hohoe, it was confirmed that the intake pump was replaced with GWCL’s own budget and the water tank was cleaned once a year. It was also confirmed that a water quality test was conducted every 2 hours daily and no particular problems were found in terms of maintenance.

Pump replaced with GWCL budget (Hohoe)

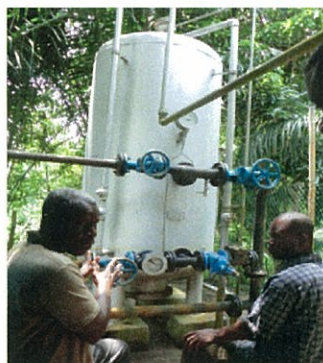
On the other hand, at small-scale facilities the inside of the tank and the sand filter were not cleaned as regularly as at large-scale facilities. According to the Volta Regional Office, regular clean-up was not carried out at any of the facilities for budgetary

Sand filter (Sovie-Digbe)

reasons. Moreover, it was also difficult to routinely conduct water quality tests by allocating personnel in charge of testing to the site due to the shortage of human resources. In the interviews, it was explained that specialists in water quality testing would be dispatched to small-scale facilities from the Volta Regional Office (approximately twice a week).

Of the facilities, it was confirmed that deterioration at some facilities had advanced and the initially targeted water supply volume was not achieved. GWCL should improve the operation and maintenance structure so that these facilities can operate properly to secure the required water supply volume. In order to maintain and inspect the facilities and machinery regularly and to retire old equipment and replace parts without fail, efforts should be made to (1) consolidate the maintenance system centering around the third party contractor (GUWL) and (2) enhance GWCL headquarters' capability to supervise the private company to which maintenance is contracted.
