Ex-Post Monitoring of Completed ODA Loan Project

Republic of the Philippines

Boracay Environmental Infrastructure Project

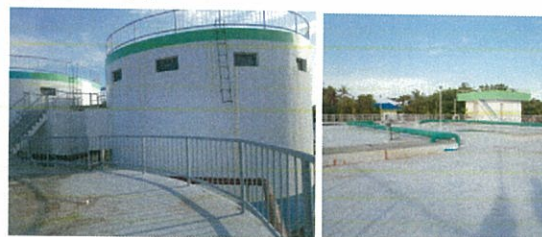
Overview of STP

- Upgrade of STP's capacity (2,600m³/day→6,500m³/day)
- Installation of primary and secondary lines, and etc. (9,576 lm)

As a result of the upgrading of the equipment in 2010, the sewage treatment capacity has expanded, and the problem of excessive treatment at the STP raised by the ex-post evaluation has been resolved. The water quality of the discharged water is shown in Table 3, which shows a great improvement in 2011, with BOD, COD, and TSS all satisfying the environmental standards of the Philippine Department of Environmental and Natural Resources (DENR). The reason for the increase in COD values from 2006 onwards, after the ex-post evaluation, is considered to be due to the reproduction of plankton etc. as a result of the discharge of untreated sewage water because of the excessive treatment at the STP.
