## **Ex-Post Evaluation of Japanese ODA Loan Project** **Metro Manila Flood Control Project – West of Mangahan Floodway**

External Evaluator: Kinuko Mitani, IC Net Limited

### **0. Summary**

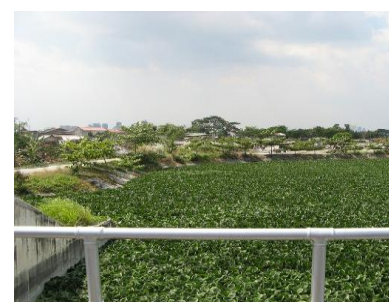
Figure 2: Water hyacinth grown in the regulation pond

The number of water hyacinth has increased enormously in the regulation ponds as shown in the photo below. Because of the water hyacinth, the ponds' capacities have reduced, which now poses a problem. Further, waste from the nearby areas of the pumping stations also flows into the regulation ponds. During the rainy season, the MMDA had to collect and remove the waste, which was more than the designed capacity, affecting the regular functionality of the pumping stations. At the time of the ex-post evaluation, it was found that a coordination mechanism in waste management had not been arranged and established. This problem is severe, and the MMDA is expected to attend to it.

- Secure adequate budget specific to O&M of the flood control facilities, including risk management of pumping stations (i.e., preventive maintenance, purchase and storage of spare parts).
- Expedite necessary internal procurement procedures and promptly procure parts that need to be replaced at pumping stations.
- Establish a coordinated mechanism with LGUs: 1) work with MMDA and Pasig City to establish a coordinated mechanism in waste management in the project area; 2) work with MMDA and Taytay Municipality to form a joint coordination mechanism in water hyacinth management in the regulation pond(s).

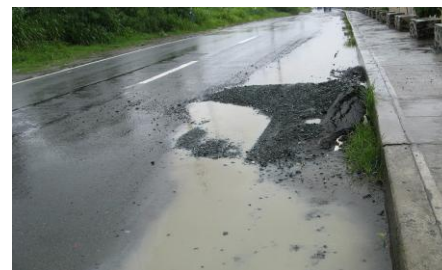
Figure 3: Service road developed in the project

Big pot holes were found along the service road developed in the project due to deterioration of the road conditions. The road was designed to connect the four pumping stations in the project area, but is currently utilized as an essential road for the community members<sup>19</sup>. The road is also used to transport construction goods by private companies for building houses and commercial buildings in the area. This has led to traffic volume beyond planned capacity, which is the reason of its deterioration. The DPWH is expected to assess the road's conditions and complete repair work as necessary.
