**Ex-Post Project Evaluation 2011
(Package IV-3 (Afghanistan, Pakistan, Bangladesh))**

Ex-Post Evaluation of Japanese Grant Aid Project

The Project for Constructing of the Terminal of Kabul International Airport

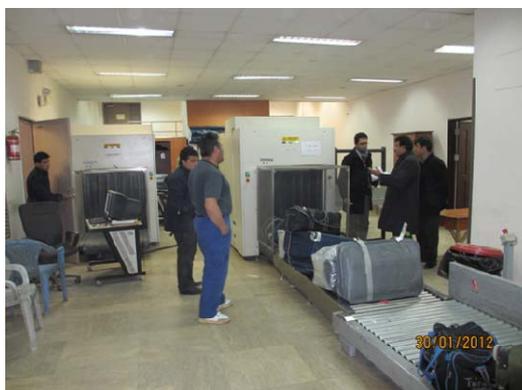
X-ray inspection machine for checked baggage

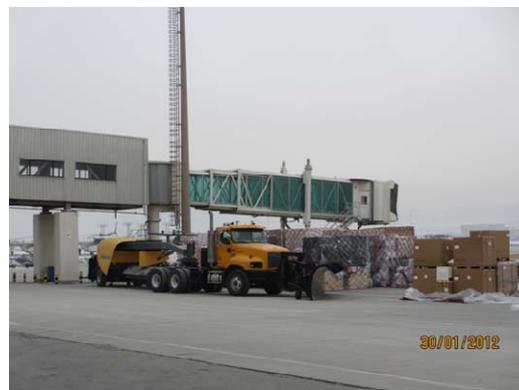
Passenger boarding bridge

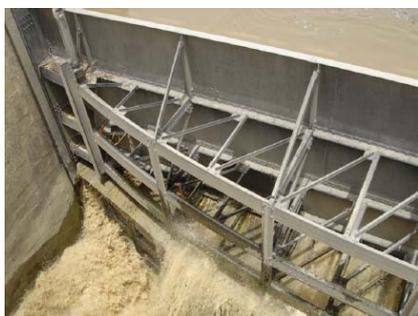
Since almost 50 years had already passed after the construction of the Taunsa Barrage, its gates and adjoining facilities were decrepit. The aging facilities caused various problems such as serious water leakage from the barrage. When the water level rose, the malfunctioning gate control system could not provide a smooth operation for discharging the water. As mentioned earlier, urgent renovation of the gates and gate hoists as well as development of a maintenance system for the barrage were indispensable.

Water leakage from the spillway gate

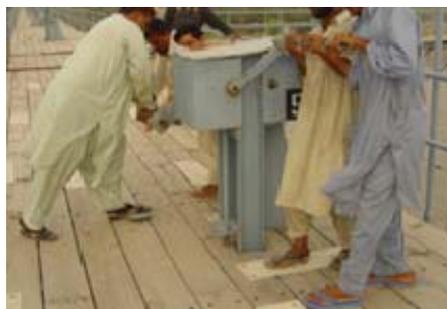
Manual operation for the gate

(It is impossible or difficult for some gates to be opened or closed due to damage to the gate hoists.)

were operated manually, they could not close without delay when floods occurred. Seeking solutions for the problems, gate hoists were motorized and the speed needed to open and close the gates was improved by 60 ft/hour (0.30 m/minute). If floods occur, the renovation would make it possible to operate the gates safely and to flow swollen water down to the lower reaches of the river in a safe and secure manner. According to the data collected during the basic design survey, the speed of gate operation was 0.05 m/minute at the time when the water level was high while 0.10 m/minute when the water level became low¹⁰.

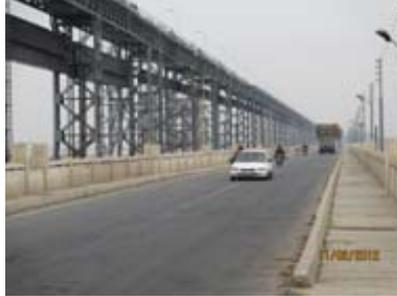
Road and Railroad established through the Barrage

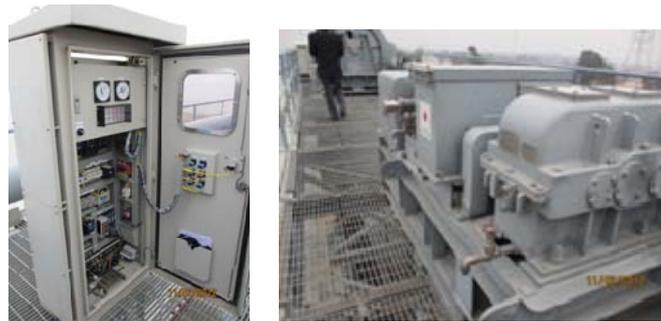
Motorization of gate hoists (operation board set near the apparatus)

During the field study, an interview survey was carried out at the Taunsa Barrage Division Kot Adu and situations of operating the gates were inspected on spot. Results of the interview and inspection confirmed that the planned speed of 0.30 m/minute was achieved at the time when the gates were opened and closed. In addition, smoothly conducted operations on the site were directly observed by the evaluator.

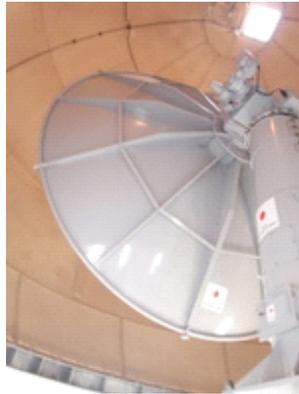
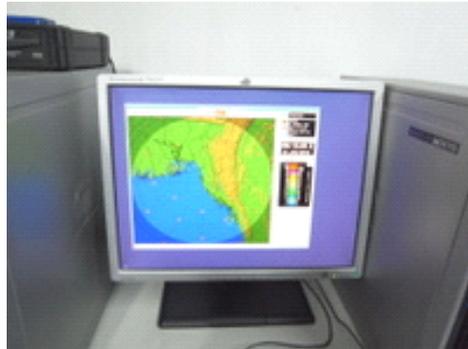
Left: The Doppler radar installed inside the radar tower in Moulvibazar
 Right: The meteorological data display system installed at SWC

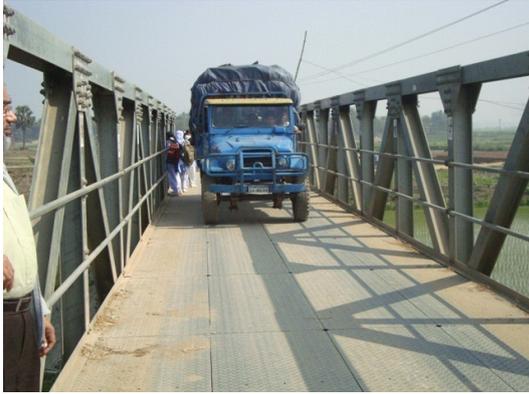
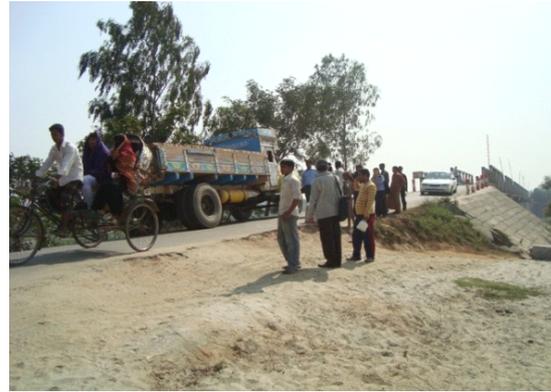
Left: children going to school, while stepping aside from a large truck (Dhaka District)

Right: Trucks and bicycles waiting an oncoming vehicle to pass the bridge. Since the bridge is designed with only one traffic line, it is difficult to cope with the traffic increase (Dhaka District)

¹⁶ As a measure for protecting pedestrians, turnouts are set on bridges whose lengths exceed 50 m in the case of the Upazila (sub-district) roads or 80 m in the case of union and village roads. There are possibilities of minor collisions or accidents on bridges shorter than 50m.
