Egypt

Ex-Post Evaluation of Japanese Grant Aid Project
“The Project for Upgrading of El Mahala El Kobra Water Treatment Plant”

External Evaluator: Noriyo Aoki, IC Net Limited

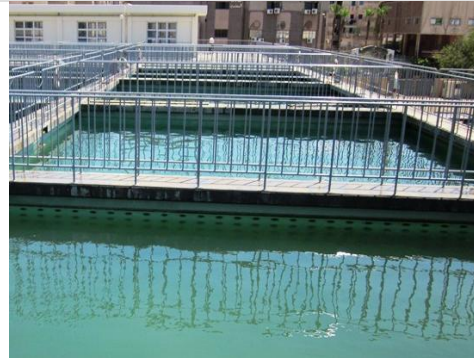
Coagulation Sedimentation Basins

Local water systems experts hired to visit facilities and conduct visual inspections and interviews have reported that the use and maintenance of facilities and equipment now, three years after project completion, is still good. However, there are cracks in two of the walls of coagulation sedimentation basins, and they both need to be repaired⁴⁵.

⁴⁵ There are no issues with facility operation; however, workers have to pump water out of the settling basins when they want to clean them because leaks in the walls prevent them from becoming empty even if they try to discharge the water. The water supply has to be stopped for the repair work. However, the repair has not yet been done.

- There are cracks in the walls of coagulation sedimentation basins. At present, there are no issues with facility operations, but workers have to pump water out of the settling basins when they want to clean them because cracks in the walls cause water to enter the basins even when they have already tried to discharge the water. This should be handled in an appropriate timing.
