Ex-Post Evaluation of Japanese Grant Aid Project  
The Project for Improving Water Supply Systems in the Cities of Huaquillas and Arenillas

External Evaluator: Tsuyoshi Ito, IC Net Limited

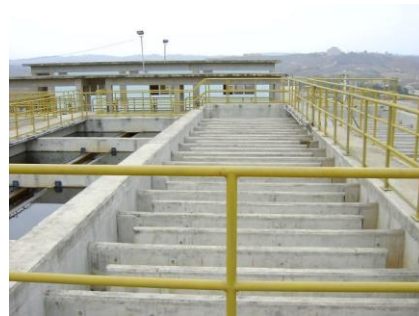
Water treatment plant built by the project

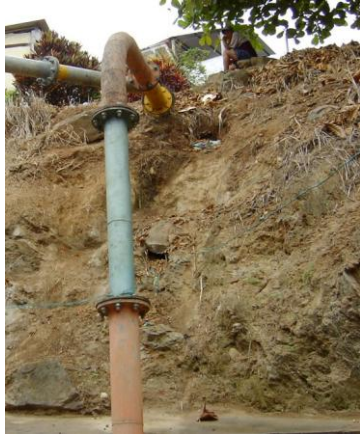
- There is a risk of collapse of the slope behind the intake pump house due to improper protection of the slope.
- The water channel leading from Arenillas River's reservoir to the intake is not well maintained. In some cases, places in which the structure has collapsed and those in which large amounts of sediment, such as sand from the slope, has collected in the channels have been left unattended. EMRAPAH is aware of this problem and estimates that it would cost 100,000 dollars to fix, but there are no prospects for raising this money.

Gradient of backside of intake

At the same time, there are points requiring improvement, including protecting the gradient of the slope to the rear of the intake pumps and upgrading the channels leading to the intake pumps. In addition, EMRAPAH has established its own individual plans to improve facilities, but these plans have not been implemented due to failure to procure funding. These difficulties in the maintenance and operation are also potential hindrance against the sustainability.

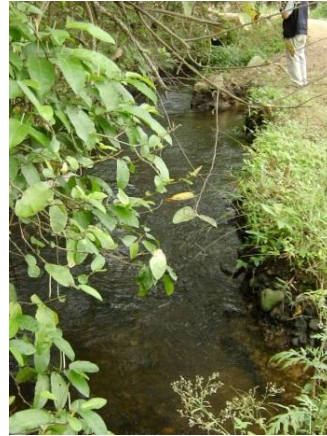
Conduit to intake
