Kiribati

Ex-Post Evaluation of Japanese ODA Grant Aid Project
“The Project for Improvement of Fisheries-related Roads in South Tarawa”

External Evaluator: Keisuke Nishikawa
Ernst & Young Sustainability Co., Ltd.

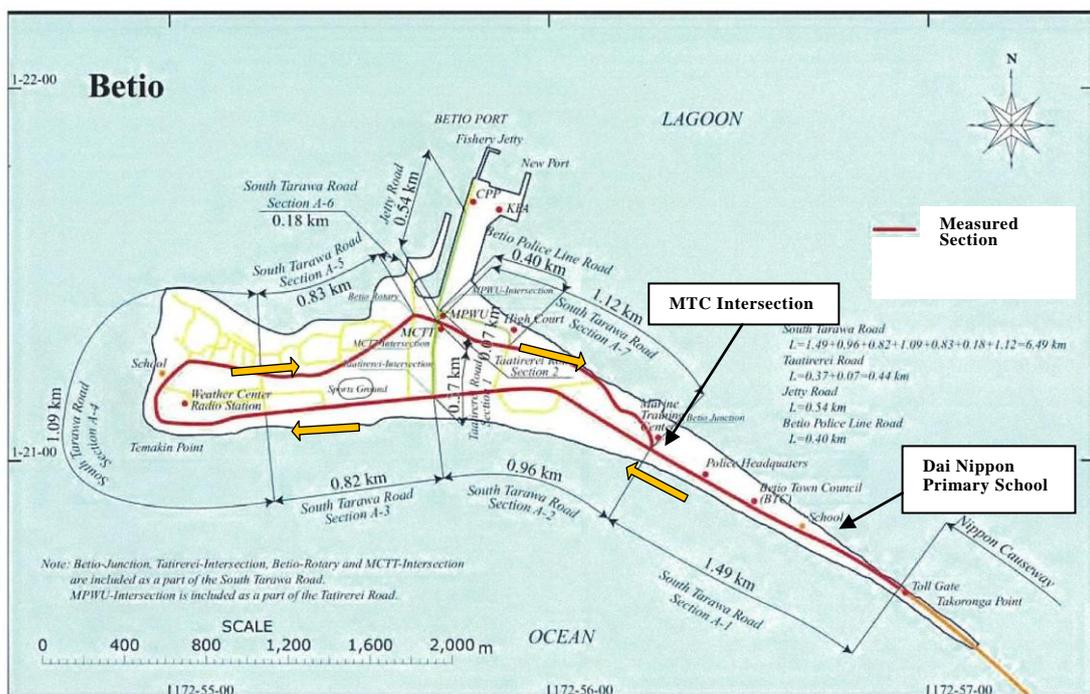
When this project was planned, the speed on open roads was 25km/h and it was expected that this speed would increase to the legal limit of 40km/h after the project implementation. In this ex-post evaluation study, the speed was measured in the section in Betio, which had been improved in this project. The result showed that travelling at 40km/h was possible without problem, apart from intersections and speed bumps. Just for reference, the speed over the entire 6.5km section of South Tarawa Road in Betio, from Dai Nippon Primary School to MTC Intersection, was recorded several times, revealing an average speed of 30.9km/h. As stated later, several areas of the road were heavily damaged, which slowed traffic down, but in all other sections of the road, 40km/h was possible. Therefore, the effect of the project can be said to have been achieved in this regard.

Figure 1: Improved Road in Betio and the Section where the Speed was Measured

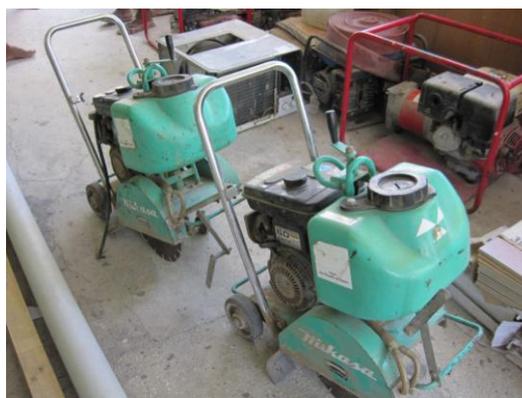
Photo 1: Two Concrete Cutters Provided in the Project

problems were seen in this respect. The concrete cutter, provided under this project, was used only when relatively large repair works were conducted.

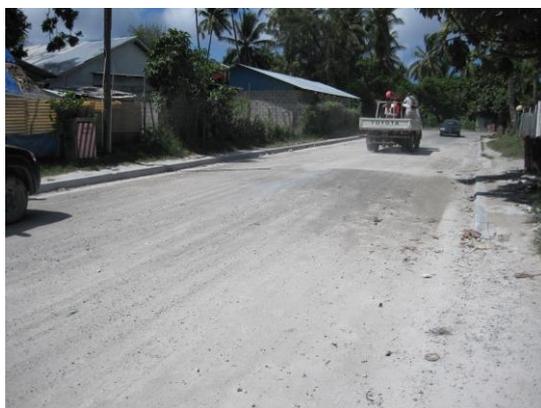
- Surface damage due to stagnant water seen on poorly drained roads (Taaitirei Road and the intersection of South Tarawa and Police Line Roads)
- Insufficient cleaning of hard shoulders, gutters and infiltration inlets
- Slow passage of heavy vehicles (e.g. at MCTT Intersection)
- Further damage while damaged spots remain unrepaired

Photo 2: Project Road with the Surface Broken Away (Taatirerei Road)

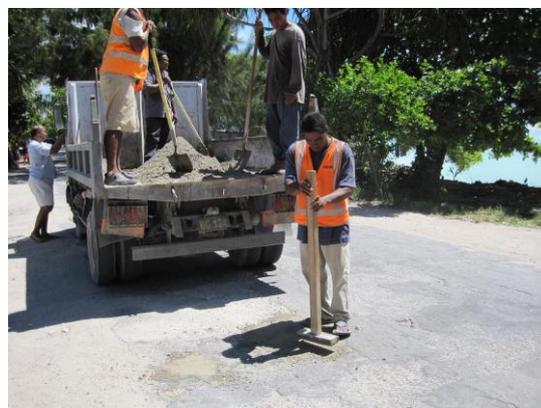
Maintenance work on the road is undertaken by the CES workers. The method of maintenance observed during the field survey in the non-project sections (heavily damaged) simply involved throwing coral stones or sand mixed with some cement into the potholes from the truck. Consequently, those materials disappear after the rain, and the road reverts to its original condition. The road in general, including the project road, is sometimes also repaired with cement and/or bitumen, but they also tend to break off, since the height of the repaired spots only comes up to the same level as the existing road and to exactly the same size as the damaged spots. Therefore, repair work is always carried out somewhere (regardless of whether a project or non-project road) as many spots must be repaired, instead of systematically implementing routine maintenance work.

Photo 3: Road Maintenance Work (Non-Project Section)
