Guatemala

Ex-Post Evaluation of Japanese ODA Loan

“Rural and Main Roads Improvement Project”

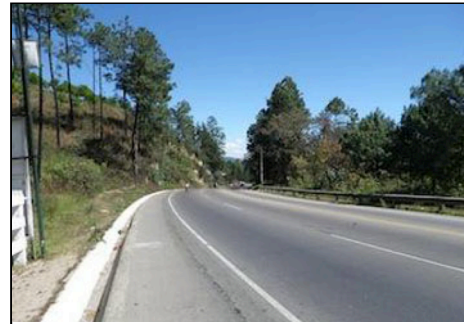
Present State of International Road CA-01W

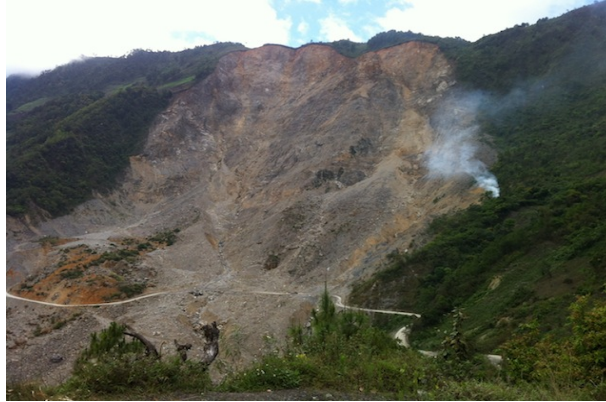
Fig. 2 Current State of the Major Landslide Site at Los Chorros on RN-7W

The major landslide mentioned earlier occurred at Los Chorros during the construction work (January, 2009), using local funds after the loan completion of the Japanese ODA loan disbursement, and some 2 km of the road was buried. The National Committee for Disaster Mitigation (consisting of the Minister of Defense, representatives of local residents and the Director General of the National Institute for Seismology, Vulcanology, Meteorology and Hydrology) promptly prohibited any construction work at this stretch of the road. Since the occurrence of the landslide, the CONRED has been conducting a ground survey at the site every three months. As landslides or subsidence takes place from time to time at this site, there is no firm prospect at present that the prohibition of construction work will be cancelled.

At the buried section of some 2 km in length, a narrow earth private road which runs in the south of this section is used as a detour. Even though this road is just wide enough to allow single vehicle traffic in some places, the detour is used by large trucks as well as buses.

The photograph below shows the state of the landslide at Los Chorros (taken in March, 2012 during the field reconnaissance).

The DGC plans to deal with the some 20.3 km long incomplete section by dividing it into two sections: (i) some 2 km long section at Los Chorros where the road is buried by collapsed sediment and (ii) the remaining some 18.3 km long section. The DGC is ready to start paving and repair work for the latter as soon as the work prohibition order is lifted. In the case of the former, the DGC is currently examining three options: (i) work on site, including stabilization of the ground and the slope, (ii) construction of a detour running in the north of Los Chorros and (iii) improvement of the current provisional detour running in the south of Los Chorros (the purchase of private land is required). Because of an existing pipeline which runs parallel to the current route of RN-7W to convey water to a nearby hydroelectric power station, the CONRED is examining possible measures to stabilize the slope at Los Chorros while preserving the road and pipeline.
