【Ex-post Monitoring of Completed ODA Loan Project】

Kazakhstan

“Irtysh River Bridge Construction Project”

External Evaluator: Jun Kuwabara

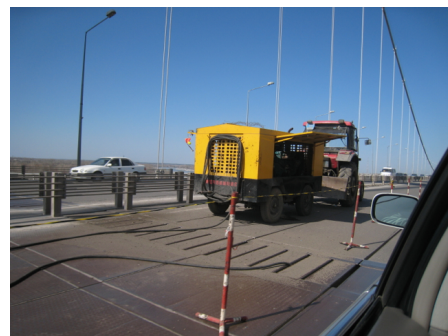
Photo 3 Repairing Pavement

- Skill and knowledge of technical inspection, especially required for a suspension bridge
- Pavement of asphalt and concrete
- Inspection of tension on cables
- Repairing of an expansion joint

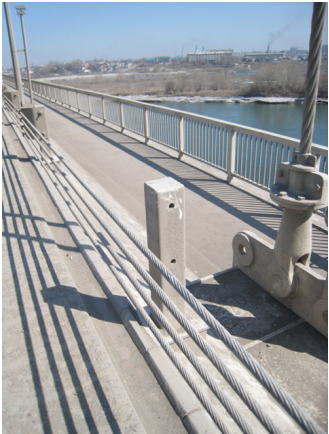
Photo 4 Unfixed Wire

- 1) Anchorages, main cables, cable band, hunger ropes, main towers: future rusting was concerned as traces of water flow were observed inside. Some painting was deteriorated.
- 2) Wind shoes, locker bearings: some painting was scratched off. Stiffing girder was de-centered (within the acceptable range)

- 3) Stiffening girder: not inspected.
- 4) Expansion Joint: repaired in 2001, part of sliding face was not cleaned.
- 5) Pavement on the bridge, guardrails: cracks were observed. It must be repaired annually. Some of the fence wire was not fixed.
- 6) Sidewalk: all the snow on the car lanes was accumulated. Removal of the snow was difficult since a park is located under the bridge.
- 7) Approach road: generally in good condition.

- 1) Foreseen rusting from water flow on the anchorages and main cables, which are important structures of the suspension bridge, will be a concern though not as much of a concern in the current condition. Further, measures shall be taken for deteriorating paint, accumulation of sand and dust on the sliding face.
- 2) Many cracks were observed on the pavement of the bridge. Fence wires of guardrails were not fixed. Further measures should be taken these sections as well.
