The State of Eritrea

**Ex-Post Evaluation of Japanese Grant Aid Project
The Project for Urban Water Supply in Debub Region**

External Evaluator: Kenichi Inazawa, Miyuki Koga, Octavia Japan Co., Ltd.

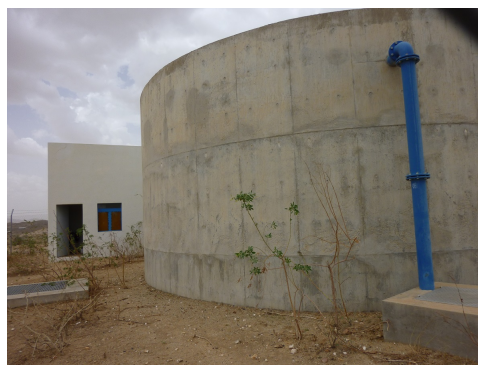
Constructed Reservoir (May-Dima)

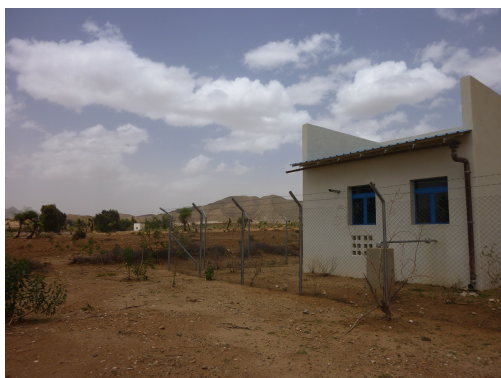
Figure 1: Pumping Facilities (May-Dima)

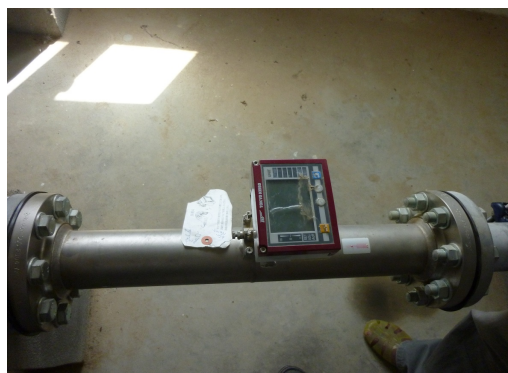
As shown in Table 2, unaccounted for water rate was not calculated in all four towns. The following reasons were provided for this: (1) The employees assigned to water supply in each town either do not measure or cannot measure²³; (2) In the case of Dekemhare mainly, a flowmeter (digital type, see Figure 2) installed inside the pumping facilities does not function because the embedded battery outlived its usefulness. While Dekemhare WSS does not have any spare, it is not possible to procure it domestically, either, due to budget shortage and others; thus it is not possible to measure accurate flow data.

Figure 2: Non-Operating Flowmeter (Dekemhare)

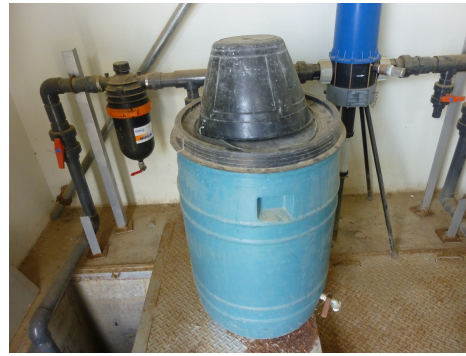
In Adi Keyih, on the other hand, a chlorine injector (see Figure 8), which has been installed at one of the transmission pumping facilities constructed by this project (1 site), is not in use at all. The original plan was that water would be chlorinated at the water transmission facilities after being collected from the wells²⁹. However, the actual practice was confirmed that Adi Keyih WSS staff members pour chlorine at a rough estimate (with buckets and others) at a reservoir located in the suburb. In other words, there is a possibility that appropriate quantity of chlorine is not being injected³⁰. When some residents were interviewed during the beneficiary survey, they commented, “The supplied water has a strong chlorine smell. It may be because the

injected amount is too much. Some abnormal change is observed in the clothes after the laundry. We are afraid that there may be some health risk to our children.”

Figure 8: Chlorine Injector

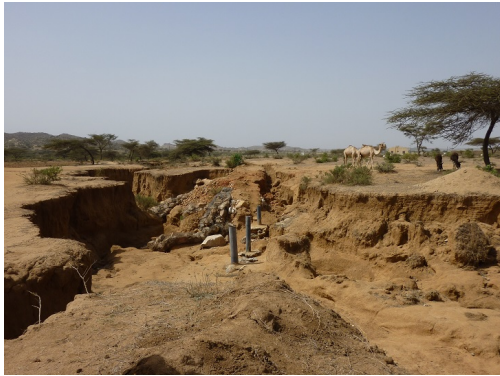
specifically, (1) one pumping facility is not being used, although it has no operational problem, because soil erosion, which occurred in one of the water transmission routes, has left a transmission pipe unfixed and interrupted (see Figure 9) (1 place); and (2) operation of one pumping facility is suspended due to an electric system failure (2 places)³⁵.

Figure 9: Interrupted Water Transmission Pipe Due to Soil Erosion⁴² (Dekemhare)

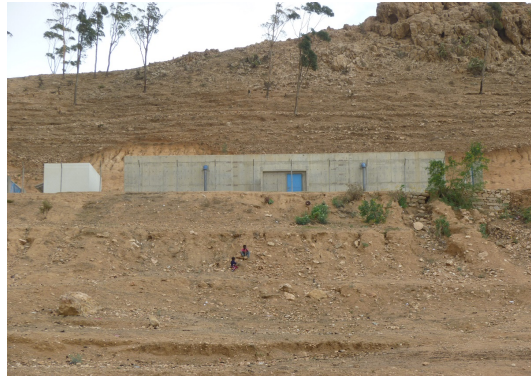
■ In Dekemhare a site of the constructed reservoir is at a risk for ground (terrace) collapse (see Figure 10). Generally this town has many places with sandy soil, and soil erosion is likely to occur when there is heavy rain. In particular, erosion has been expanding in the slopes since the completion of the project; some grounds are found to be fragile. Recently, erosion is progressing in the entire slope³⁶. No repair work has been done up to the point of this ex-post evaluation³⁷.

Figure 10: Constructed Reservoir (Dekemhare)

- In Dekemhare, a terrace on which a reservoir has been constructed has a risk of collapsing due to soil erosion. The municipality office is recommended to allocate budgets necessary for the slope repair work as quickly as possible and to proceed with the work, thereby making efforts toward eliminating the risk.

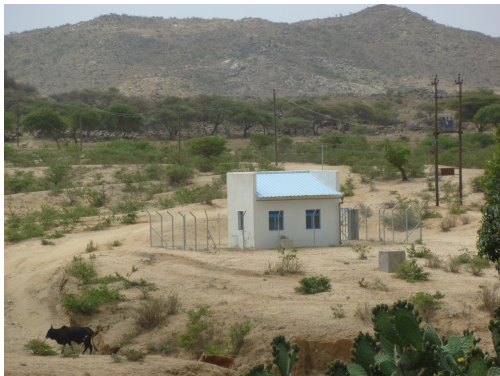
³⁵ With regard to one of two places, although an exact reason remains unknown, the lightning arrester was not activated when the lightning hit according to the WSS staff. However, it could be the case that this happened because the arrester (embedded part, consumable) was not replaced, while it was pointed out during the inspection that arresters would need replacement.

Figure 11: Non-Operational Well and Pumping Facility Due to Electrical System Failure Caused by Lightning (Dekemhare)

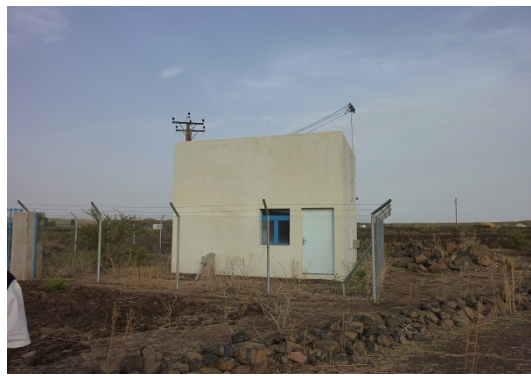
■ The foundation parts and doors of some well and pumping facilities were designed and constructed at low elevations in Debarwa, Dekemhare and Adi Keyih⁴¹, as a result of which these facilities get flooded in the case of heavy rain. Pumping equipment installed inside the facilities has to be stopped during the flood; and it cannot be operated for water intake until

floodwater recedes. According to the provincial government of Debub, from April 2010 up to the time of the ex-post evaluation, the facilities got flooded four times in Debarwa, five times in Dekemhare, and six times in Adi Keyih. They also commented that although there has not been any failure of pumping equipment thus far, equipment is apparently becoming worn fairly quickly because they had been under water.

Figure 12: Well and Pumping Facility in Debarwa (it gets flooded in the case of heavy rain as the foundation and the door are built at too low an elevation)
