Ex-Post Evaluation of Japanese ODA Loan Project
“Agno River Flood Control Project (Phase II) (Phase II-B)”

External Evaluator: Masumi Shimamura
Mitsubishi UFJ Research and Consulting Co., Ltd.

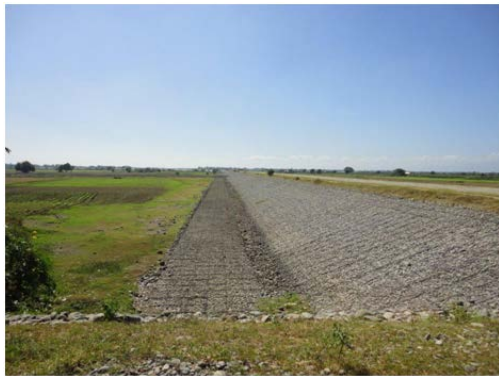
¹² Closure dike is a type of dike that blocks the water flow of the main river and to channel the water into a planned diversion. (The project aims to channel 25% of the 10-year return period flood to the main river (1,000m³/sec) and the rest of 75% to a diversion (3,000m³/sec) in order to mitigate flood.)

Closure Dike (taken from side)

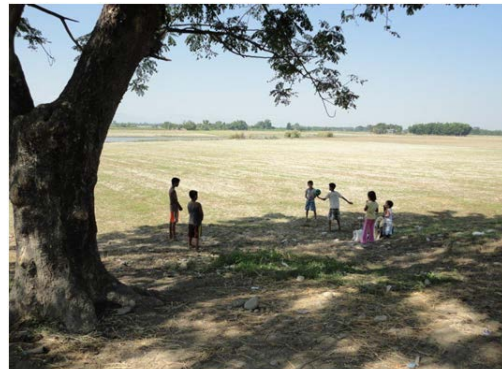
According to the interview with the beneficiaries (residents) during filed survey, the area around the closure dike¹² (the municipality of Alcala) has not suffered from flood damage by typhoons and monsoon rainfalls (rainy season: from June to November) any longer after the project completion. There were also such responses indicating that there has been no flood occurrence after the project completion, which has made possible for residents to live in peace, even though they had suffered from flood damages twice or three times a year before the project. Some residents pointed out that the EMCs constructed in the Poponto Swamp have contributed to mitigate flood damages and have been utilized effectively by the local people during times of flooding. Because the Poponto Swamp is always inundated during typhoons and rainy seasons, these EMCs are

Poponto Swamp

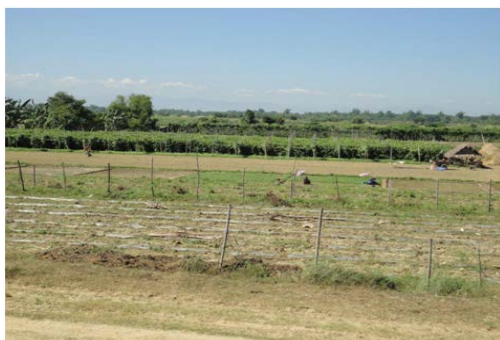
- Construction of closure dike has changed alignment of the Agno River, turning a land between the old Agno River and the closure dike into productive agricultural lands. Three barangays¹⁴ (villages) in the municipality of Alcala have largely reaped the benefits of the change and the unused land prior to the project is now in use as agricultural lands.
- After the project completion, crop yields and income have increased¹⁵ since arable areas expanded. Additionally, the project has contributed to secure stability and predictability of farm work and has stabilized living conditions of local residents.
- Local residents' relief of anxiety from flood damages has induced construction of new houses in the area and thus resulted in population increase.

New agricultural land

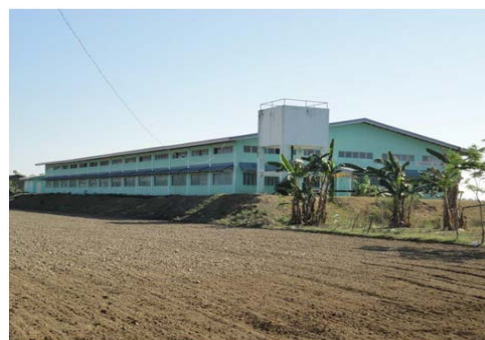
The EMCs in the Poponto Swamp have contributed to provide education and other opportunities such as business, agricultural, and community activities in ordinary times in addition to being effectively utilized as evacuation facilities during times of flooding as mentioned before. For example, the EMC which was visited during the field survey is utilized as nursery school, kindergarten, and elementary school (243 students in total) in ordinary times.¹⁶ Another EMC is used for T-shirt printing business (20 staffs in total).¹⁷ Other EMCs are used as storage of agricultural products (corns, palays, onions, etc.), sports gym, community center, and so on.

Manambong Sur EMC

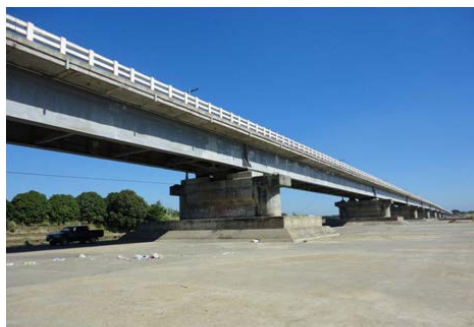
- Hector Mendoza Bridge constructed by the project has connected the municipalities of Alcalá and Bautista even at the time of flood occurrences. Furthermore, with permanent connection between the municipalities of Bayambang, a center of economy in the project area, where markets are located, and Alcalá, the agricultural production area, farmers in Alcalá have been able to save time, cost and labor for transporting products. Hector Mendoza Bridge has been functioning as farm-to-market road as well.
- The closure dike and the earth dike constructed along the Bayambang floodway by the project have also contributed to improve traffic convenience as well as transport for agricultural products as farm-to-market road.¹⁸

Hector Mendoza Bridge

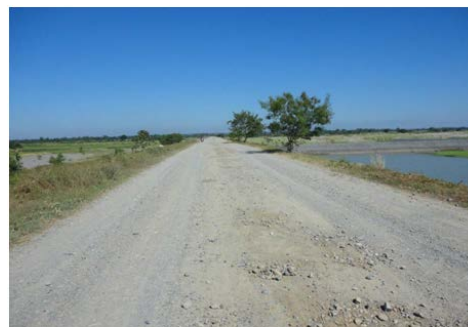
Closure Dike (taken from the top)

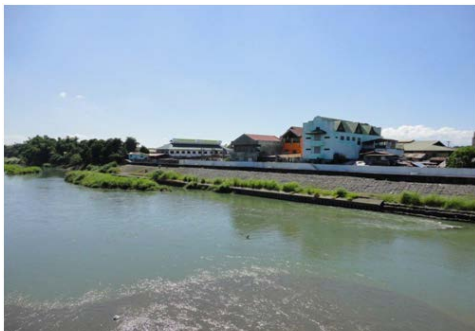
Agno River after improvement

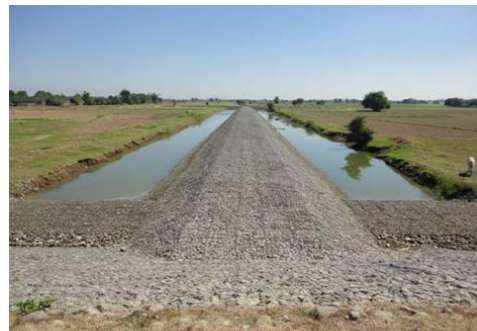
T-head spur dike

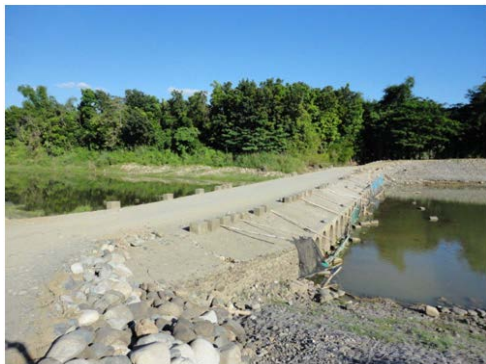
The super typhoon Pepeng hit the project area in October 2009 and destroyed the approach road of the Grade Control Structure (GCS²²) and dikes constructed by the project. The LGU (the municipality of Bautista) had undertaken urgent repair to the damaged approach road of the GCS but the road remained as a gravel road, and was not fully repaired at the time of ex-post evaluation. The PMO-AFCS intends to prioritize 2013 budget allocation to fully repair the GCS approach road (with concrete) and dikes. In fact, the GCS has been utilized by local residents for crossing. As urgent measures for residents, hanging bridge was constructed right next to the GCS after the Pepeng typhoon hit the project area.

Grade Control Structure

The PMO-AFCS conducts periodic inspection and maintenance work such as removal of vegetation, soil and stone as well as cleaning of channels and diversions. Additionally, non-regular inspection and maintenance works are carried out every time typhoons or monsoon rainfalls approach the project area and the PMO-AFCS prioritizes inspection in important places such as dikes and guide channels. Furthermore, the PMO-AFCS monitors the status of sediments and obstacles. In emergency situation, urgent repair of damaged facilities is conducted using the Calamity Fund as mentioned above.

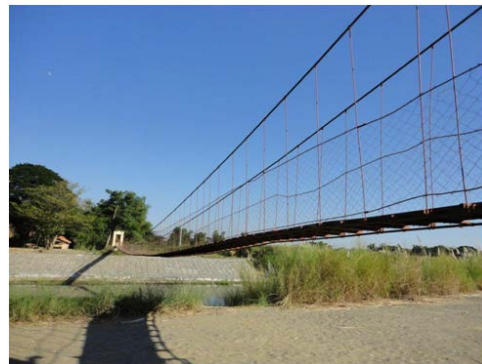
Hanging bridge
