0. Summary

1. Project Description

1.2 Project Outline

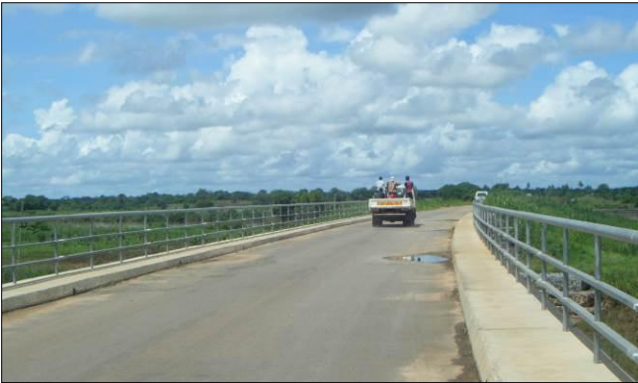
Improved Bridge (Licungo Bridge)

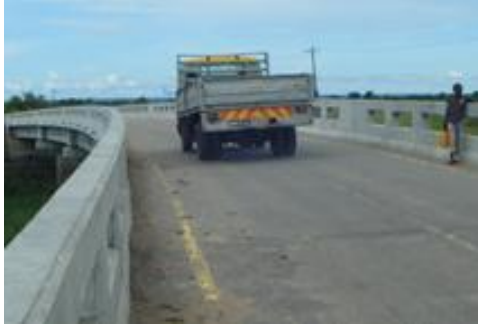
Replaced bridge (Cuacua I)

Cuacua I	<ul style="list-style-type: none"> • Main bridge mostly in good condition • Graffiti on guardrail • Damage to the surface of the connecting road to the bridge^{Note} • Water pit clogged by grass • Removal of old bridge incomplete • Damaged bridge name plate

Although all temporary bridges had already been removed, the existing Cuacua I bridge (currently an old bridge) has not been removed due to budget shortages²⁴. According to the implementing agency, there was no practice to remove old bridges in Mozambique and the priority was low. Accordingly, no removal plan is expected to be implemented within a couple of years. The old bridge was located downstream of the current Cuacua I and is considered less affected by

- The old bridge (Cuacua) had not been removed at the time of ex-post evaluation, although its removal was planned after the project under the responsibility of Mozambique. The old bridge is currently unused and aging. If untouched, it may hinder efforts to ensure the safety of neighbors due to the bridge collapsing during the rainy season. The implementing agency needs to strive to secure sufficient budget and remove the old bridge.
- Some cases of inadequate maintenance work, including clogged drains or weeds around the water pit and connecting roads emerged at the time of ex-post evaluation. Accordingly, there is a need to examine the necessary measures such as reviewing the frequency of maintenance work to prevent the serious damages, which require extensive repairs, under the proper O&M .

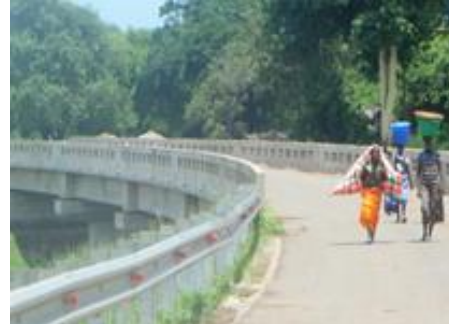
Constructed bridge (Chueza)

Chueza	<ul style="list-style-type: none"> • Main bridge mostly in good condition • Water pit clogged by grass • Damaged bridge name plate • A part of rough dirt road to the bridge

At Chueza, where the traffic volume tripled compared to the pre-project level, both traffic volume and the number of speeding cars increased¹⁹. Accordingly, at Chueza, which was constructed as a single-lane road, the safety of pedestrians and neighbors²⁰ become relevant issues, particularly due to increasing traffic volume as well as speeding cars, which mean consideration to secure safety and any action minimizing accidents would be required.
