Ex-Post Evaluation of Japanese Grant Aid Project
“The Project for Construction of Primary Schools in Oromia Region”

External Evaluator: Yuko Ogino, KRI International Corp.

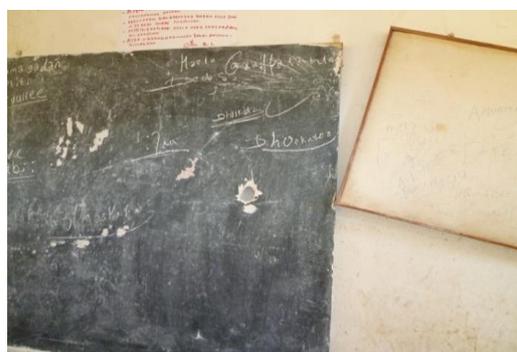
Figure 1 Blackboard with holes and noticeboard (right) not in use

and were mostly vacant except for a few cases. In many schools, there were problems with the surface of the blackboards. In addition, there was one site where many materials for furniture items were left unassembled²¹.

With regard to furniture, as mentioned in 3.2.1.2 Operation Indicators, the surfaces of the blackboards were worn down and sometimes had holes. Many schools pointed out the low quality of the original blackboards³⁸. However, there are some schools which repaint them regularly and therefore, the problem of the blackboards could be due to both the original quality and maintenance issues. Regarding other furniture items, some of the students' desks and chairs and many of the noticeboards and shelves were found to be damaged. According to the Beneficiary Survey, out of 36 valid responses, 15 schools complained about the quality of the furniture.

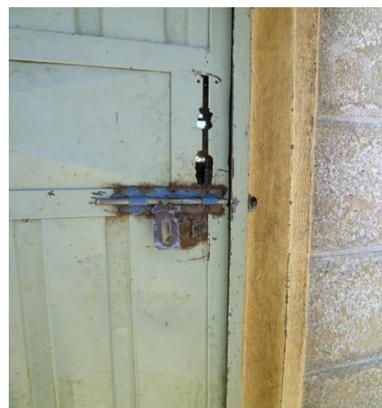
By confirming the situation at the directly visited school sites, door problems such as damage to knobs and keys were obvious in most of the schools. (The problems could have been avoided by using a different type of key, such as a bar-type lock.) In addition, problems were found of cracks in the concrete basement, floors and walls, leaking roofs in several schools, and a cover of precipitating tank of the latrine and a big hole in 1 school, which would not be regarded as minor defects and raise concerns in view of safety and durability. Most of the water

Figure 2 Broken door knob & key hole that is changed to a bar key

- Regarding the facilities and equipment at the target sites, OEB is requested to grasp the current situation in collaboration with local education offices in view of safety and durability as well as urgency and need for repairs. In doing so, it is recommended to include technical personnel with professional knowledge in construction and design because a deliberate survey is required to assess the cause of the defects, including whether there are any serious defects. In addition, the school directors need to take measures to mobilize the budget which will be necessary on a regular basis for maintenance (repainting and sludge removal) together with the PTA and village educational management committee members.

- Regarding the facilities and equipment at the target sites, JICA needs to facilitate OEB for appropriate maintenance. JICA is recommended to confirm with OEB the survey results in order to grasp the current situation including judgment of the urgency and need for repair as well as the progress of measures taken for the necessary budget appropriation. At the same time, it is recommended that JICA should conduct monitoring visits to target sites to confirm the status of use of the facilities and equipment.
