0. Summary

The project aimed to improve the stability of electric supply capacity in Costa Rica by constructing a hydroelectric power plant in the middle stretches of the Pirris River which runs through the central plateau of the country.

Figure 1: Pirris Hydroelectric Power Development Project

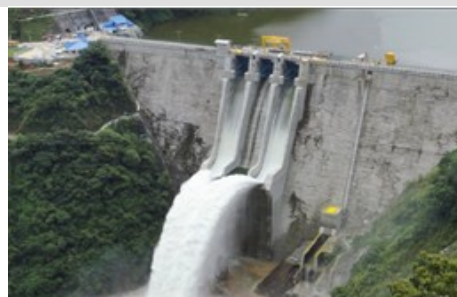
Pirris Hydroelectric Power Plant RCC² Dam
(provided by Costa Rican Institute of Electricity, ICE)

² RCC (Rolled Compacted Concrete) is an extremely stiff consistency concrete with less amount of cement. Because it is possible to place large amounts of concrete at once, it has the advantages of shorter construction periods and less construction costs, characteristics that make it a reasonable construction method (Reference: Website of the Japan Concrete Institute and the Japan Dam Foundation).
