Ex-Post Evaluation of a Japanese ODA Loan

“North Java Corridor Flyover Construction Project”

External Evaluator: Hideyuki TAKAGI, Ernst & Young Sustainability Co., Ltd.

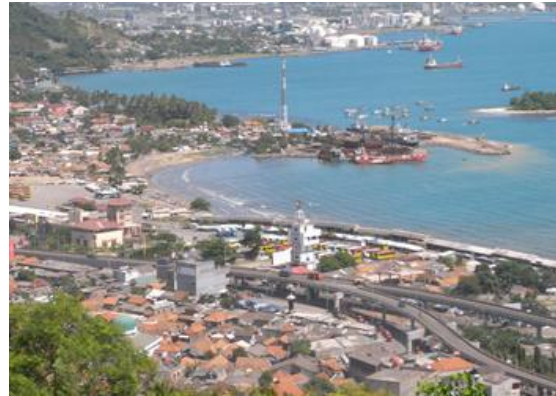
A distant view of Merak flyover

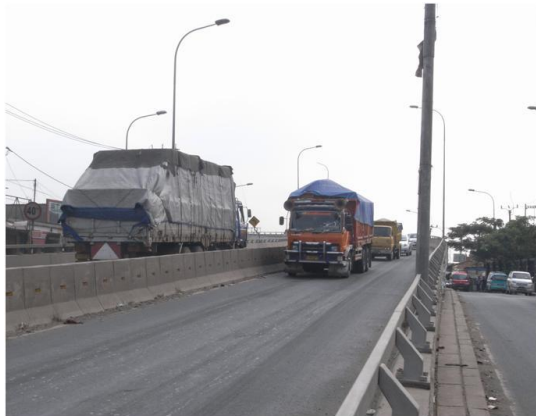
Photo 1. Trucks with heavy loads passing over the flyover (Balaraja FO)

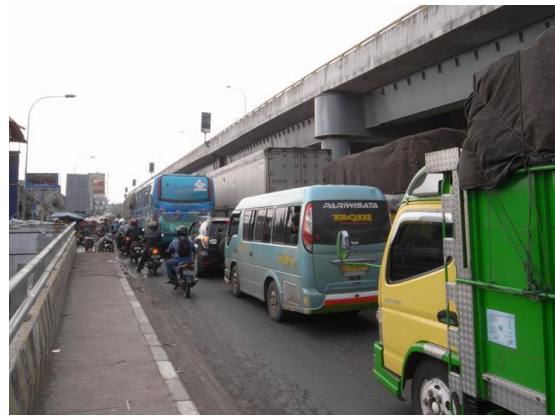
It is observed, however that the roads under the flyovers are still crowded, and traffic congestion still occurs during peak hours. In particular, traffic congestion is observed during the peak hours at Balaraja and Geban, caused by the lines of commercial vehicles such as mini buses waiting for passengers and the fish market opening during noon, respectively. Regarding the situation at Balaraja, countermeasures should be taken to ensure smoother traffic flows, such as by setting up bus stops, guiding the drivers to wait for passengers a certain distance away from intersections and controlling the parking of vehicles around the intersections. Regarding the situation at Geban, this is expected to become better if a plan for moving the fish market is implemented. According the local government that is proceeding with the plan, it is now seeking a contractor capable of implementing the moving of the fish market. Although it is not certain about the completion of the moving of the fish market, there has been land secured along the road and the local government intends to find a contractor and implement the plan

Photo 2. Traffic congestion under the Geban flyover (the line of vehicles extends from the fish market ahead)

There are problems regarding the traffic control and safety measures surrounding the flyovers especially at Balaraja. Traffic congestion caused by lines of parked commercial vehicles such as mini buses during the peak hours hinders smooth traffic flows. In addition, the school adjoining the intersection pointed out that the speed of vehicles is higher when vehicles pass over the flyovers, which causes a danger for the school children when they cross the road on the way to school. Countermeasures should be taken by the administrative bodies for traffic control and safety measures surrounding the flyovers. For example, the following measures are expected to cope with vehicles stopping around intersections: the setting up of bus stops, guiding the drivers to wait for passengers at a certain distance away from intersections and controlling the parking of vehicles around intersections, which should be executed in coordination with the local government and police stations, etc. To improve the safety of pedestrians, countermeasures should be taken such as the setting up of pedestrian crossings and signs and giving safety education to the school children, in coordination with the local

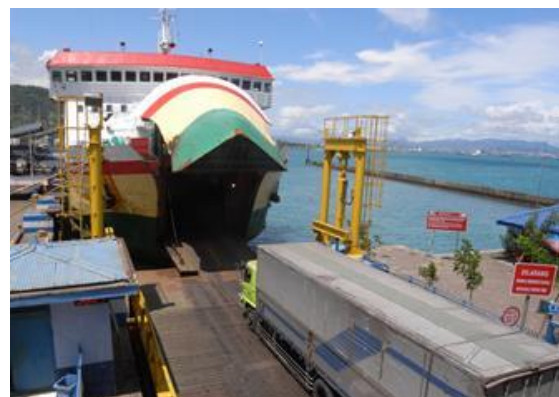
Photo 3. Merak ferry terminal (The FO contributes to the movement of goods and people between Java and Sumatra)

With respect to the economic effects due to improvements to cargo transportation, an analysis was also conducted of the improvement in convenience when using the ferry terminal at Merak. Since the construction of the Merak flyover, traffic congestion around the entrance has been greatly alleviated.

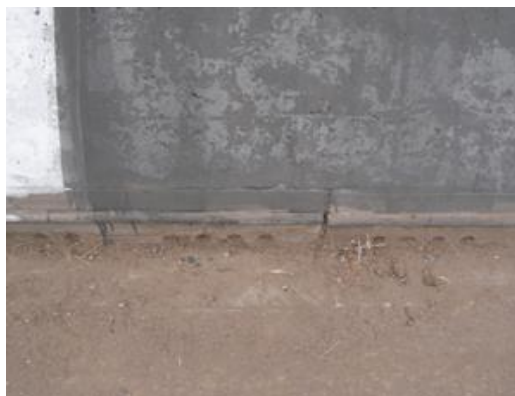
As the maintenance of flyovers is different from the maintenance of national roads in general, problems were observed regarding the maintenance of the drainage system of the flyovers during the site visits. Specifically, the lid of the drainage ditch cannot be opened in some places due to damage and curved road surface caused by a large traffic volume of trucks with heavy cargo and patch repair. In addition, there are places where sand had covered the drainage ditch

due to the lack of cleaning, and drainpipes seemed to be clogged with sand. In order to recover the functions of the drainage system, the maintenance methods for flyovers as a whole should be improved by reviewing how to repair damaged road surfaces and how to clean the inside of drainage systems.

Photo5. Road side of Balaraja FO (sand still remains inside the drainage system after cleaning)

The road surface is curved and damaged probably due to the large volume of truck traffic carrying heavy loads, and patch repairs for the damage and unrepaired large hollows were identified. In addition, sand has accumulated on the roadside and inside the drainage system. The maintenance condition seems worst among the three flyovers. As of the 2nd field study, the maintenance of the flyover has been in process mainly by patch repair and cleaning of the roadside, and the badly damaged road surface near the exit of the flyover is under pavement construction. However, removal of the sand inside the drainage system has not yet been completed.

There are problems regarding the maintenance condition of the drainage system of the flyovers: the lid of the drainage ditch cannot be opened in some places due to damage, such as a curved road surface caused by a large volume of truck traffic with heavy loads and patch repairs. There are also places where sand covers the drainage ditch due to the lack of cleaning and the drainpipes also seem to be clogged with sand. In order to recover the functions of the drainage system, the maintenance method of the flyovers as a whole should be improved by reviewing how to repair damaged road surfaces and how to clean the inside of the drainage system.

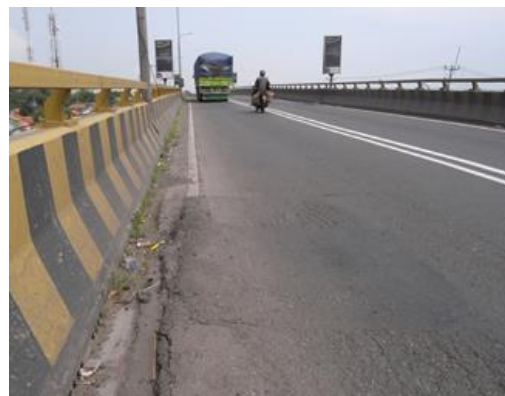
Photo6. Patch repair and drainage ditch. The lid of the ditch cannot be opened (Geban FO)

The condition is similar to that of Balaraja, where the road surface is curved and damaged, and maintained with a patch repair. According to the local office of the Ministry of Public

Works, the lid of the drainage ditch cannot be opened due to the curved road surface and problems in the repairs to the damaged points, therefore the inside of the drainage system cannot be cleaned to remove the sand. As a result, the malfunction of the drainage system causes pools of rain water at the entrance and exit of the flyover in the rainy season.
