Ex-Post Evaluation of Technical Cooperation Project

“The Water Sector Capacity Development Project in Southern Nations, Nationalities and People's Region”

External Evaluator: Makoto Tanaka, ICONS Inc.

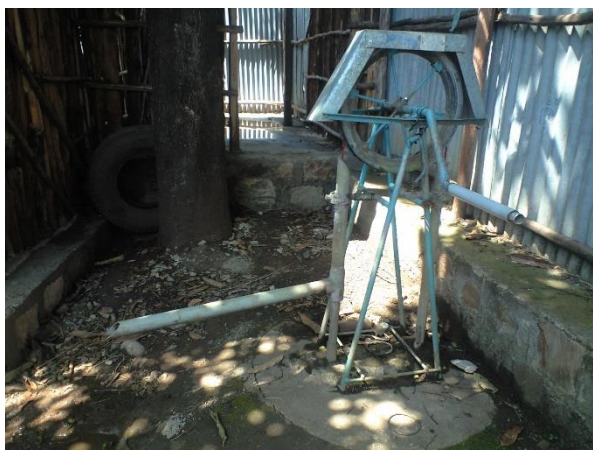
Household rope pump installed in the Project²

² A rope pump is a kind of pumps that are intended for shallow wells. It is believed that rural inhabitants can bear the initial cost of installation and maintain rope pumps by themselves, the users can pump water with simple operation, and they can save time for household work. The structure and the principal of rope pumps are shown in Figures A1 and A2 at the end of this document, respectively.

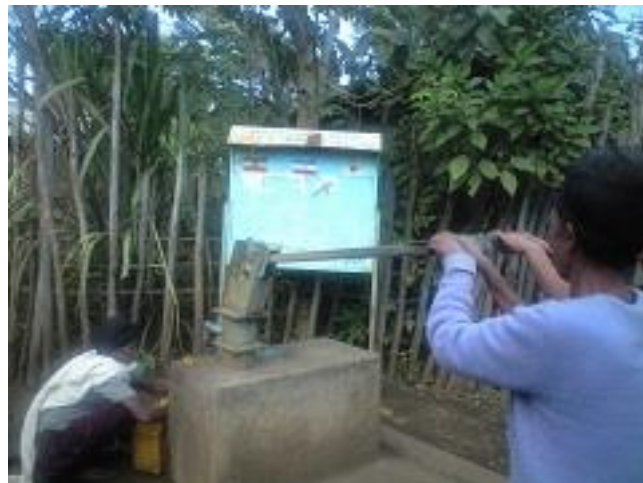
Photo. 1 Scene of water pumping at a public hand pump site (Gara Godo Kebele, Boloso Sore Woreda)
(Photo by the evaluator)

said to be indirect effects of this project. At public hand pump sites in this kebele and Sile Sira Kebele in Arba Minch Zuria Woreda, the upper limit of monthly water quantity, the charge and the order of pumping and water collection were decided in meetings at each WASHCO, so that the order in pumping was established (see Photo. 1). Through the fact that the inhabitants share the common work of pumping at public hand pump sites, local order is established and the connection between the inhabitants is strengthened.

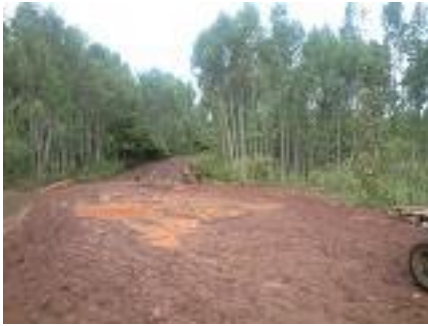
Photo. 2. A bad road over which it is difficult to travel with 4WD vehicles (Bolosso Sore Woreda, Wolayita Zone)
(Photo by the evaluator)

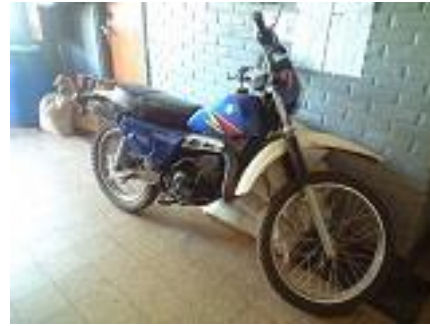
Photo. 3. An example of an off-road type motorcycle⁴⁷ (Suzuki TS185 owned by Wolayita ZWMED)
(Photo by the evaluator)

⁴⁷ The motorcycle in Photo. 3 was not supplied in this project, but is shown here as an example.

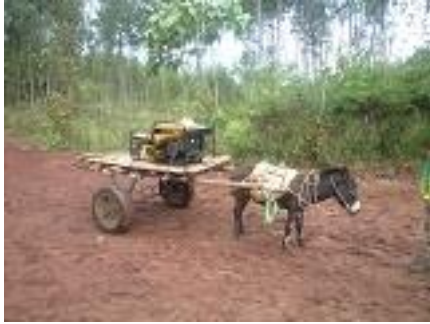
Photo. 4. A donkey cart loaded with a generator traveling over a bad road (Bolosore Woreda, Wolayita Zone)
(Photo by the evaluator)

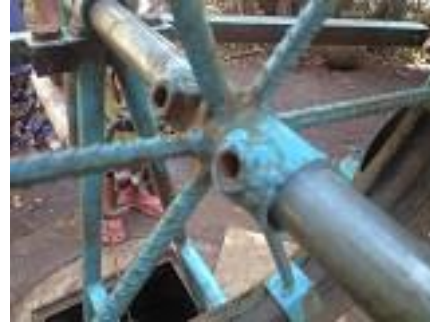
Photo. 5. The wheel of a rope pump that is not working because it has had its bolt removed (Bolosore Woreda, Wolayita Zone)
(Photo by the evaluator)
