Ex-Post Evaluation of Japanese Grant Aid Project

“The Project for Rehabilitation of Monshat El Dahab Regulator on Bahr Yusef Canal”

External Evaluator: Kenichi Inazawa, Octavia Japan Co, Ltd.

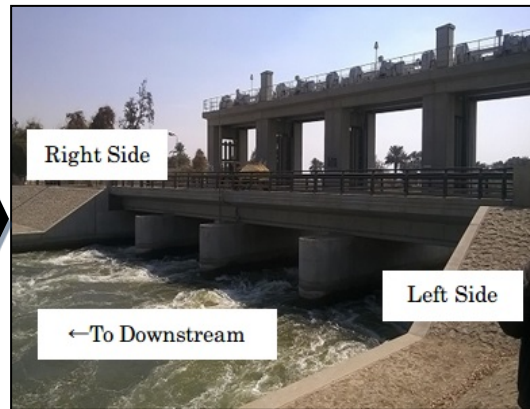
Photo 2: Dahab Regulator after rehabilitation
(At the time of the ex-post evaluation)

It has been confirmed through site visits during the field survey that the Dahab Regulator is fully functioning as an appropriate civil structure at the time of the ex-post evaluation, thanks to proper maintenance works. No problems were observed in the operational status of the main body of the regulator, gates, hoists or consoles inside the control building. Silt and wastes are being removed around the Dahab Regulator and the regulator bridge and roads are regularly cleaned.

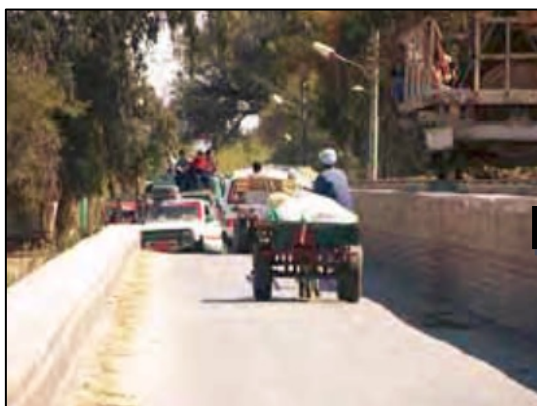
Photo 3: Regulator Bridge and Road prior to Rehabilitation
(narrow with a 4m width and prominent congestion)

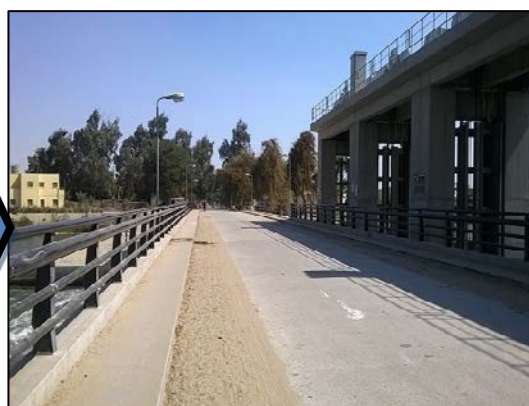
Table 3 indicates the waiting time at the regulator bridge, which was rehabilitated along with the Dahab Regulator. There has not been any vehicle waiting time since the completion of this project (July 2010). As a result of this project, widening the bridge from 4m to 10m saw two-lane traffic realized and vehicles no longer need to wait on one side of the bridge for a clear lane, making the traffic smooth (see Photo 3 and 4). Through regulator bridge inspections and interviews with staff members maintaining the Dahab Regulator during the field survey of the ex-post evaluation, it has been confirmed that congestion was addressed after widening of the bridge and that this had led to the smooth transportation of agricultural products. It can therefore be said that this project addressed the problem of waiting time for vehicles crossing the bridge.

Photo 4: Regulator Bridge and Road after the Rehabilitation
(expanded to 10m wide by this project)

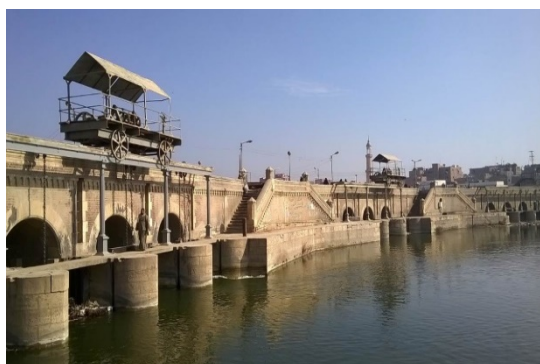
Other factors include the aging Dairut Regulator Group (see Figure 1), which exists upstream of the Dahab Regulator, as mentioned above. While irrigation water along the Bahr Yusef Canal flows through the Dairut Regulator Group, more than 100 years have elapsed since the construction of the latter and problems exist regarding the controlling and opening-and-closing of gates, as well as with the management of water distribution. At the time of the ex-post evaluation, the Government of Egypt requested the Japanese Government to assist the "New Dairut Regulator Group Construction Project", which aims to rehabilitate this regulator and improve the water management system including that of the Bahr Yusef Canal. In March 2015, the Government of Egypt and the Government of Japan agreed to implement this as an ODA loan project. After completion of this project, more stable water supply and efficient water distribution are expected for the Bahr Yusef Canal as a whole. Thus, irrigation water volume from the Dahab Regulator to its beneficiary areas is also expected to increase.

Photo 5: Dairut Regulator Group
(The mobile pulley above opens and closes the gates.
The structure is generally old.)
(At the time of the ex-post evaluation)
