Country Name	<b>The Project for the Urgent Rehabilitation of Markham Bridge</b>
The Independent State of Papua New Guinea

**I. Project Outline**

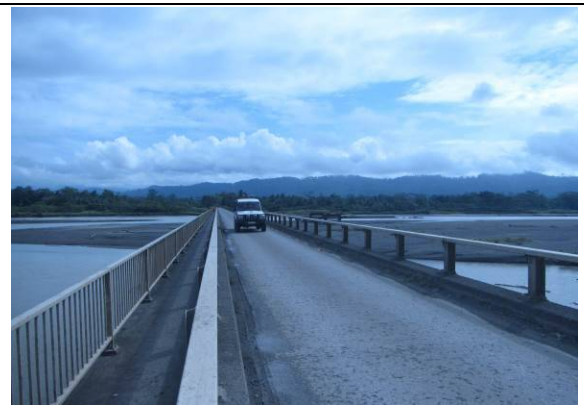
Markham Bridge

After the rehabilitation works on the bridge by the project, the expected lifetime of the bridge can reach the target value of 20 years since the project completion in 2011. Namely, it means that the bridge will be well functioning for the next 16 years as planned. Also, the project contributed to improving safety and stability of traffics and pedestrians crossing the bridge. No damage was observed or reported on tires of the passing vehicles after the repair of bridge foundation. In addition, the approach road allows smooth flow of traffic over the bridge without any further delay. The waiting time at the edge of the bridge has reduced on average to 36 seconds at the time of ex-post evaluation from 43 seconds at the time of Basic Design in 2006<sup>2</sup> of. In terms of the safety of pedestrians crossing the bridge, the stable condition of the walk way and handrails guarantee safe crossing by the pedestrians. According to an interview with a Land Owner Group, no accident was reported after the project completion up to the time of ex-post evaluation. No negative impact of the project was observed at the time of ex-post evaluation.

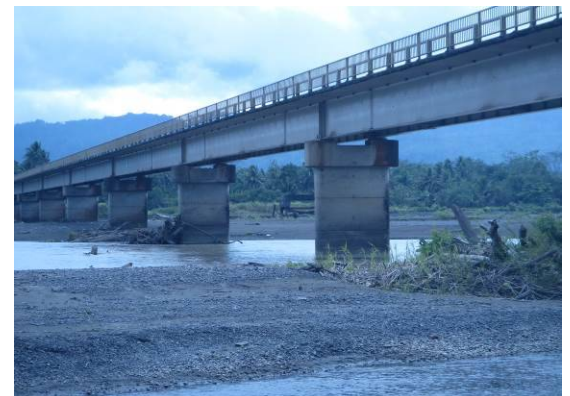
Bride Piers of Markham Bridge

The project has achieved its objective, "to strengthen stability of structures and improve bearing capacity of bridge piers of the Markham Bridge against floods". Despite lack of data for the bearing capacity safety ratio and the bearing capacity of the bridge piers which require very technical calculation, it was observed that the bridge is in good condition. Although a number of floods occurred at the time between the project completion and ex-post evaluation, they did not cause any damage owing to the enhanced durability of bridge piers against the floods. As a result, there was no occasion that the Markham Bridge had been impassible.

As mentioned above, the Markham Bridge has been in good condition after the rehabilitation works by the project. The maintenance plan for the bridge has been in place but no necessity to implement it so far because of its good condition. In addition, as the DOW Morobe Office has been conducting awareness raising activity for the public including the surrounding communities not to litter and not to make the bridge dirty, neither rubbish nor dirt was observed at the time of ex-post evaluation. Although DOW does not have stock pile of the materials and has not procured any necessary materials and spare parts, DOW has sufficient budget and maintenance system in place so that the materials and spare parts shall be procured when need arise for maintenance.

Since the bridge has been in good condition, it is recommended that DOW Morobe Office conduct routine checks on monthly basis to make sure that the bridge is well maintained at all times for safety of pedestrians and transportation of good and services. In terms of procurement of spare parts, it is recommended that DOW make an asset management plan for the bridge maintenance based on which DOW requests for necessary budget to stockpile of necessary materials such as concrete blocks and cement and make them readily available so that whenever in need for maintenance; they can use the parts without delay even though the timely procurement of necessary materials is guaranteed.
