Ex-Post Evaluation of Japanese Grant Aid Project

“Project for Development of Potable Water, San Juan River System in Potosí”

External Evaluator: Hajime Sonoda, Global Group 21 Japan, Inc.

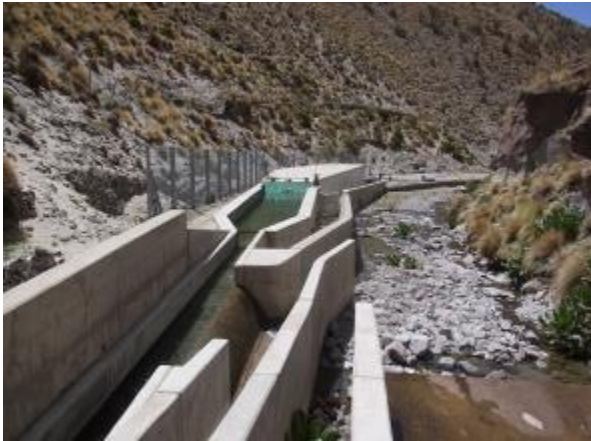
Water Intake

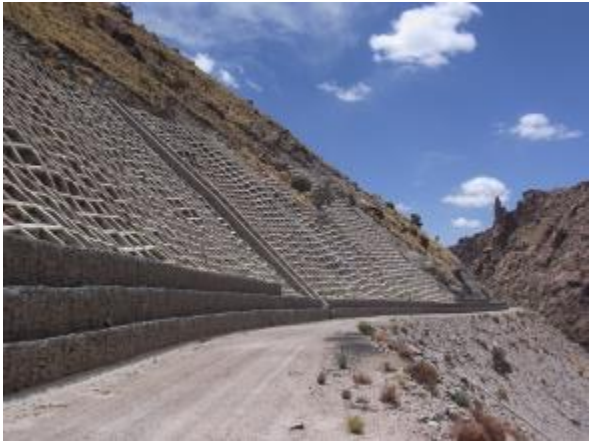
Before the Project, vehicle access to the water intake was impossible because of slope failure along the access road. The renewed protection of the conduction pipeline as well as the access road under the Project has enabled vehicle access to the water intake throughout the year. Therefore, it is judged that the risk of water cut due to troubles at the water intake has been significantly reduced, as prompt action could be taken when a problem occurs.

Slope Protection for the Access Road to Water Intake

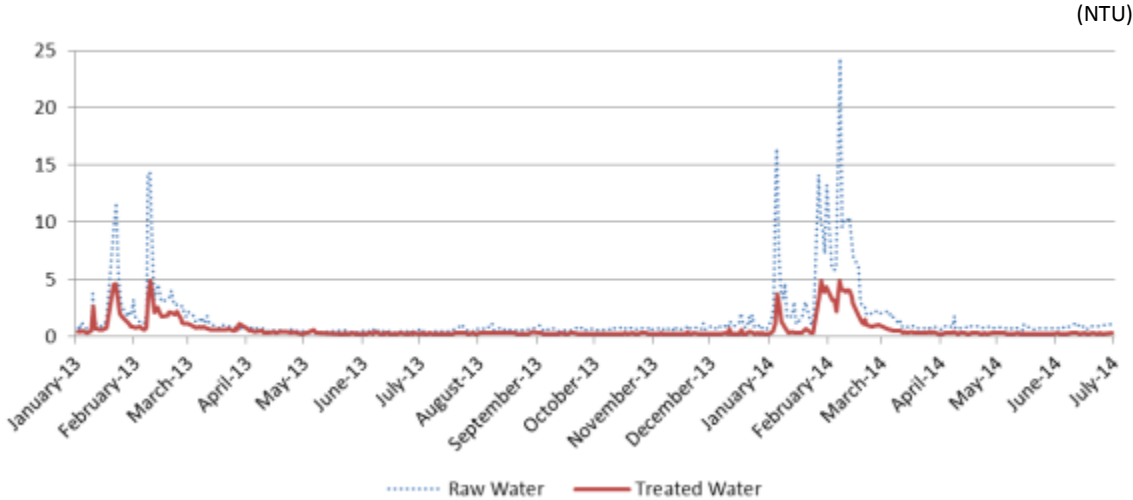
Figure 2 Turbidity of Raw Water and Treated Water of the San Juan Water Treatment Plant

The water quality has much improved, especially in terms of turbidity. The number of days when the turbidity of the raw water exceeded the relevant water quality standard in Bolivia of 5 NTU was five days in 2013 and 20 days in 2014.⁹ There have been no occasions of the turbidity of the treated water exceeding 5 NTU (Fig. 2). Water quality inspection in 2013 found that all of the water quality standards were met at both the WTP and the distribution network and no coliform bacilli were found.¹⁰ The

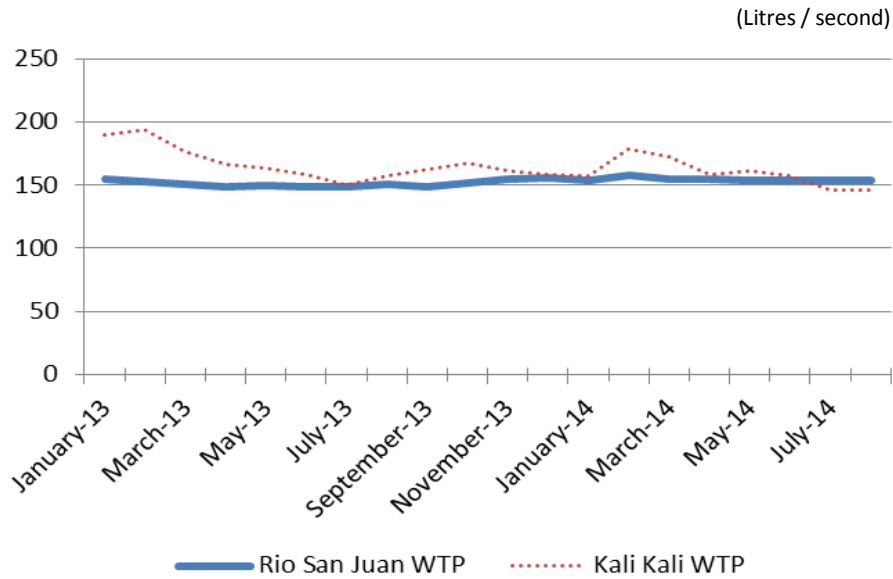
Figure 3 Historical Changes of Water Production Volume in Potosí

The water production rate of the San Juan River System before the Project was approximately 130 litres/sec. As the Project enabled the adequate removal of dirt from the conduction pipeline, boosting the effective capacity of this pipeline, the water production volume in the post-project period has been steady at approximately 150 litres/sec (115% of the pre-project figure) which is the maximum volume which the conduction pipeline and the new WTP can handle. The combined water production volume in Potosí, including that of the Kali Kali System, is approximately 300 litres/sec.

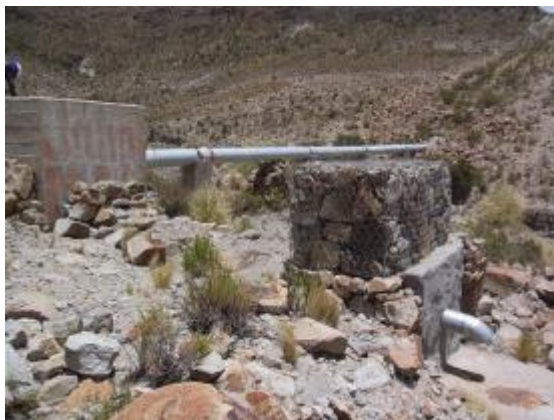
The dirt removal facility

The dirt removal facility and air valve of the conduction pipeline are operated twice a year (before and after the rainy season) while regular inspection for preventive maintenance is conducted once a year. One problem found is that although more than half of the staff members which underwent training under the Soft Component are still working for AAPOS, none of them are involved in the regular inspection of the conduction pipeline. This means that the technical know-how which they learned, including the use of the conduction pipeline monitoring manual, was not being properly utilised (Refer “3.5.4 Current Status of Operation and Maintenance”). Responding to comments made by the evaluator in the first field survey (October-November 2014), AAPOS mobilized the two employees who had received training in November 2014 and had remained in AAPOS and implemented an inspection of the conduction pipeline using the check sheet that had been used in the training. It intends to conduct further inspections when the rainy season ends in May 2015.

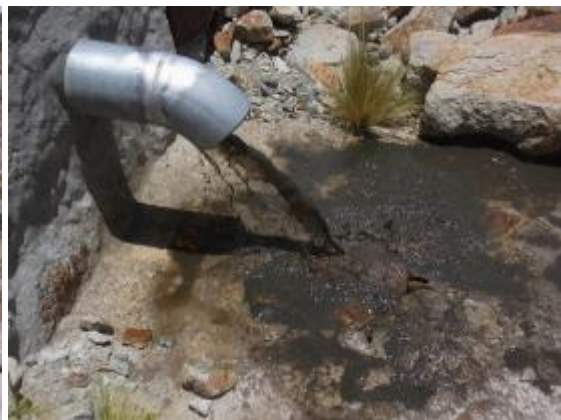
Operation of the dirt removal facility

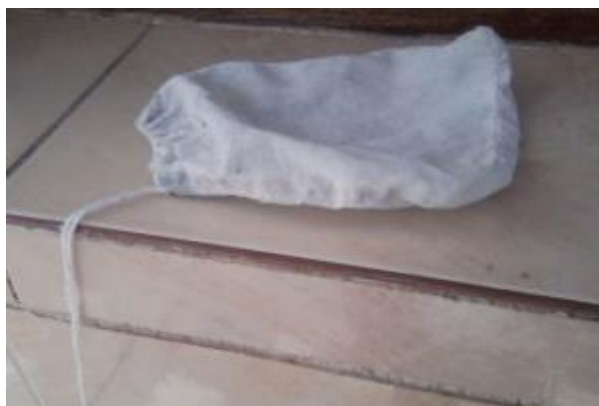
Cloth filter that was used until some years ago

Project and most of these impacts were related to improvement of the water quality¹³. Many respondents mentioned that before the Project, the turbid water in the rainy season in particular was unpleasant, especially when it smelled bad and small insects were found in the water. Most households, therefore, found it necessary to boil the supplied water before using it or attached a cloth bag to the tap to filter the water. The ratio of households using these measures has been dramatically reduced today and the level of convenience concerning water was improved greatly. When the survey of beneficiaries was implemented, 74% of beneficiaries responded that they were happy with the water supply service provided by AAPOS.

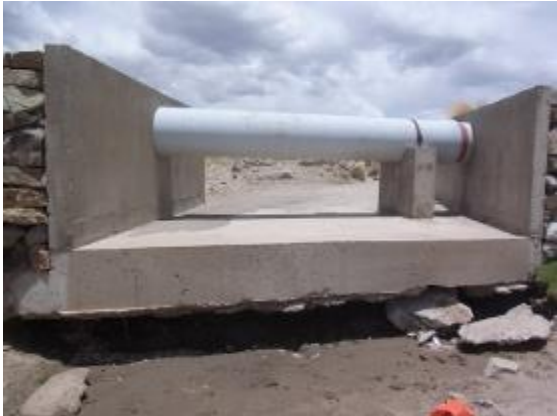
During this field visit, however, scouring of the basis of some of the conduction pipeline protection facilities by flowing water was discovered. This is a result of a lack of adequate preventive maintenance. It is necessary to urgently deal with this situation as further scouring could damage the conduction pipeline.

Scouring of foundations around the protection work of the conduction

- As the security arrangements at the water intake require strengthening, the relevant possible measures should be examined, including the deployment of an additional caretaker, restriction of entry to the access road, erection of protective fencing at the water intake, and introduction of a reliable communication system.
- In regard to the preventive maintenance of the conduction pipeline protection facilities, the maintenance system should be rebuilt, focusing on those staff members who underwent training for the transfer of skills under the soft component of the Project. On that basis, the total inspection of these facilities (scouring of foundations around the protection work, etc.) from the view point of preventive maintenance should be conducted as soon as possible so that the necessary protective measures can be employed before the arrival of the next rainy season.
