Ex-Post Evaluation of Japanese Grant Aid Project

“The Project for the Improvement of Masasi-Mangaka Road”

External Evaluator: Noriyo Aoki, IC Net Limited

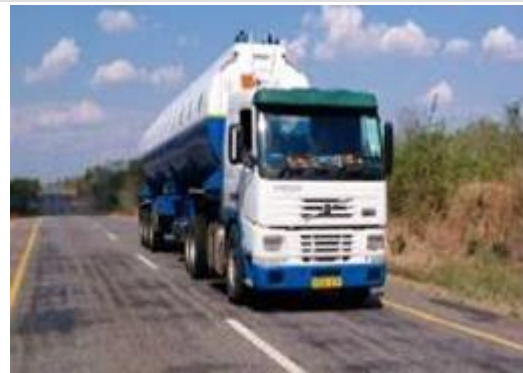
Vehicle on Section of Road Covered by the Project

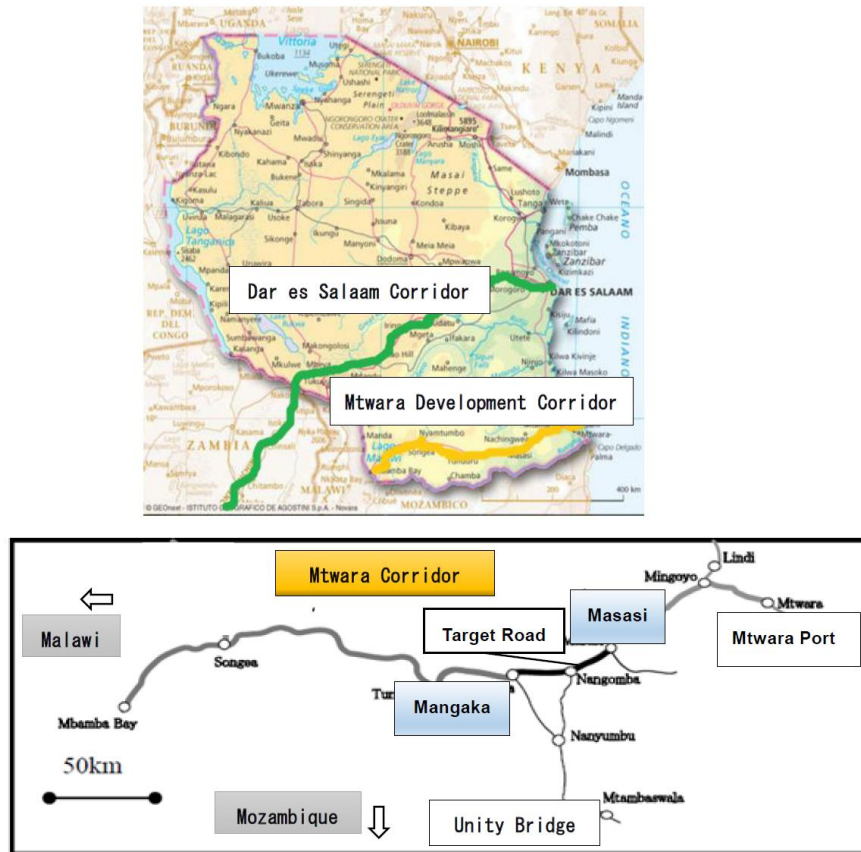
Figure 1: Maps of Project Road and Mtwara Corridor

including coal, iron ore and uranium and has a high potential for economic development, it is one of the least developed areas of Tanzania¹. The section of road covered by the project is part of the Mtwara Corridor, which is included in the Southern African Development Corridor Strategy promoted by the Southern Africa Development Community (SADC). The Mtwara Development Corridor is an international corridor linking Mtwara Port in southern Tanzania with Malawi, Mozambique and other neighboring countries. The four countries involved in the Mtwara Corridor, namely, Tanzania, Malawi, Mozambique and Zambia, were expected to improve the roads within their own countries, and to work together to promote the development², but at the time the project was planned, the only surfaced road was a section from the regional capital Mtwara City and Mtwara Port to the small town of Masasi. An improvement of the road connecting to the Unity Bridge³ spanning the border with Mozambique through the Masasi-Mangaka road, and of the road through Mbamba Bay to Malawi along the Mtwara Corridor, had been lagged behind. Under these circumstances, the road between Masasi and Mangaka covered by the project was regarded as an important section of road in the development of the Mtwara Development Corridor (see Figure 1).

At the time of planning, the Tanzanian National Development Plan, namely the National Strategy for Growth and Reduction of Poverty 2005 – 2009 (NSGRP), made the improvement and maintenance of trunk roads a priority issue. Under the 10 Year Road Sector Development Program 2001 – 2010: (10Y-RSDP) formulated in 2001, the road covered by the project, being part of the Mtwara Development Corridor, was ranked a key trunk road (see Figure 1).

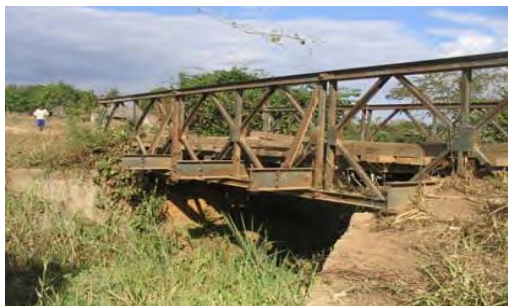
(Source) Preparatory Survey Report
 Figure 3: Bridge Subject to Flooding Before the Project

There are no data on the reduction in the number of days or hours of flooding²⁴, but according to the implementing agency, the problem of flooding was resolved as a result of anti-flooding measures taken in the project. In interviews, cashew nut traders said that at a number of points prone to flooding²⁵ each time there was flooding the road would be impassable for 3-5 hours, but after completion of the project, traffic delays caused by flooding had disappeared.

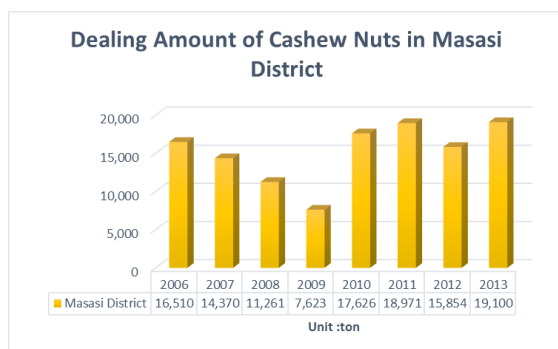
(Source) Cash Nuts Board Materials
 NB 1) The amount of production was decreased due to lots of rain in 2009
 NB 2) The pest influenced the production in 2012

Figure 6: Amount of Dealing of Cash Nuts in Masasi District

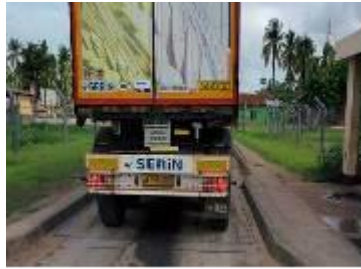
Imposition of Axle Load and Vehicle Weight Measurement
Mingoyo Weighing Station in Mtwara Region

In order to prevent the overloading of large vehicles, there is a weighing station in Mingoyo near Mtwara, where all large vehicles heading to Mtwara or Masasi are measured. The construction of a weighing station in Mangaka is also planned. A crackdown on violations of the weight/axle load restrictions in recent years has reduced the number of violations by large-size vehicles across the board.⁶³
