FY2015 Ex-Post Evaluation of Japanese Grant Aid Project

“The Project for Reconstruction of Bridges (Phase 3)”

External Evaluators: Yuko Kishino and Ryuji Kasahara, IC Net Limited

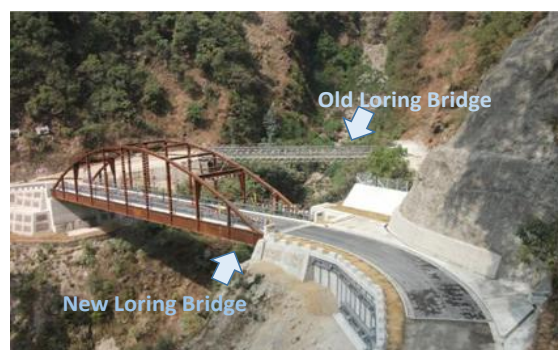
The Roads Improved by the Project<sup>2</sup>

<sup>2</sup> Document provided by JICA (taken around March 2013.) The new Loring Bridge is at the front and the old Loring Bridge is at the back in the photograph. The old Loring Bridge was removed after the completion of the new Loring Bridge and does not exist anymore.

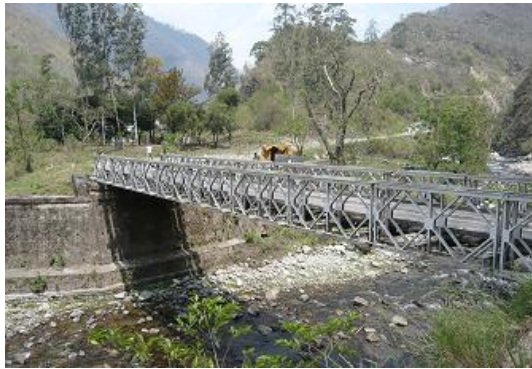
Photograph 1: Before Construction Work<sup>15</sup>

Photograph 1 and Photograph 2 show a comparison of before and after the construction work of Burichu Bridge.

<sup>15</sup> Materials provided by JICA (Burichu Bridge, a condition before construction work)

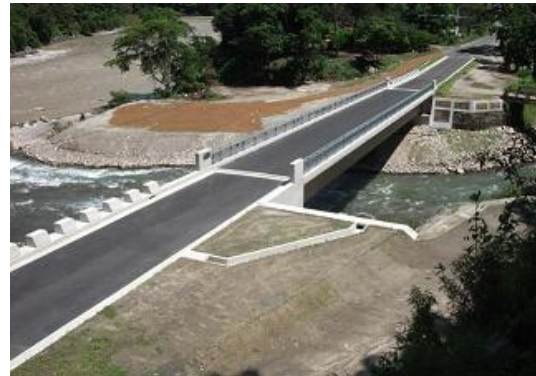
Photograph 2: After Construction Work<sup>16</sup>

<sup>16</sup> Materials provided by JICA (Burichu Bridge, a condition after construction work)
