Country Name	The Project for Urgent Rehabilitation of Water Supply System in the Capital City Podgorica
Montenegro

I. Project Outline

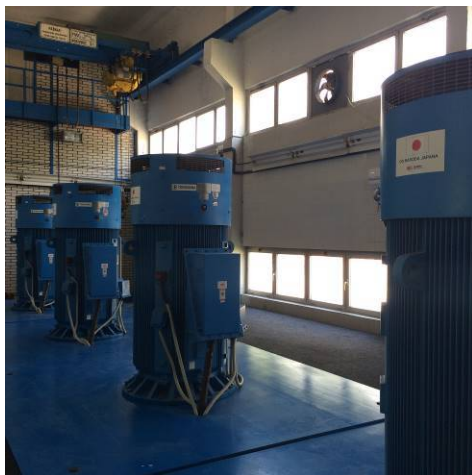
All four pumps and pump control system at Mareza 2 pump station as well as water distribution monitoring system procured under the project function well¹. Capacity of Mareza 2 pump station has improved from 544l/s to 960l/s. Whole population in Podgorica is served with stable water supply after the project was completed while the number of population served with stable water would have dropped if the project was not implemented due to the limited capacity. In addition, population increased as the migration to Podgorica is larger than expected. After the project was completed, there is no water suspension for population in areas where suspension occurred frequently

Four pumps at Mareza 2 pump station

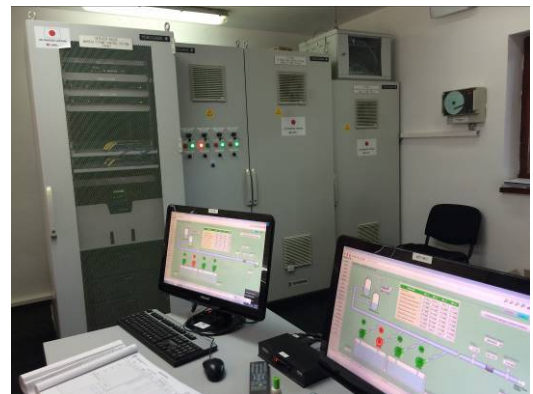
¹ The monitoring system is functioning without difficulties, however, part of the software related to reporting function is malfunctioning. Although PWS has tried to sort it out with the supplier, the issue is still pending. PWS can use data collected through system, but they have to extract it and analyze it manually.

Monitoring room at Mareza 2 pump station

- It is recommended to PWS to continue sorting out the problem of reporting function of the monitoring system.
- It is strongly recommended to PWS to establish system of education and training for staff in charge for operation and maintenance. Currently, the weakest point related to the technical capacity is notified at segments software component of monitoring system and calibration of equipment at measuring points. Therefore, PWS should start with training including these issues at earliest possible convenience.
