Country Name	The Program for Emergency Water Supply for Addressing Climate Change (Programme d'urgence pour l'approvisionnement en eau pour faire face au changement climatique)
Republic of Niger

I. Project Outline

II. Result of the Evaluation

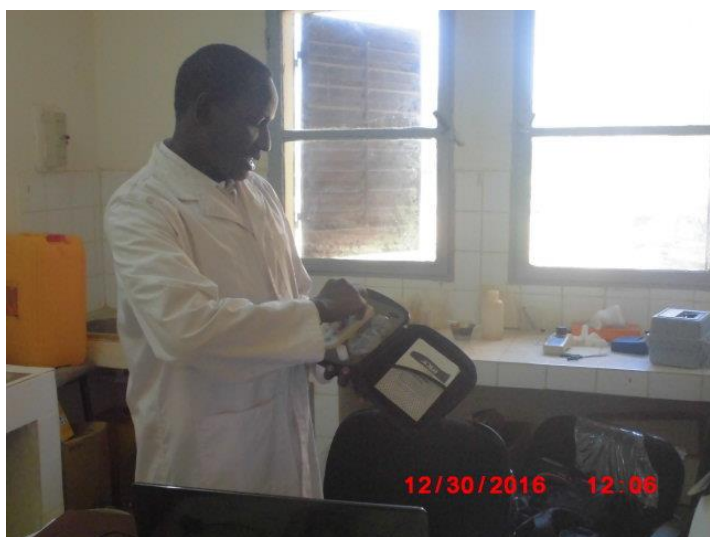
Utilization of Water quality test equipment provided by the program in the laboratory of Tillabery

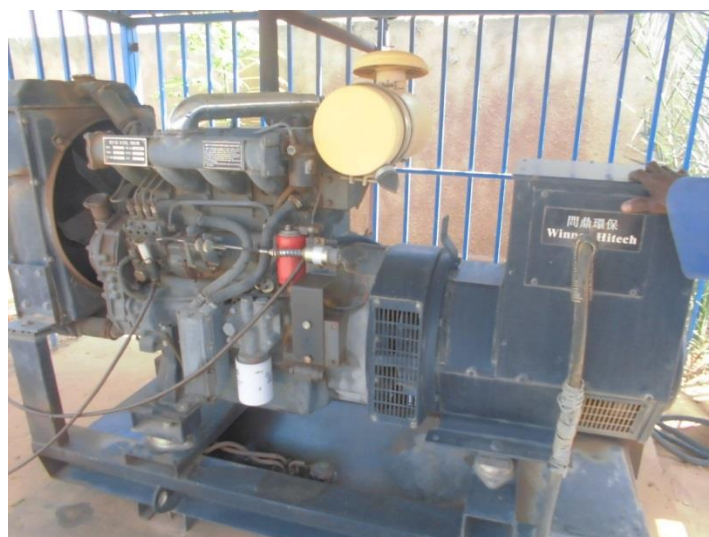
Generator used by SEEN on the site of Libore (Tillabery region)

Although the decrease in the number of water suspension by the use of the generators procured by the project was expected, the data on the suspension of water supply was not obtained. According to the Niger Water Development Corporation (SEEN: Société exploitation des Eaux du Niger), a private water operating company, which carries out Operation and Maintenance (O&M) of the generators procured under the project, the generators have faced frequent breakdowns from the outset. At the time of ex-post evaluation, 14 out of 23 generators did not perform. The majority of breakdowns relates to the problem of a choke coil which triggers the safety devices. There are also frequent engine failures that cannot be repaired because of lack of spare parts on the local market. Sometimes, engines were repaired by taking parts of the old generators

Some of the equipment items, especially generators are not functioning well as mentioned above. However, this is not due to the lack of proper checkup, but it is because of the poor quality of the equipment procured. Regular maintenance is carried out appropriately. Spare parts are difficult to find in the local market.
