FY2016 Ex-Post Evaluation of Japanese Grant Aid Project

"Project for Rehabilitation of National Trunk Road N8"

External Evaluator: Noriyo Aoki, Alfapremia Co., Ltd.

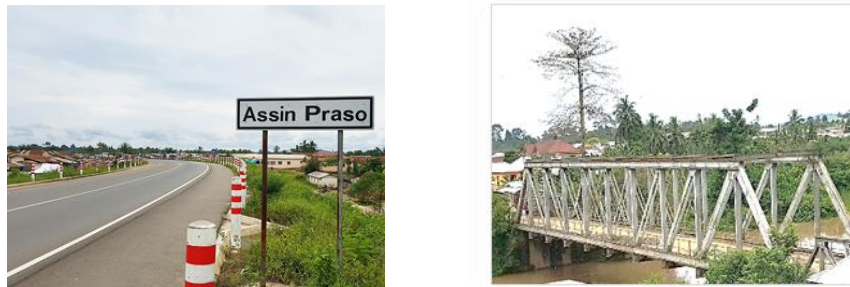
New (left photo) and old (right) Assin Praso Bridge

The new bridge has specifications based on the B-live load of the technical standard *Road and Bridge Specifications* formulated by the Ministry of Land, Infrastructure, Transport and Tourism of Japan<sup>28</sup>, which also satisfies Ghanaian bridge standards<sup>29</sup>.

Waiting time was no longer required, and the waiting hours to cross the bridge was reduced from 1/3 to 1/2<sup>26</sup>. Stores and residences surrounding the old Assin Praso Bridge and the connecting roads were submerged under water about three times a year. The new bridge was constructed at a higher position and flooding no longer influences vehicle travel<sup>27</sup>. According to the results of the beneficiary survey, 99% of respondents said that its convenience improved.
