Samoa

FY2016 Ex-Post Evaluation of Japanese ODA Grant Aid Project

“The Programme for Improving the Weather Forecasting System and Meteorological Warning Facilities”

External Evaluator: Hisae Takahashi, Japan Economic Research Institute Inc.

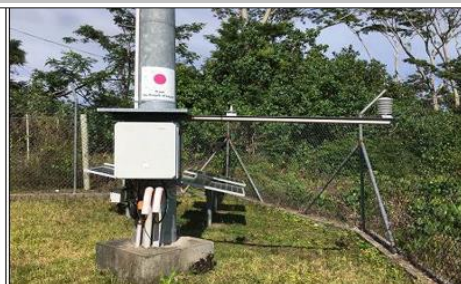
Data Collection Unit, Barometer,  
Temperature and Humidity Sensor  
(Le Piu Tai in Savaii Island)

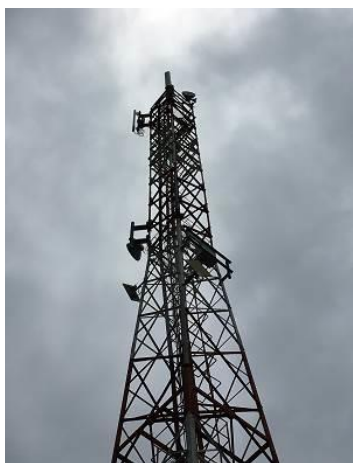
Meteorological Data Communication System (Vaisala)

Meteorological data, available at the AWS installed at each site in Samoa, are transmitted to SMD via a meteorological data communication system and then distributed to the WMO GTS system via the GTS switch system. Simultaneously, since meteorological data observed by other countries can also be received the data communication capacity for transmitting and receiving meteorological observed data in Samoa is considered enhanced. It also indicates how SMD can make forecasts based on more meteorological data and trends, led to enhance forecasting accuracy in Samoa.

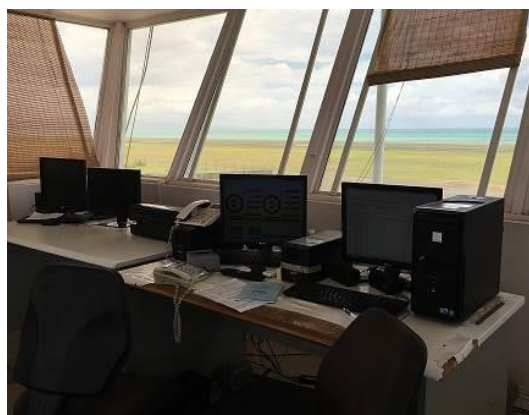
Inside the airport control tower: AWOS Display System (Faleolo International Airport)

This project installed AWOS capable of observing data on a real-time basis at two sites of a runway, and an AWOS Display System in Faleolo airport displaying the same information as could be monitored with SMD. Thanks to these systems, SAA can now confirm information such as wind direction, wind speed, temperature, rainfall, cloud height and visibility, which was formerly observed manually by SMD and informed to SAA via phone. Those data are currently observed on both sides of the runway every five minutes and shown in displayed systems, allowing timely and accurate weather forecasts via the SMD observation systems. Moreover, SAA no longer needs to perform observations, which also helps reduce its workload.

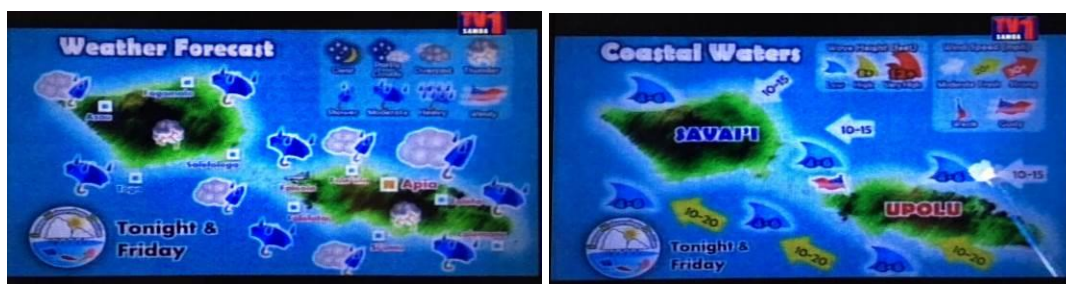
(Photos) Screens of the TV weather forecast program showing the weather icon

As well as improvements made to the observed data and forecast information, the project provided technical assistance to prepare weather icons and maps for weather forecasting as well as displaying and explaining meteorological information and reporting weather forecast services, allowing SMD to provide weather forecast programs on TV.

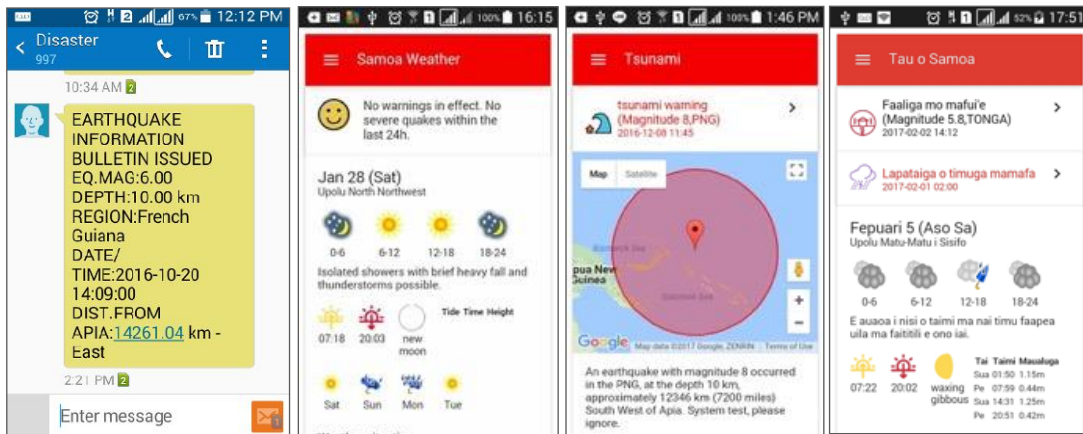
Early warning information  
Issued by SMS

App Screen ①  
Weather forecast in  
four hours and four days

In 2012, the project installed AWS and Early warning system in SMD. Through this equipment, meteorological information for Samoan people can be provided in a format which is more easily understood. It also included swift responses to deliver the information to major institutions using the disaster information and leaders of each village via SMS in the event of disaster. Meanwhile, there have been issues such as an inability to send SMS messages to all people in Samoa due to the capacity limitations. Also, an SMS only contains up to 160 characters per message. To improve the system, SMD has worked to develop a smartphone application (App) with technical support by a JICA volunteer and an app service was finally launched from February 2017. This app was developed to complement the existing system which has been utilized and delivers early warning information to a wider scope of people in Samoa. In addition, information useful for daily life in Samoa, such as weather forecasts of every six hours, sunrise and sunset times, tide tables and so on is displayed in both English and Samoan (users can set the preference).

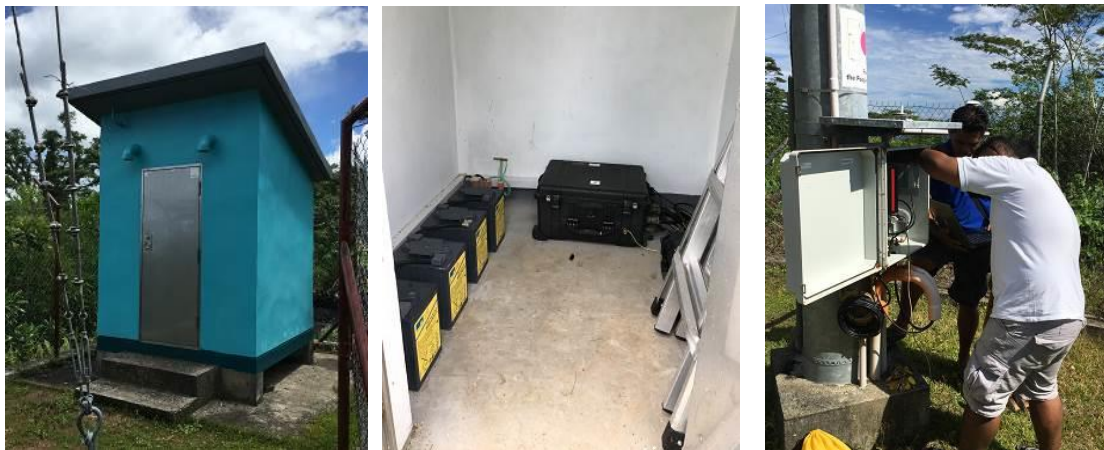
also well maintained with cleaning and grass cutting. Daily checks suggested as part of technical support were not followed at the mandated frequency, due to a lack of human resources. However, daily mandated check items are still conducted every two or three days and this had not caused any serious issues or breakdown by the time of the ex-post evaluation. SMD properly conducted the refinishing paint of concrete shelters and responded to the broken equipment. Although no supplies and replacements except batteries can be locally procured in Samoa, all the equipment remained in operation without any problem by replacing broken parts with spare parts provided under this project. As indicated above, when all the spare parts are used, they need to procure supplies and replacement from outside Samoa. If SMD makes a proper plan and secures a budget, there will be no sustainability issues.

(Left) Concrete shelter: repainted wall by SMD (Togitogiga observation point)  
 (Centre) Inside the concrete shelter: Batteries (Left), Indoor units (Centre), IP phone (Mt. Talu observation point) (Right)  
 (Right) SMD staff working to maintain the data collection system (Le Piu Tai observation point)

By the time of ex-post evaluation, the supplies and replacement parts necessary for the equipment had been provided from stocks procured at the time of project completion. However, four years have now elapsed since that time and the remaining spare parts in stock are scarce, hence SMD needs to procure additional supplies and replacement parts in the near future. SMD requires to immediately make a procurement plan for stocks from the following year onward and must submit a budget to MNRE and the Ministry of Finance showcasing its importance, reflecting the need to import all spare parts except batteries, consider budget limitation and avoid system outages due to a lack of spare parts.
