FY2016 Ex-Post Evaluation of Japanese Grant Aid Project

“The Project for Rural Water Supply (Phase II)”

External Evaluators: Yuko Kishino and Yukitoshi Matsumoto, IC Net Limited

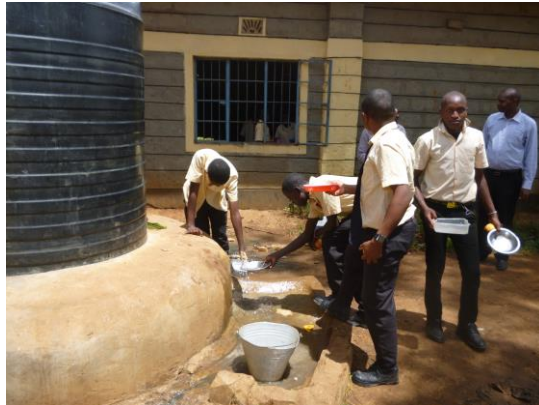
Facility at the Miu Secondary School,  
Mwala, Machakos County

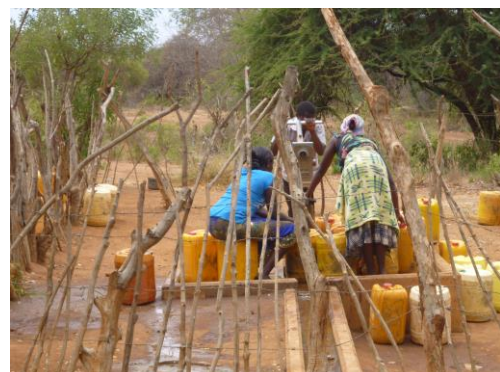
Photo 1: Facility in Nguuswini Village

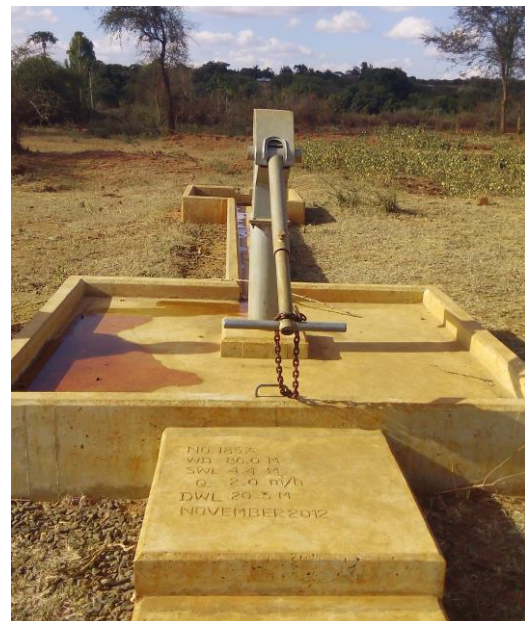
Fifteen facilities out of the 58 were not functioning at the time of ex-post evaluation because of the malfunctioning of equipment and parts, the theft of generators and pumps, worsening water quality, inconvenient locations for users, and water shortages. Meanwhile, as seen in Photo 2, very few people use the facility at Kikulumi village because of the inconvenient location and the salinity of the water. Some facility compounds (especially where a water attendant is not hired because a use fee is not collected) are not cleaned regularly, and dung from livestock are not removed. The fences built by residents at many facilities also require repair work.

Photo 2: Facility at Kikulumi Village

Most of the nonfunctioning facilities at the time of ex-post evaluation failed because of the malfunctioning of a part, except in two cases of the theft of a generator and hand pump. However, the technical malfunction was not serious in many cases and could have been repaired if appropriate measures had been taken swiftly. Therefore, to maintain the facilities properly, it is important that the county government, in particular at the sub-county level (also at the ward level in Makueni County), institutionalize a mechanism for information management, regular monitoring, and communication and reporting with the Water Users Associations. As some users of the facilities expressed concerns about the safety of the water, it is also necessary to establish a mechanism to check water quality on a regular basis. While some facilities provide water free of charge, it is vital to collect water user fees to further ensure the sustainability of the facilities.

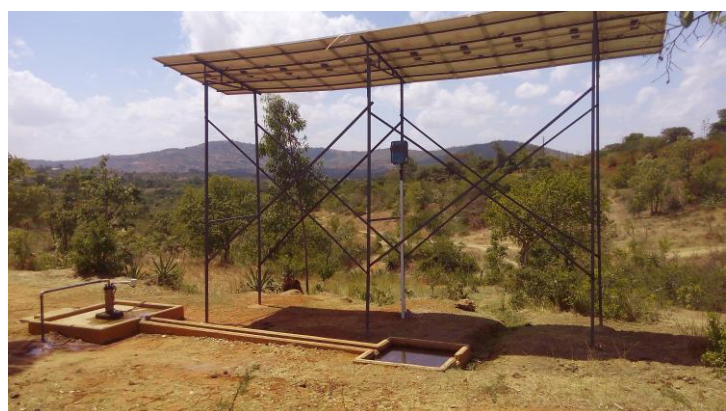
Meanwhile, it was found that the initiatives of some members of the WUA led to support from the county government in which solar power systems (Photo 3) or water tanks, water pipes, and water kiosks were installed at two facilities in Machakos County. In Makueni County, two facilities started repairing equipment

Photo 3: Facility at Liyuni Village
