FY 2016 External Ex-Post Evaluation of Japanese Grant Aid Project
“The Project for Reconstruction of Bridges on Managua-El Rama Road”

External Evaluator: Hiromi S. Suzuki, IC Net Limited

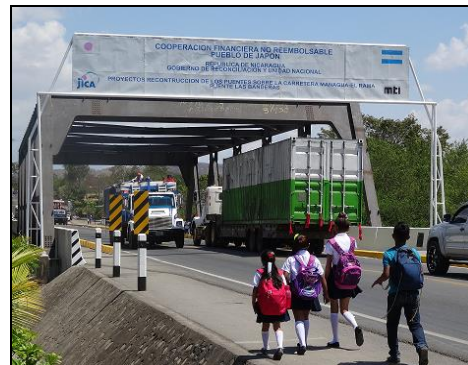
Las Banderas Bridge:
Primary school children crossing the bridge
to attend school

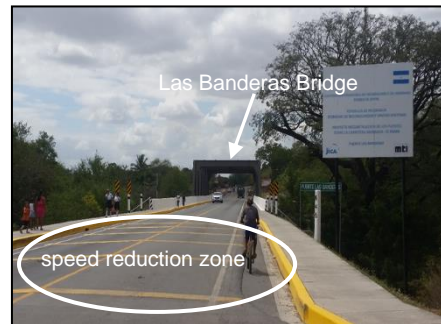
Speed reduction zone at Las Banderas Bridge (towards El Rama)

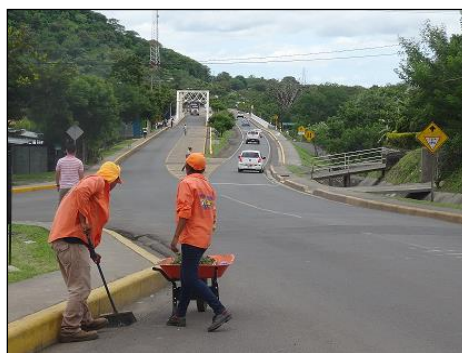
FOMAV workers conducting cleaning work near Tecolostote Bridge

As an autonomous entity, FOMAV signs an annual agreement with the MTI and conducts the above mentioned routine maintenance and periodic maintenance. For the Project, FOMAV is in charge of the routine maintenance and periodic maintenance of bridges and access roads. FOMAV employs some 50 staff members (three engineers are directly involved in the maintenance of the bridges of the Project). FOMAV enters into a road maintenance contract with micro companies²⁵ formed by local residents for each
